Section/division Accident and Incident Investigations Division

LIMITED ACCIDENT INVESTIGATION REPORT

Reference Number		CA18/2/3/9998									
Classification	Accid	dent	Date		6 May 2021		Time		1450Z		
Type of Operation		Private (Part 91)									
Location											
Place of Departure		Zebula Airfield		Р	Place of Intended Landing			Rand Airport (FAGM)			
Place of Accident Parking bay, Zebula Airfield, Limpopo Province											
GPS Latit		tude 24°45´22" S		Longitude	027°58′12" E		Elevat	Elevation		65ft	
Aircraft Informat	ion	'						- 1			
Registration		ZS-FJU									
Model/Make	Cessna 172K										
Damage to Aircraft		Substantial			Total Aircraft Hours			13252.18			
Pilot-in-comman	ıd										
Licence Valid		Yes		Gende	er	Male		Age	29		
Licence Type	Private Pilot Licence (Aeroplane)										
Total Hours on Type		±46.3			Total Flying Hours			118.3			
People On-board	1+1	Injur	ies	0	Fatalities	()	Other (on ground)		0	
What Happened

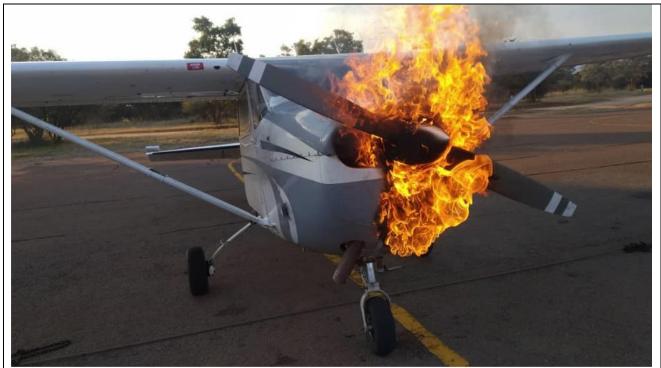
The aircraft sustained fire damage to the engine compartment and the paint work on the cowlings. The pilot and the passenger did not sustain any injuries during the accident.

Figure 1: Front section of the nose compartment that caught fire. (Source: Pilot)

The cause of fire was due to over priming the engine, which led to fuel flooding the cylinder heads which were still hot, and thus, ignited the fuel.
