LIMITED ACCIDENT INVESTIGATION

Reference Number	CA18/2/3/9997						
Classification	ACCID	Date	6 May 2021	Time	1245Z		
Type of Operation	Private (Part 94)						
Location							
Place of Departure	Tankwa Padstal	Place of Intended Landing	Loeriesfontein Airfield				
Place of Accident	Loeriesfontein Airfield (FALF), Northern Cape Province						
GPS Co-ordinates	Latitude	30°54'25" South	Longitude	019°25'33" East	Elevation	2811feet	
Aircraft Information							
Registration	ZU-PBB						
Model/Make	Jabiru J230						
Damage to Aircraft	Substantial	Total Aircraft Hours	808.2				
Pilot-in-command							
Licence Type	National Pilot Licence	Gender	Male		Age	57	
Licence Valid	Yes						
Total Hours on Type	26.7		Total Flying Hours	556.9			
People On-board	1+0	Injuries	0	Fatalities	0	Other (On Ground)	0
What Happened							
<p>On 6 May 2021 at about 1130Z, a Jabiru J230 aircraft with registration ZU-PBB was operated as a private flight from Tankwa Padstal private airstrip with the intention to land at Loeriesfontein Airfield (FALF). On-board the aircraft was a pilot flying solo. The flight was conducted under Visual Flight Rules (VFR) by day. The entire flight was uneventful and lasted approximat

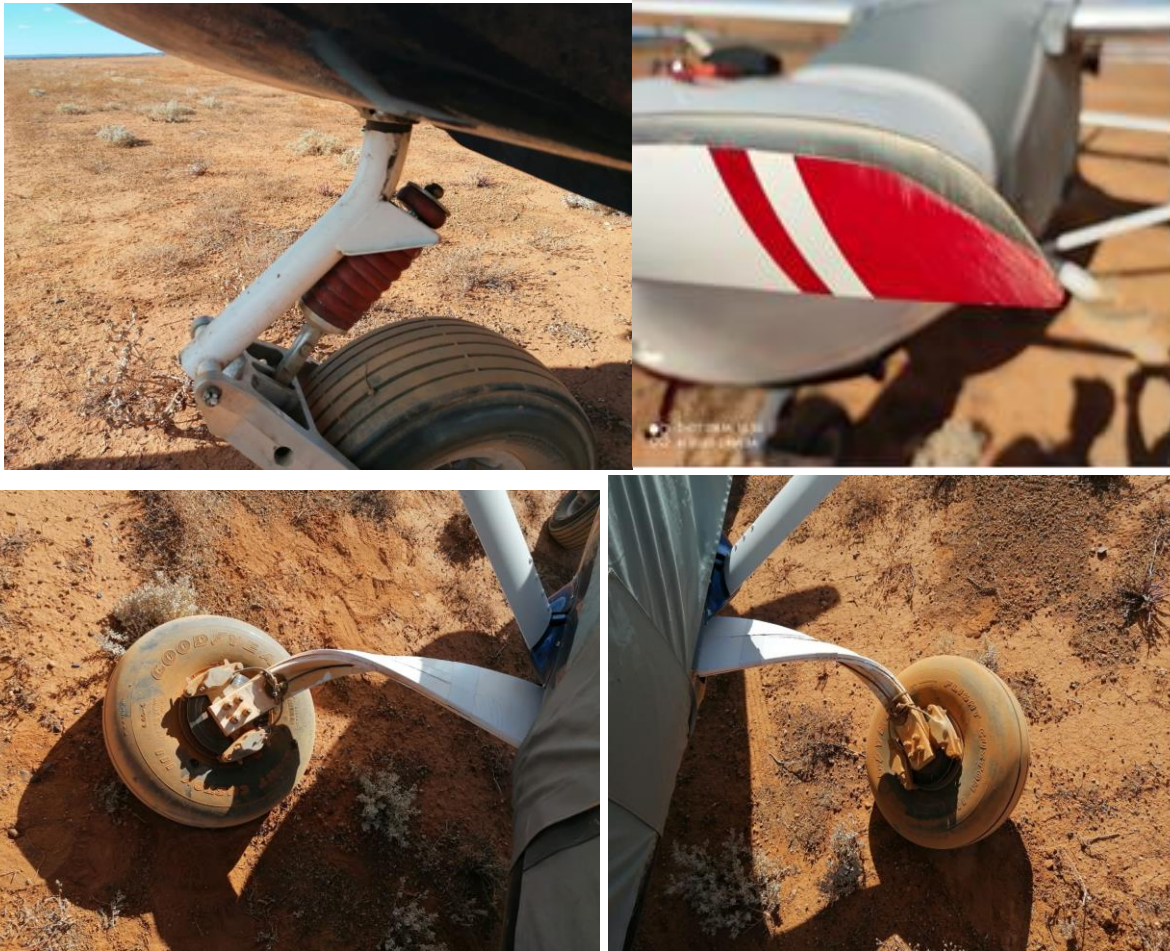
Figures 1, 2, 3 & 4: Damage to the nose gear strut (top left), one of the propeller blades (top right), left main landing gear (bottom left), and right main landing gear (bottom right). Damages are all consistent with hard landing.

Probable cause: Although the pilot stated that the aircraft was hit by a downdraft and, as a result, lost control, it is likely that the aircraft had an unstable approach which led to a hard landing. It is also possible that the pilot was not familiar with the airstrip.
