LIMITED ACCIDENT INVESTIGATION REPORT

Reference Number	CA18/2/3/10014						
Classification	Accident	Date	16 June 2021	Time	1100Z		
Type of Operation	Private (Part 94)						
Location							
Place of Departure	Margate Aerodrome (FAMG), KwaZulu-Natal Province		Place of Intended Landing		Magwa Private Airstrip, Eastern Cape Province		
Place of Accident	Next to a beach, North of Port St John's, KwaZulu-Natal						
GPS Co-ordinates	Latitude	S31°23'.736	Longitude	E029°41'.548	Elevation	1 500 feet	
Aircraft Information							
Registration	ZU-ENP						
Make / Model	Savannah MXP-740V						
Damage to Aircraft	Minor		Total Aircraft Hours	603			
Pilot-in-command							
Licence Valid	Yes		Gender	Male		Age: 67	
Licence Type	National Pilot Licence (NPL)						
Total Hours on Type	17.4		Total Flying Hours	8000			
People On-board	1 + 1	Injuries	0	Fatalities	0	Other (On Ground)	0
What Happened							
<p>On Wednesday, 16 June 2021, a pilot accompanied by a passenger were on a private flight from Margate Aerodrome (FAMG) in KwaZulu Natal province, destined for Magwa private airstrip, situated on the northern side of Port St John's in the Eastern Cape province when the accident occurred. The flight was

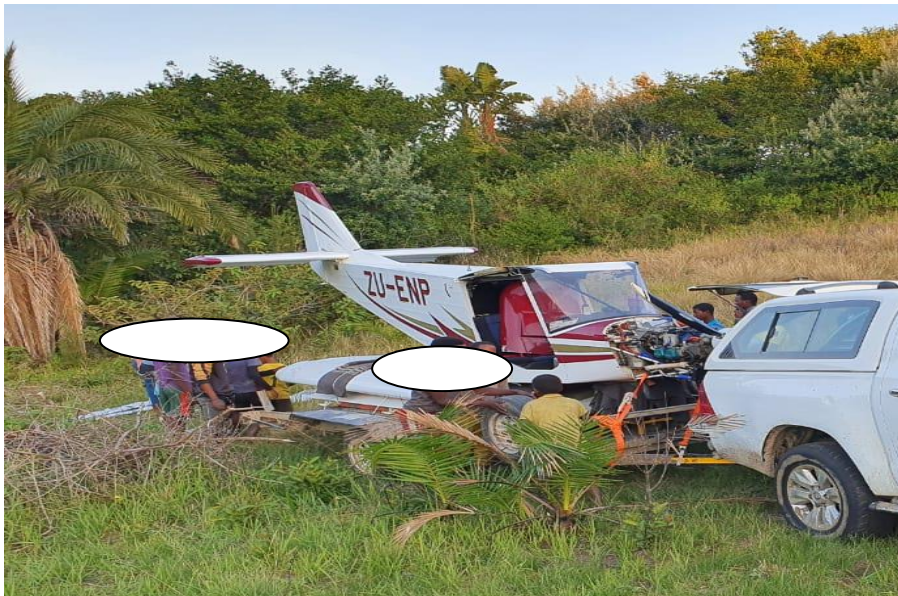
At this point, the aircraft was cruising at about 1000 feet (ft) above ground level (AGL) and travelling at 90 miles per hour (mph) along the coastline. After 20 minutes into the flight, the pilot was alerted to an erratic engine oil temperature warning indication. As a safety precaution, the pilot switched off the engine to avoid possible engine damage and glided the aircraft to an open space to execute a forced landing. Touch down next to the beach was normal, however, during the ground roll, the nose wheel dug into the soft sand. As a result, the aircraft's nose pitched down and the propeller hit the ground. The aircraft sustained minor damages and the occupants on-board were not injured.

Figure 1: The aircraft as it was loaded onto a trailer with wings removed. (Source: Pilot)

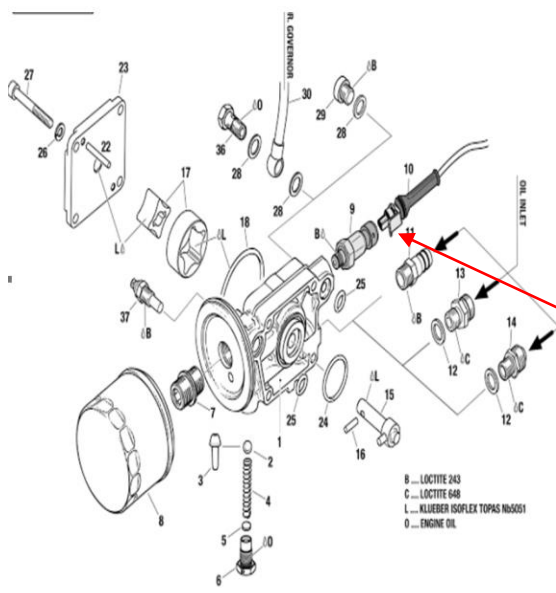
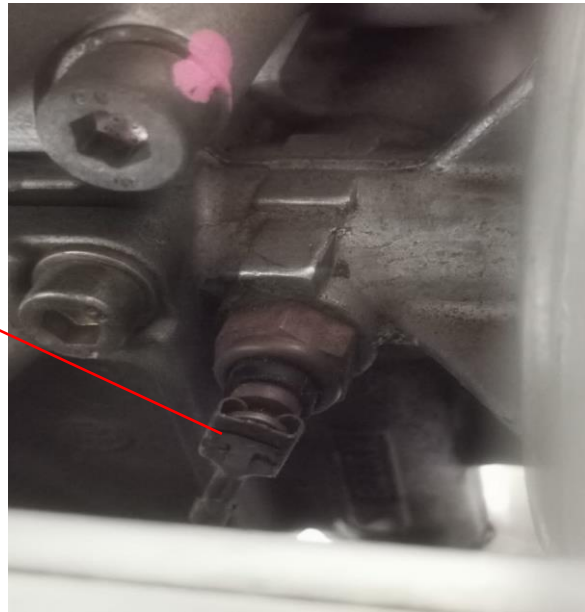
Post-accident, the pilot inspected underneath the instruments panel to verify if the electrical wiring and connections were in order; he found that all was normal. The pilot then disembarked the aircraft and opened the engine cowlings; visual inspection of the engine, a Rotax 912-ULS four-cylinder engine, was conducted and there were no signs of oil leak. The pilot noticed that the electrical temperature sensor wire for the oil temperature gauge that is mounted on the engine casing was not properly secured (it was loose). The pilot pushed it into position with a plier and tightened it. He then switched on the master and checked the oil temperature needle position, which indicated normal pressure at green arch. *The oil temperature sensor on a Rotax 912-ULS engine measures the temperature of the oil as it enters the engine after coming out of the oil cooler.*

The investigation concluded that the erratic oil temperature warning indication was due to a faulty signal from the electrical temperature sensor wire which caused the oil temperature gauge to show erratic readings.

Figures 2/3: (Left) The engine schematics from the illustrated parts catalogue (IPC) shows the location of the oil temperature sensor on the engine casing. (Right) The engine oil temperature sensor mounted on the engine casing.

Pilots to ensure that they conduct a proper pre-flight inspection with emphasis on the security of components and their associated wiring.
