LIMITED ACCIDENT INVESTIGATION REPORT
--

Reference Number		CA18/2/3/10032						
Classification	Accident	Date	24 August 2021	Time	0924Z			
Type of Operation		Helicopter Aerial Work (Part 137)						
Location								
Place of Departure		Private farm near Nylsvlei Nature Reserve		Place of Intended Landing		Private farm near Nylsvlei Nature Reserve		
Place of Accident		Private farm near Nylsvlei Nature Reserve, Limpopo province						
GPS Co-ordinates		Latitude	S 24° 41' 17"	Longitude	E 28° 40' 15"	Elevation	3624 ft	
Aircraft Information								
Registration		ZS-ROA						
Model/Make		Robinson R22 Beta II						
Damage to Aircraft		Substantial		Total Aircraft Hours		2293.2		
Pilot-in-command								
Licence Valid		Yes	Gender		Male	Age	38	
Licence Type		Commercial Pilot Licence (Helicopter)						
Total Hours on Type		1832.0		Total Flying Hours		9011.3		
People On-board		1 + 0	Injuries	0	Fatalities	0	Other (On Ground)	0
What Happened								
<p>On 24 August 2021, a pilot on-board a R22 Beta II helicopter with registration ZS-ROA was engaged in a game capturing flight at a private farm near Nylsvlei Nature Reserve. The flight was conducted during day light under the provisions of Part 137 of

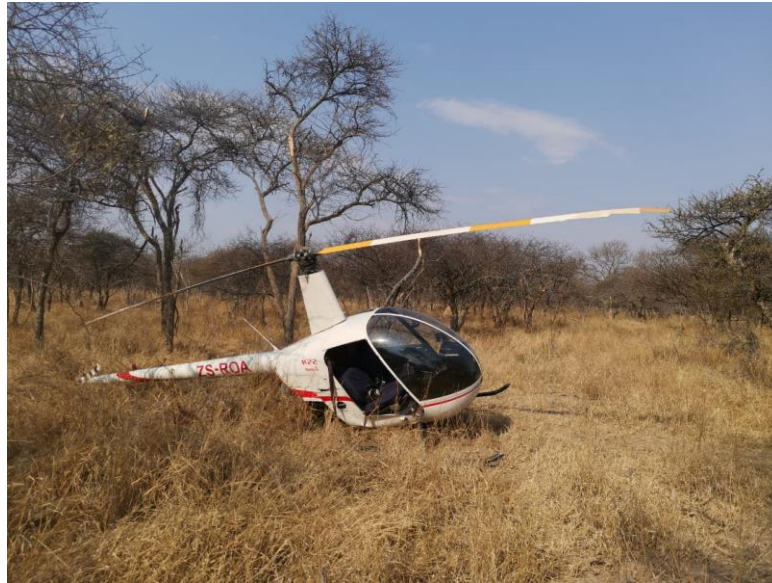
The helicopter sustained substantial damage to the tail rotor, main rotor blades and skids. The pilot was not injured during the accident sequence.

Figure 1: The helicopter at the accident site. (Source: Pilot)

The trees (in Figure 1) were likely lower in height than what the pilot had stated (as 30m tall). Therefore, it is probable that the pilot was operating the helicopter at a lower height when the helicopter's tail cone struck a tree.

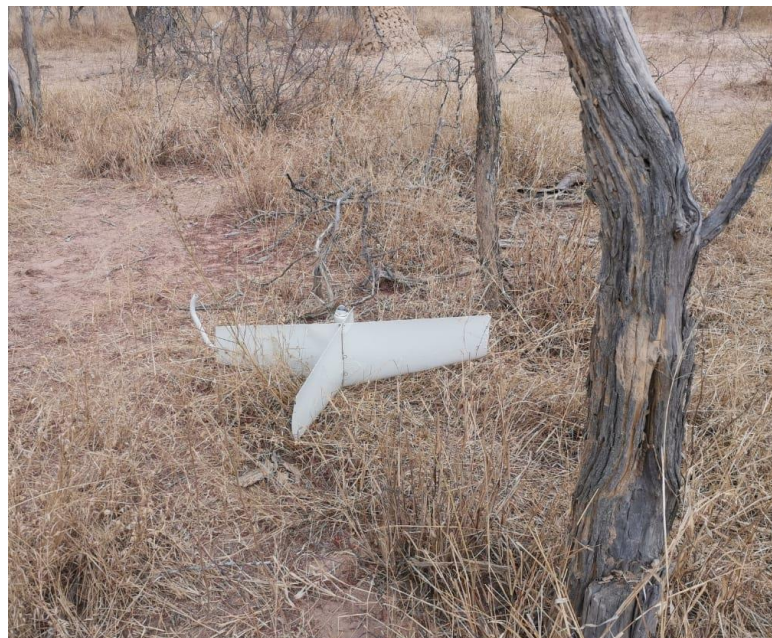
Figure 2: The helicopter's severed stabiliser. (Source: Pilot)

<p>Probable cause:</p> <p>The helicopter's tail cone struck a tree during a low-level operation, which resulted in the severing of the stabiliser assembly, as well as loss of tail rotor effectiveness. This caused an uncontrollable yaw and the subsequent crash.</p>	
<p>Safety Action/s</p> <p>None.</p>	
<p>Safety Message and/or Safety Recommendation/s</p> <p>None.</p>	
<p>Purpose of the Investigation</p> <p><i>In terms of Regulation 12.03.1 of the Civil Aviation Regulations (CAR) 2011, this report was compiled in the interest of the promotion of aviation safety and the reduction of the risk of aviation accidents or incidents and not to apportion blame or liability.</i></p>	
<p>About this Report</p> <p><i>Decisions regarding whether to investigate, and the scope of an investigation are based on many factors, including the level of safety benefit likely to be obtained from an investigation. For this occurrence, no investigation has been conducted, and the Accident and Incident Investigations Division (AIID) has relied on the information submitted by the affected person/s and organisation/s to compile this brief report. The report has been compiled using information supplied in the initial notification, as well as follow-up information to bring awareness of potential safety issues to the industry in respect of this occurrence, as well as possible safety action/s that the industry might want to consider in preventing a recurrence of a similar accident.</i></p> <p><i>This report provides an opportunity to share safety message/s in the absence of an investigation.</i></p> <p><i>All times given in this report are Co-ordinated Universal Time (UTC) and will be denoted by (Z). South African Standard Time is UTC plus 2 hours.</i></p>
