**LIMITED OCCURRENCE INVESTIGATION REPORT – FINAL**

<b>Reference Number</b>	CA18/3/2/1402						
<b>Classification</b>	Serious Incident	<b>Date</b>	4 September 2022	<b>Time</b>	0910Z		
<b>Type of Operation</b>	Training (Part 141)						
<b>Location</b>							
Place of Departure	Port Alfred Aerodrome (FAPA), Eastern Cape Province	Place of Intended Landing	Virginia Aerodrome (FAVG), KwaZulu-Natal Province				
Place of Occurrence	On the beach near the old Durban Aerodrome						
GPS Co-ordinates	Latitude	29°58'32.95" S	Longitude	030°58'22.60" E	Elevation	20 feet	
<b>Aircraft Information</b>							
Registration	ZS-PET						
Make; Model; S/N	Piper Aircraft Corporation; PA-28-180 (Serial Number: 28-7305163)						
Damage to Aircraft	None		Total Aircraft Hours	13 936.0			
<b>Pilot-in-command</b>							
Licence Type	Student Pilot Licence		Gender	Female		Age	28
Licence Valid	Yes	Total Hours	113.9		Total Hours on Type	71.5	
Total Hours Past 90 days	39.6		Total Flying Hours on Type Past 90 days	7.3

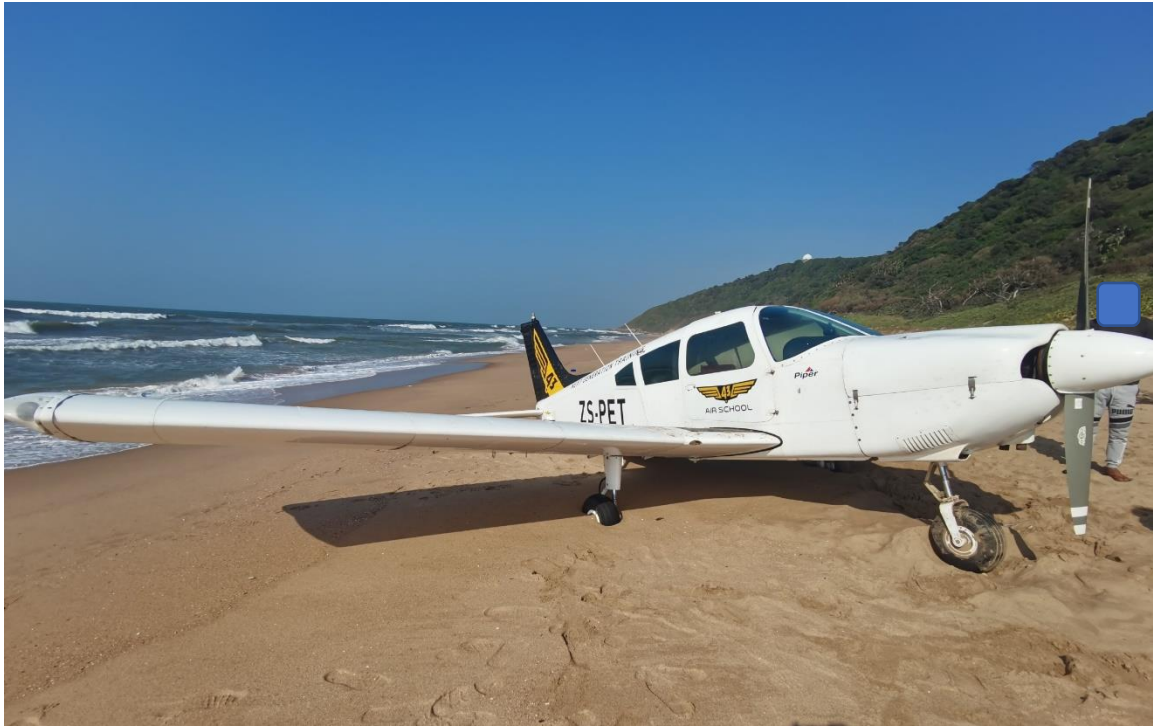
**Figure 2:** The aircraft as it came to rest on the beach. (Source: AMO)

- (viii) No person was injured during the incident sequence.
- (ix) The aircraft did not sustain any damage during the landing sequence on the beach.
- (x) Four (4) litres of fuel was drained from the right tank and forty (40) litres from the left tank.

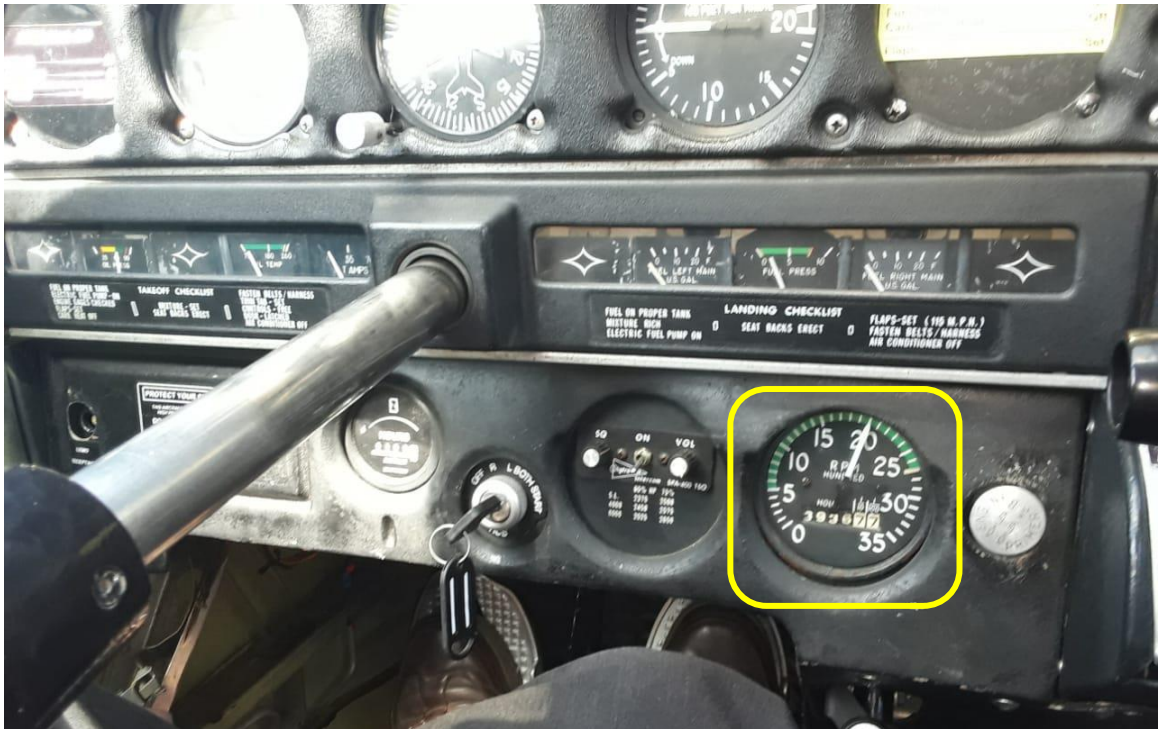
- (v) The photograph in Figure 3 was taken during the engine ground-run with the engine revolutions per minute (RPM) gauge indicating a reading of 2 000rpm.

**Figure 3:** Photograph taken during the engine ground-run. (Source: AMO)

- (xi) An engine test-run was conducted post recovery and no anomalies were noted that prevented normal engine operation.
