Flap control lever unintentionally released, Schempp-Hirth Nimbus-3T, D-KJUN

Terlet glider airfield, 4 September 2022

Reference: 2022129

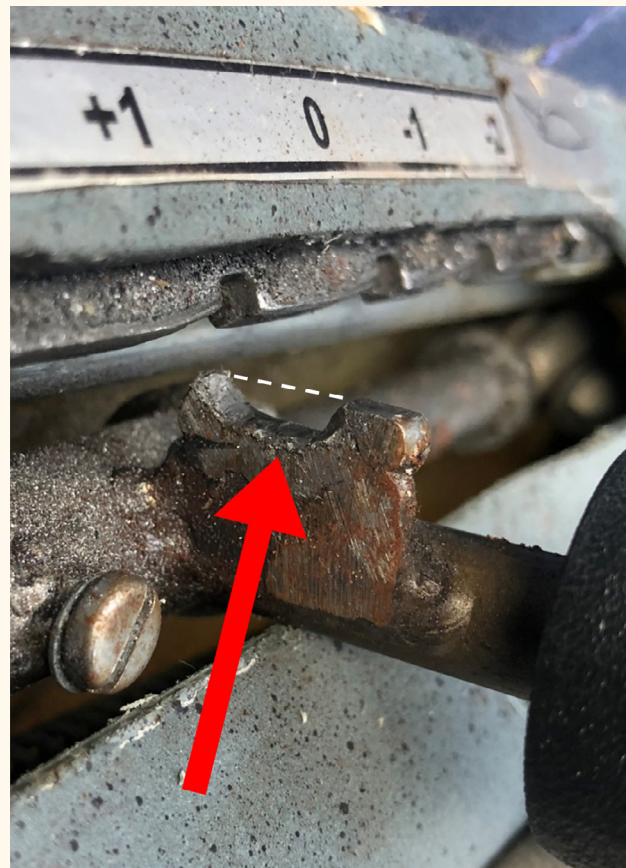
Inspection of the flap handle mechanism showed that the pawl on the flap handle showed wear and that a notch had formed. This allowed the pawl to release from the detent plate, when forces on the flaps increased after the pilot had opened the air brakes.

▲ The pawl, with a notch in it, which is part of the flap control lever.

control SHK-M-01-11 must be noted. This information must also be appended to the service instructions. The maintenance information stated, among other things, that in addition to the detent plate, the pawl on the flap handle must also be checked for wear, that it must have a rectangular cross-section and the edges must not be excessively rounded. It contained a picture of a badly worn pawl in which also a notch had formed, along with the text that this example has come a long way above the wear limit that would have required a repair.
