A case history involving wreckage analysis

Lessons from the Ustica investigations

A. Frank Taylor
Cranfield University – now Visiting Fellow

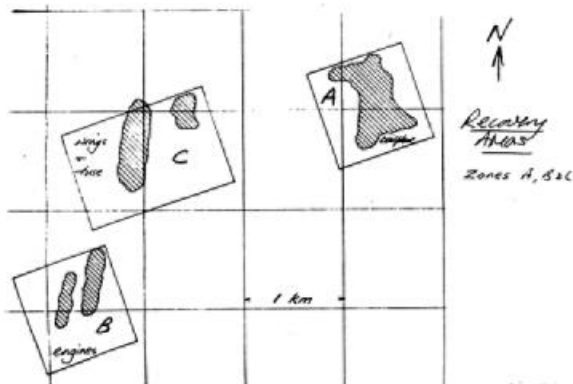
- The relative positions of the engines, of the fuselage pieces and wings, and of the tailcone and tailplanes, in recovery Zones B, C and A respectively, not only fitted the expected locus of debris expected

from an in-flight break-up but also gave the approximate position of the break-up.

The three recovery Zones

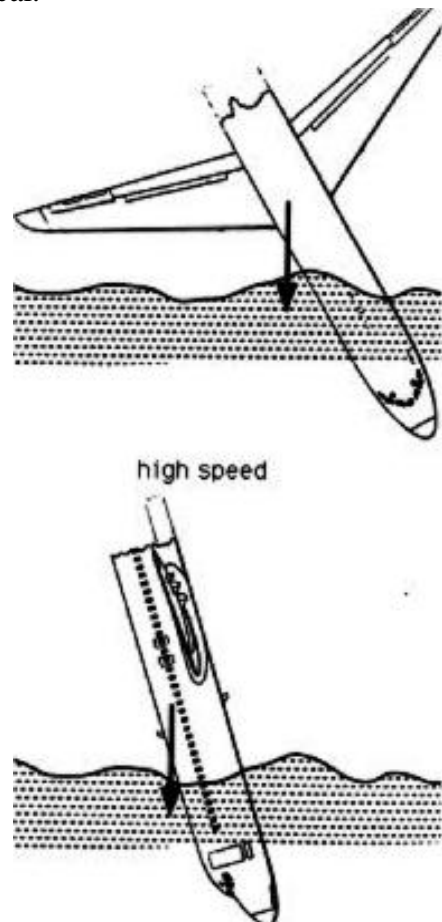
The buckling of the front fuselage, cockpit windows and the starboard wing clearly showed that these parts had entered the water at high speed, almost straight down, with the wing leading edge parallel with the sea surface and the fuselage just over the vertical.

Probable attitude on hitting water

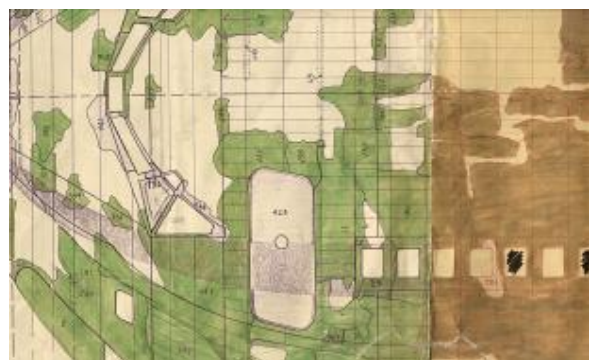
Note that several web sites show a picture similar to this with the claim that there is a large hole aft of the door, through which a missile passed. There is in fact no hole at all as can be seen from the following diagram depicting the pieces of skin as if opened out (unbuckled) to the original shape.

Skin diagram prepared during reconstruction

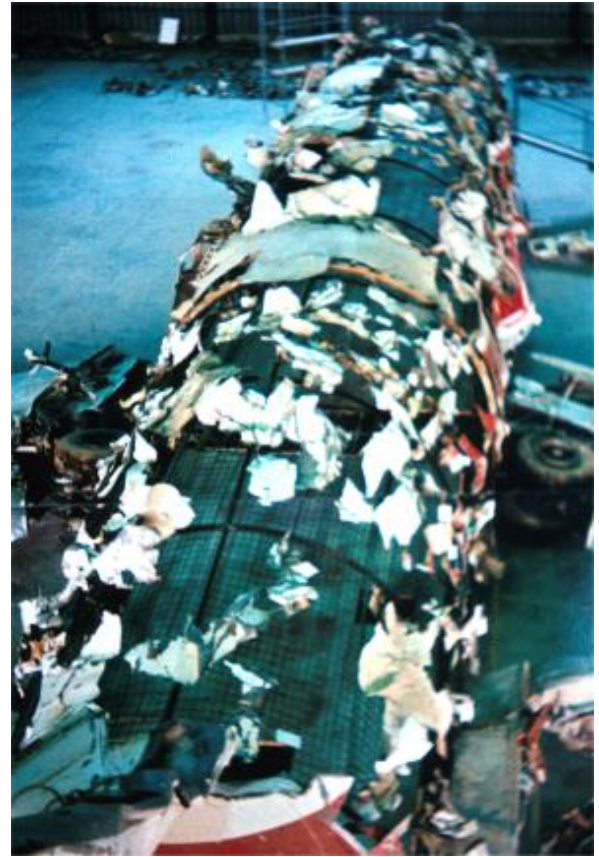
Some pieces, it was later found, had been correctly identified and labelled by Alitalia engineers but then incorrectly positioned. Nevertheless it took several hours of close study to discover where other pieces actually

Rear fuselage after 'contamination'

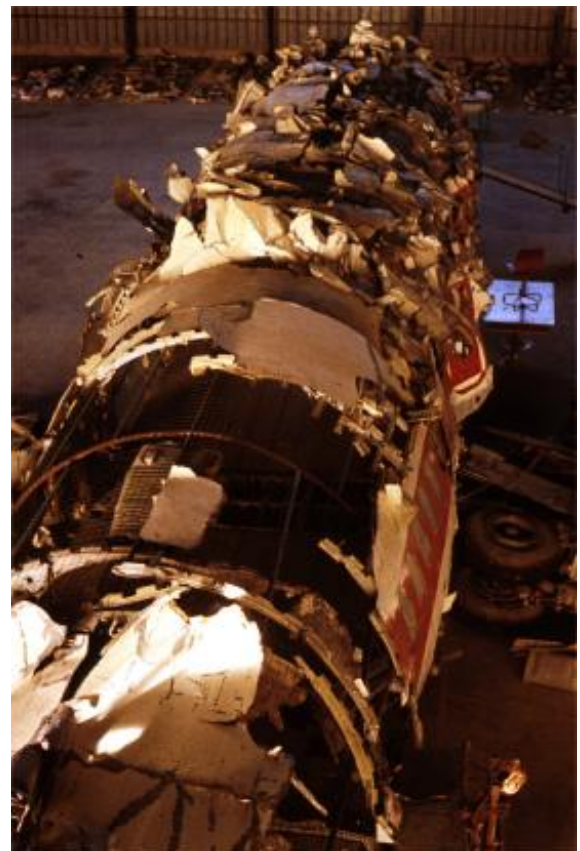
came from and to show that they all in fact belonged to the forward fuselage.

Rear fuselage after re-positioning of 'contamination'

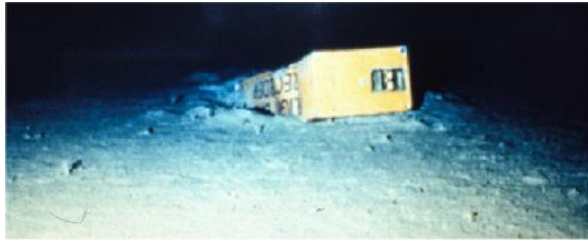
FDR on seabed after 12 years

Under normal circumstances these both took their power from the starboard engine. They were found detached from their aircraft mountings but within the same general area, the CVR was found and read out by the Blasi Commission, the FDR later by the Priore Commission.

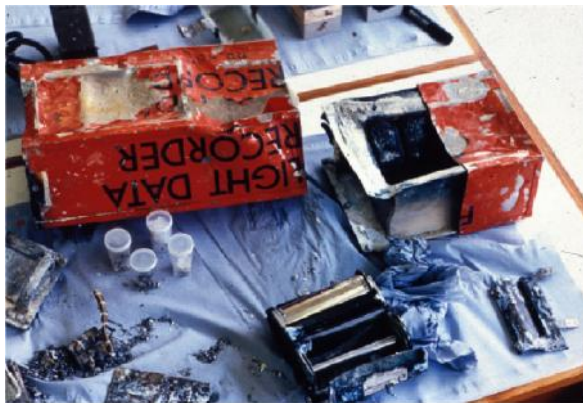
The FDR was of an old, scratch foil type and confirmed only that the aircraft flight path was as derived from the radar data. It contained no data changes immediately before the cessation of power.

The FDR at the AAIB Farnborough

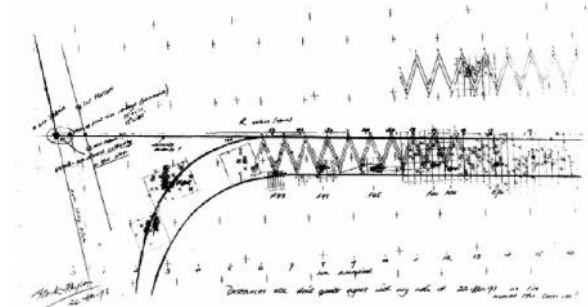
The wreckage of the DC-9 was found to be distributed along an essentially west to east trail approximately 1.5 km wide and at least 16 km long. The Blasi Commission located wreckage in Zones A, B and C, initial recovery by the Priore Commission was from

within this combined area but subsequently the search was continued some way downwind in Zone E and finally in Zone F, between A and E.

Sketch of the wreckage trail

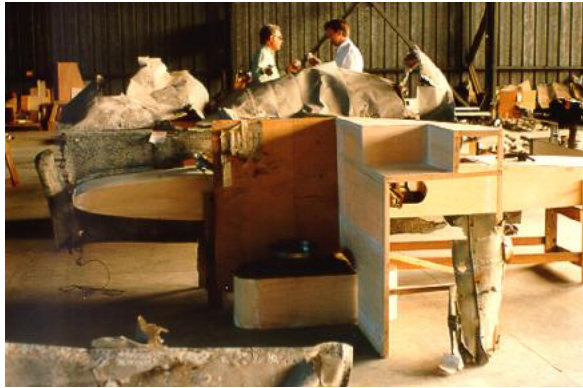
Rear toilet mock-up with engine cowling beyond - also note position of tissue holder referred to in 3.2.7

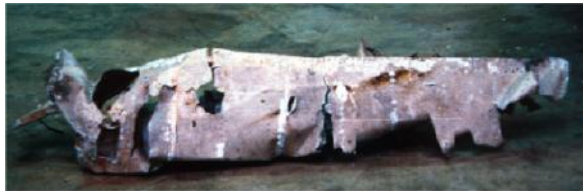
While the port engine cowlings had no significant damage other than the paint marks on the intake, the starboard engine cowlings had a variety of dents, cuts, holes, scratches and paint marks on the left side, that is on the parts adjacent to the fuselage side and thus to the toilet wall.

Part of the starboard engine cowling

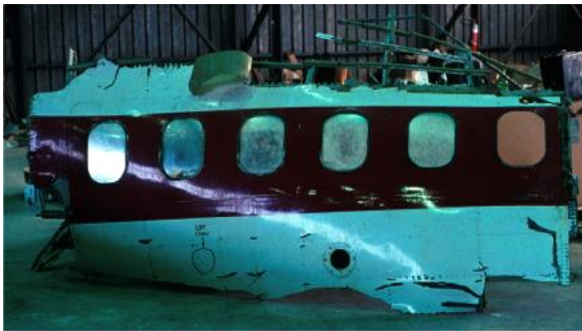
The position of this piece on the sea bed had been accurately predicted after the recovery of the equivalent section from the starboard side.

Starboard skin next to and forward of engine

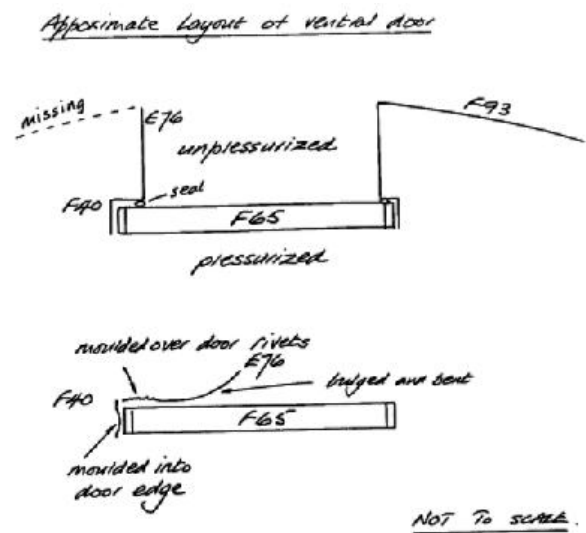
Sketch of ventral door and frame with impressions

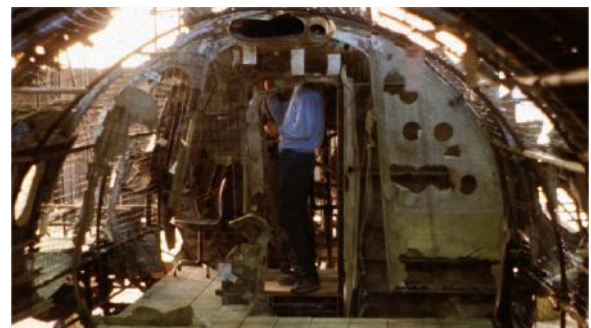
- The loss of the rear pressure bulkhead above floor level behind the toilet and the damage to the forward face of the duct behind it
- The outward and forward distortion of the fuselage frame AZ528 (F9) and fracture of the forward engine mounting struts at station 786

Rear cabin with web containing forward engine mount

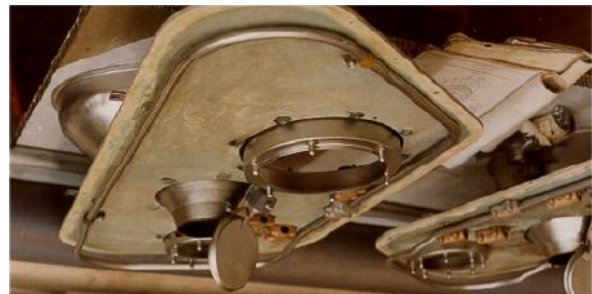
Intact pipe beneath a new toilet tank lid

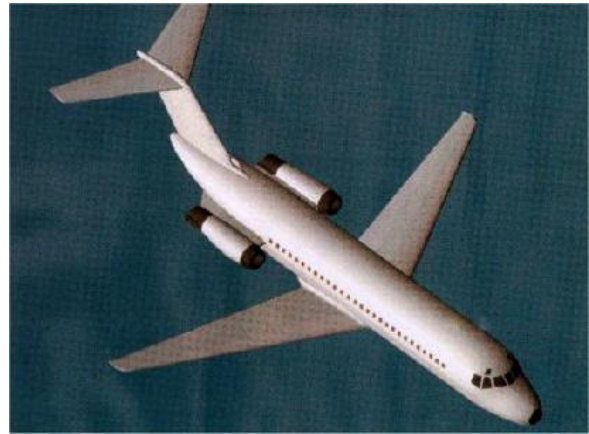
Time zero

1. An explosion occurred in the rear toilet outer wall just behind Station 801 and just above Stringer 16, i.e. just above the lower skin of the starboard engine pylon. The explosion was of a relatively small quantity of explosive probably wrapped only in plastic sheet.
2. The explosion caused local damage and, as a result of both the elevated pressure and shock waves, blew the toilet walls outwards in all directions. The first 'contact' was of pieces of fuselage skin from above and below the pylon hitting the starboard engine cowlings.
3. The principal local structural damage was to the outside skin, the rear pressure bulkhead, the forward starboard engine mounting at station 786, the roof and the floor.

Pictorial views of break-up sequence

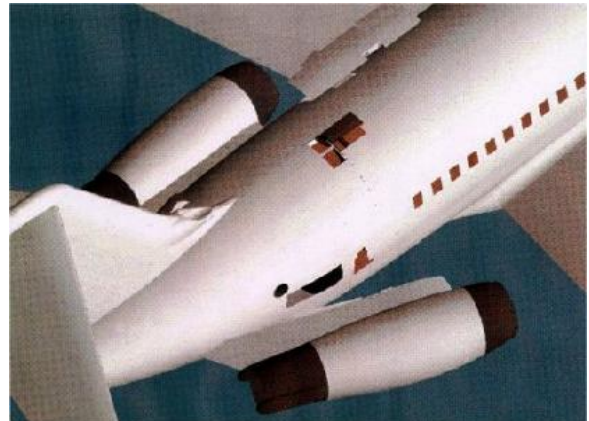
Approx 1 second from the explosion

6. As a result of the inner wall of the toilet and the toilet door blowing into the cabin a shock wave was felt by the upper skin on the port side, this, possibly in conjunction with the already failing top skin, caused skin on either side of station 642 to fold rapidly upwards at about stringer 6L leaving the distinctive scratch marks.

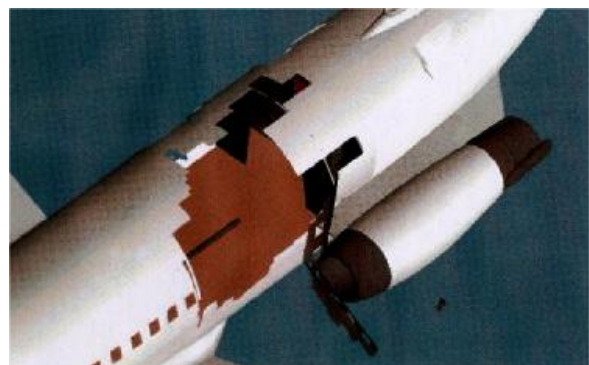
Approx 2 to 3 seconds from the explosion

8. Also within this period the starboard engine came off and the download on the tailplane, plus the additional aerodynamic drag caused by the open-topped rear fuselage, started to overload the window belt at station 642.

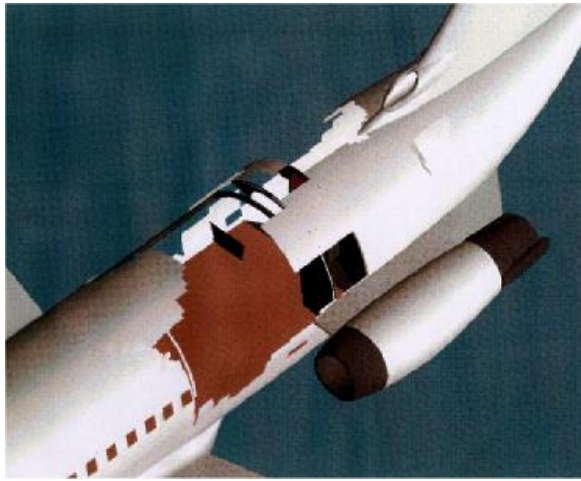
Approx 4 seconds from the explosion

10. Probably towards the end of this period the port engine came away together with the remaining piece of port window belt, F13, from station 718 to 817. This left virtually no structure above floor level to the rear of station 642 and significant damage at and below floor level at station 817.

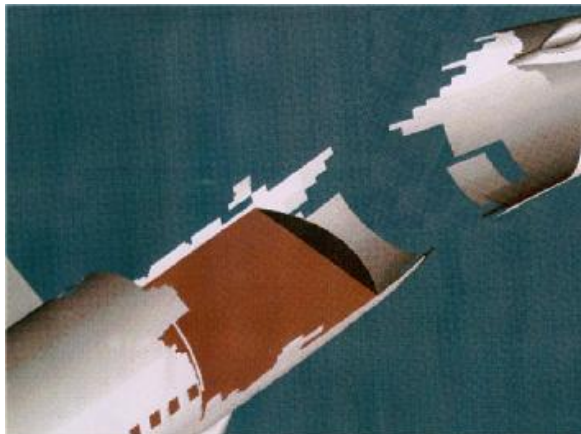
11. The break-up was effectively completed during the next second, the fifth since the explosion. The remaining pieces of frame 786 above floor level broke away followed by the final failure at the rear pressure bulkhead, station 817. This allowed the tail fuselage, fin and tailplane to break away and separate, releasing a large number of trapped pieces and the bulk of the rear, ventral stairs.

Approx 5 seconds from the explosion

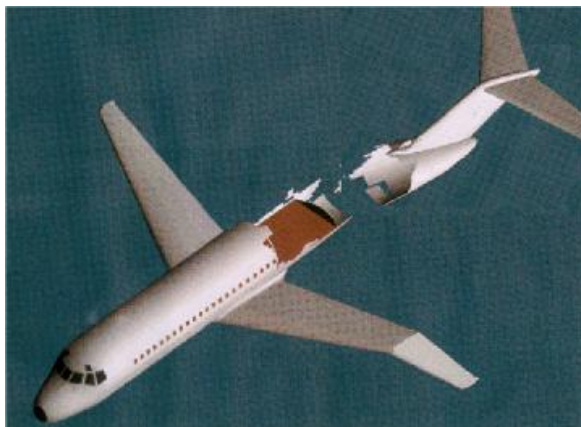
Approx 6 to 7 seconds after explosion

Pitch down breaks wing in down load
