# SOUTH AFRICAN CIVIL AVIATION AUTHORITY

## ACCIDENT REPORT – EXECUTIVE SUMMARY

# AIRCRAFT ACCIDENT REPORT

**Name of Owner/Operator** : Dr M.S. Kritzinger  
**Manufacturer** : Bell Helicopters Textron  
**Model** : 407  
**Nationality** : South African  
**Registration Marks** : ZS-RHV  
**Place** : Private farm, 20km North of Beaufort West  
**Date** : 28 April 2000  
**Time** : 0410Z

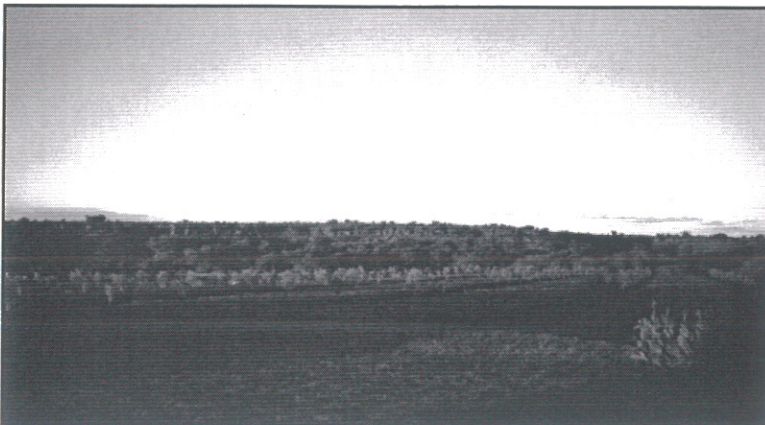
1.1.3 Within a few minutes after take-off the helicopter crashed, fatally injuring both occupants.

1.1.4 A farm worker located the wreckage later the day, at approximately 0830Z, behind a hill, some 400m from the place where the helicopter took off.

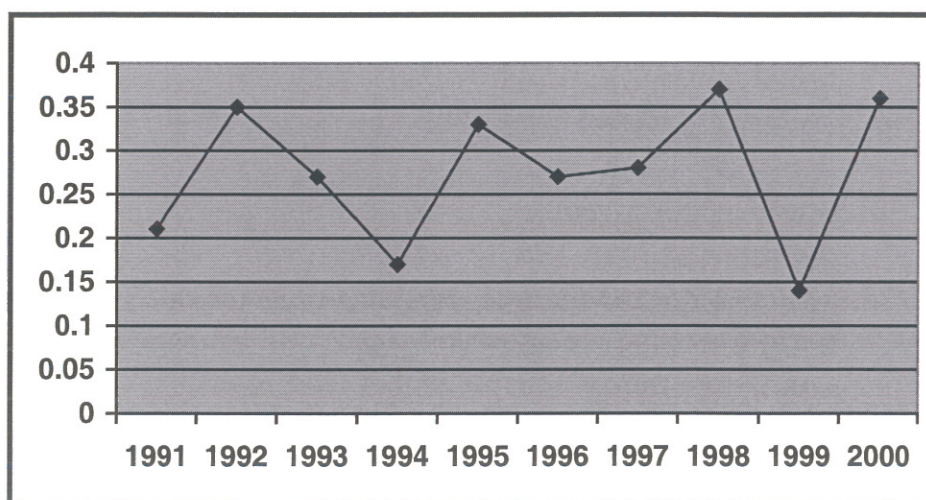
#### SD mishaps compared to G-Induced Loss of Consciousness (GLOC)

The rate of SD mishaps is not decreasing. The graph shows the number of SD-related mishaps per 100,000 flight hours compared to the G-Induced Loss of Consciousness (GLOC) Class "A" mishap rate.

1999 was an excellent year and slowed the upward trend when figuring in the first two quarters of 2000. Looking at mishaps from 1991 through the second

quarter of 2000, 19% of Class "A" mishaps involved SD. Many lives were lost as a result of unplanned impact with the ground.

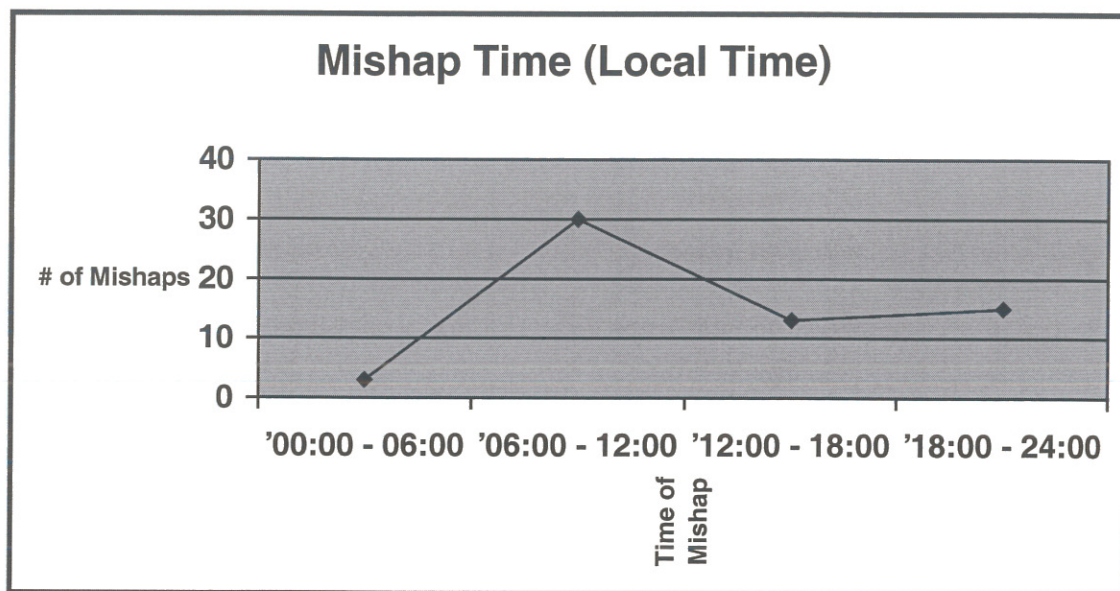
SD occurs commonly in the absence of good visual cues. It was found that most of the mishaps occurred during the hours of 06:00 and 18:00 Local time. (Unfortunately, the database does not accurately describe the actual meteorological conditions, only that it was day/night/dusk.)

It would appear that most of the mishaps occur during daylight hours.

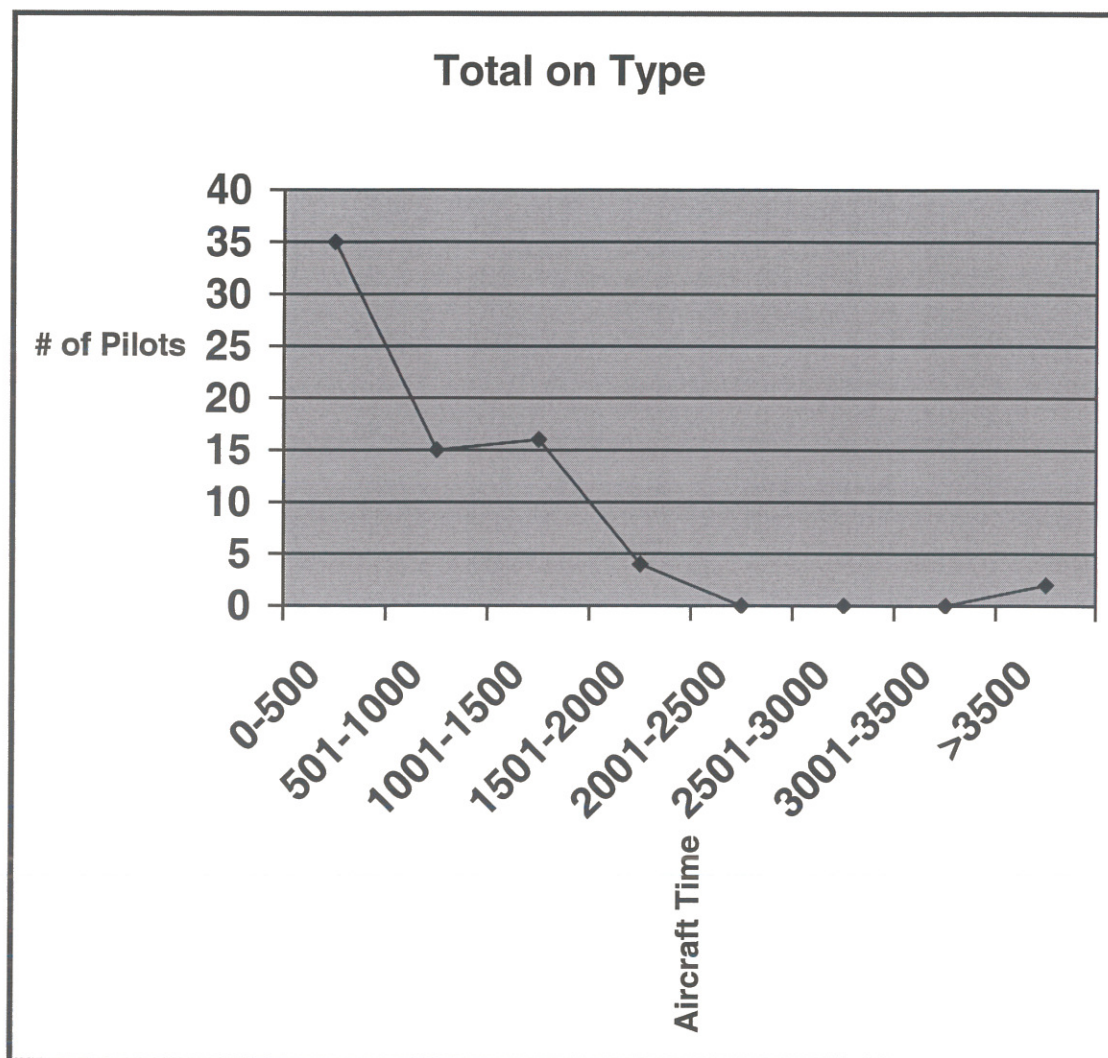
### **SD Mishaps vs Total Time on Type**

The following graph shows the hours pilots had in total on a aircraft type when they had their mishap. The majority of pilots involved in SD mishaps have between 0-500 hours on type. Here, it appears, the total time on the aircraft type may influence susceptibility to SD.
