**ROYAL AIR FORCE  
PROCEEDINGS OF A BOARD OF INQUIRY  
INTO AN AIRCRAFT ACCIDENT**

To inquire into an accident involving HARRIER T10 ZH654 on 24 Aug 00.

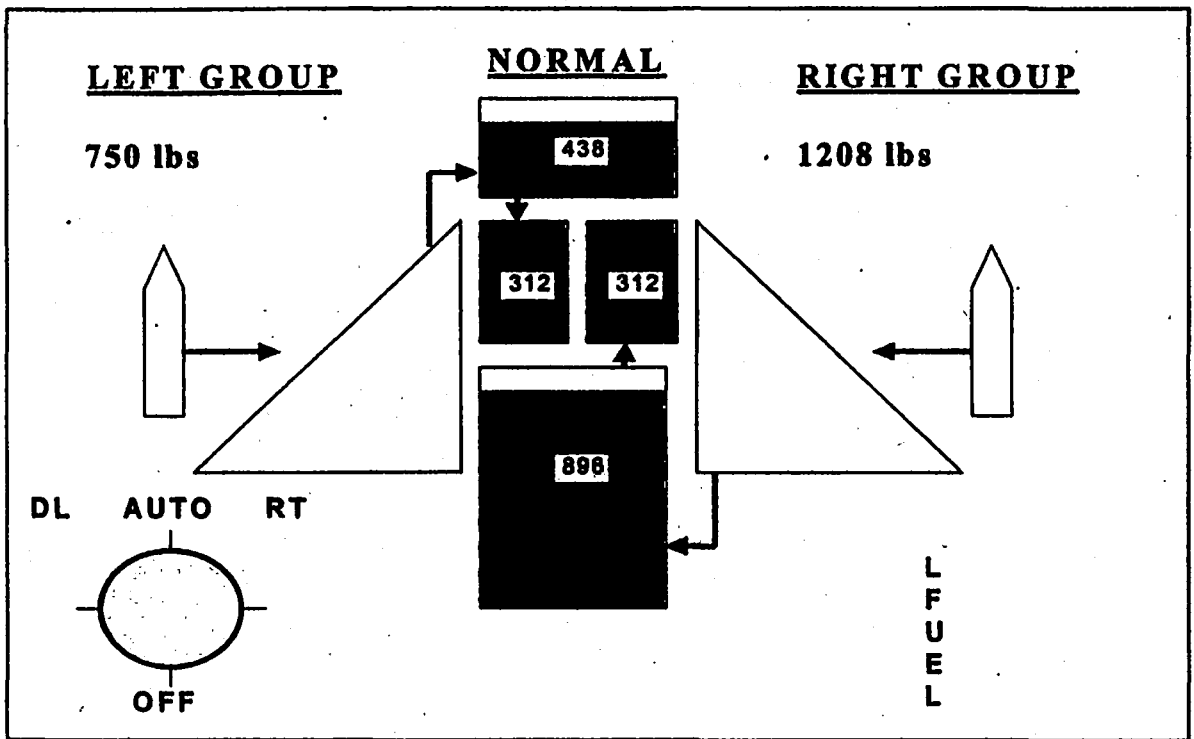
Diagram 2 - Illumination of LFUEL Caution

When the front tank, which is part of the left group, has 438lbs of fuel remaining there is only 750lbs total fuel remaining in the left hand side (LHS). At this stage the silent and steady LFUEL caution illuminates as shown above.

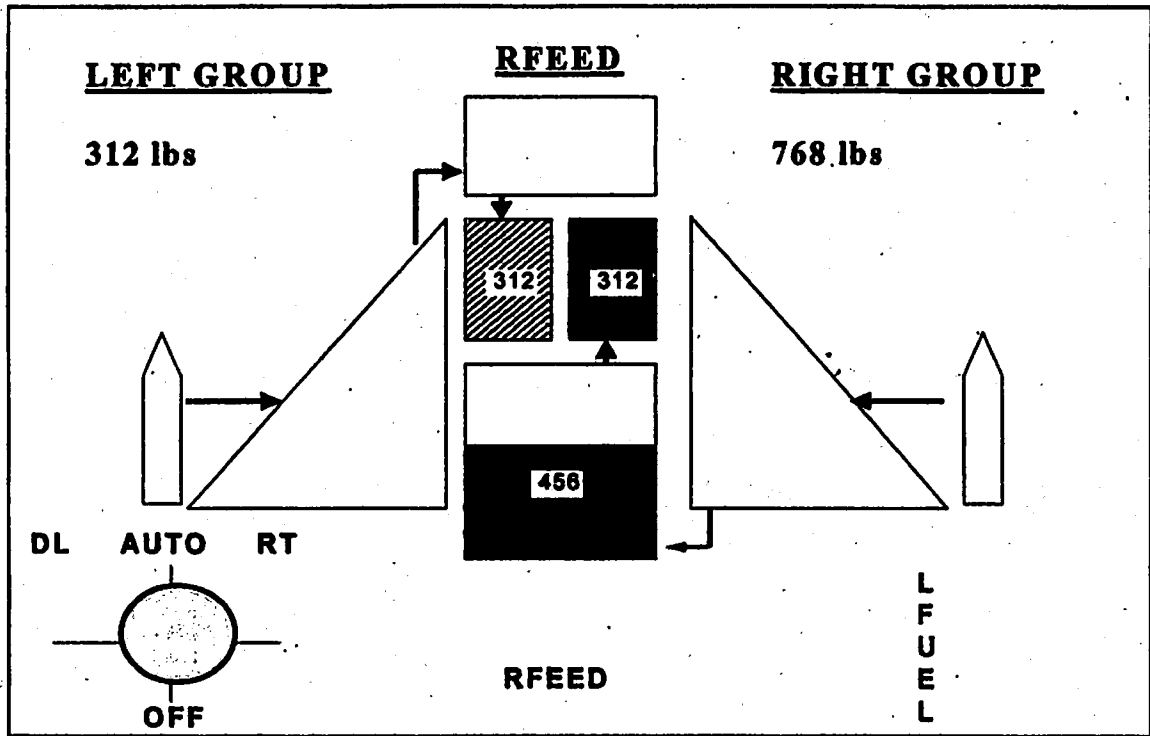
Diagram 3 - Illumination of the RFEED Advisory Caution.

The fuel continues to feed equally from both sides until the front tank is empty as seen below in Diagram 3. At this point there is still an imbalance between the sides of 450lbs. The fuel stops feeding from the left group and the RFEED advisory light illuminates as confirmation of this event.

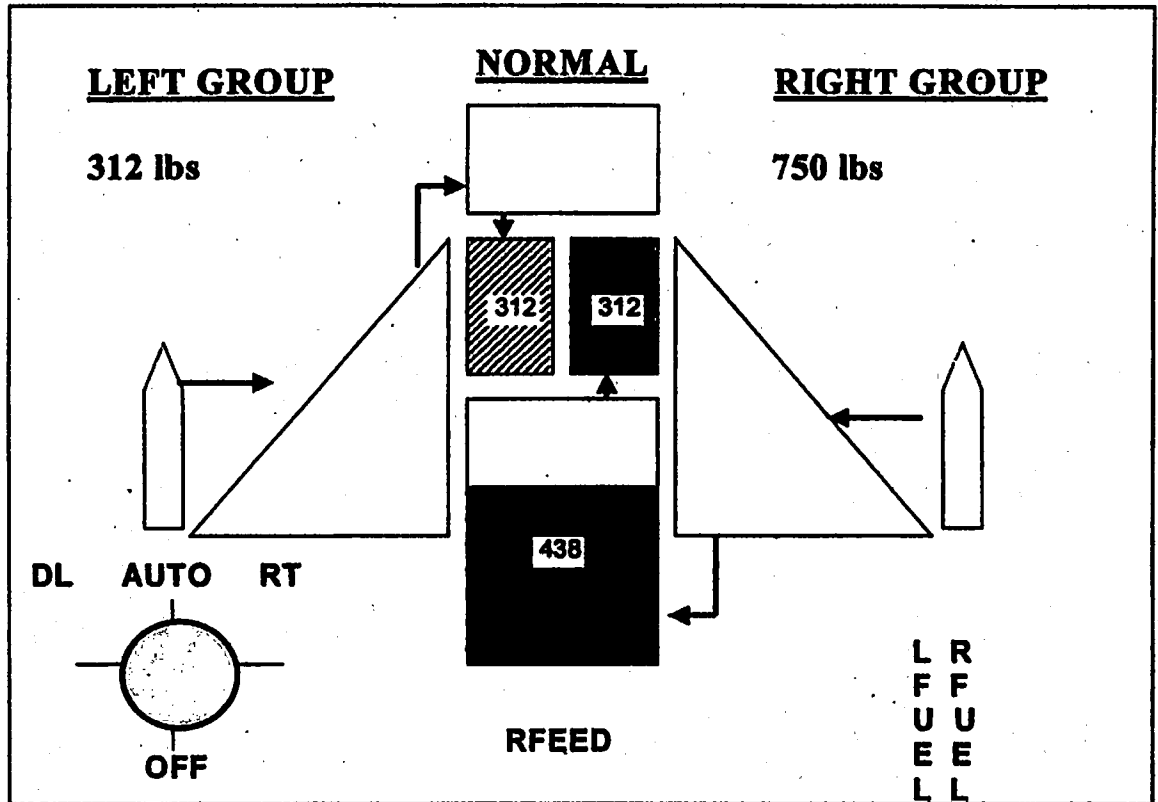
Diagram 4 - Illumination of RFUEL Caution

When 750lbs of fuel is remaining in the right hand side (RHS) the silent and steady RFUEL caution illuminates as in Diagram 4.
