AIRCRAFT ACCIDENT REPORT AND EXECUTIVE SUMMARY

Reference:	CA18/2/3/8362	
Aircraft Registration	ZS-RWW	Date of Accident	9 September 2007		Time of Accident	1000Z
Type of Aircraft	Robinson R44 Raven II		Type of Operation	Training Flight		
Pilot-in-command Licence Type		Commercial	Age	25	Licence Valid	Yes
Pilot-in-command Flying Experience		Total Flying Hours	668.8		Hours on Type	Unknown
Last point of departure		Port Alfred Aerodrome (FAPA)				
Next point of intended landing		Port Alfred Aerodrome (FAPA)				
Location of the accident site with reference to easily defined geographical points (GPS readings if possible)						
Farms Welgevind and Hopedale, Cove Ridge area near East London (GPS: South 33°04.210' East 027°47.212')						
Meteorological Information		Surface wind; 070°/9kt, Temperature; 18°C, Cloud cover; BKN 1000ft, BKN at 2100ft and OVC at 3000ft. Top of cloud between 6000 and 7000ft AGL.				
Number of people on board	2 + 0	No. of people injured	0	No. of people killed	2 + 0

Name of Owner : Activest 23 (Pty) Ltd
Name of the Operator : 43 Air School
Manufacturer : Robinson Helicopter Company
Model : R44 Raven II
Nationality : South African
Registration Marks : ZS-RWW
Place : C

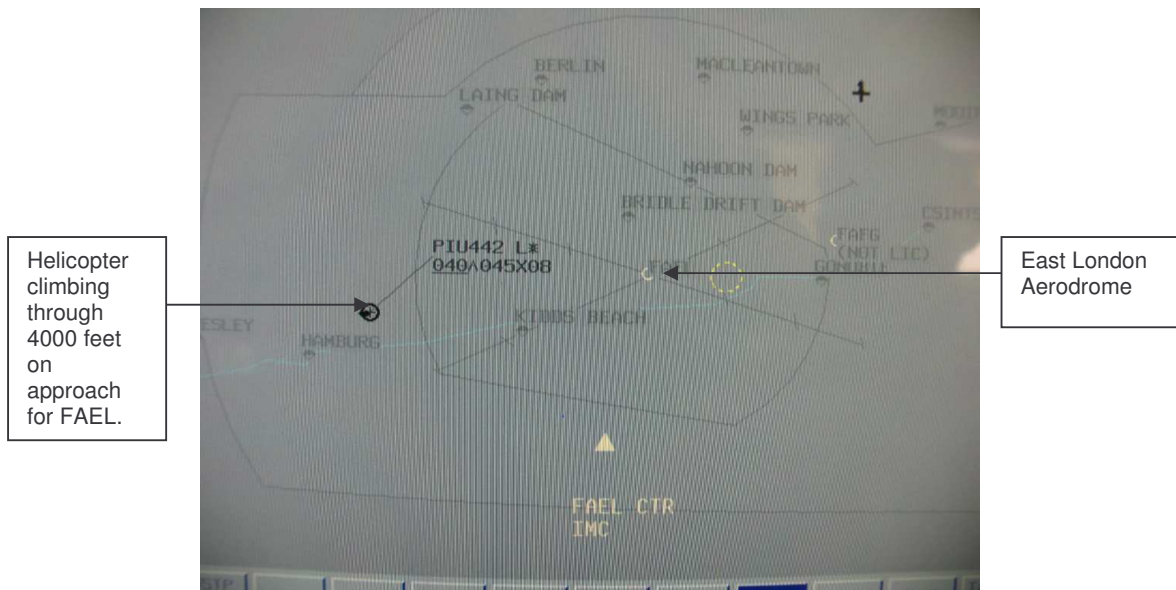
Height indicated at 4 300 feet, airspeed 20 knots.

The aircraft (target) then disappeared from the radar screen. The sequence of events occurred within a time frame of between 30 to 40 seconds.

Photo 2. A view of the radar screen with the helicopter (PIU442) approaching FAEL.

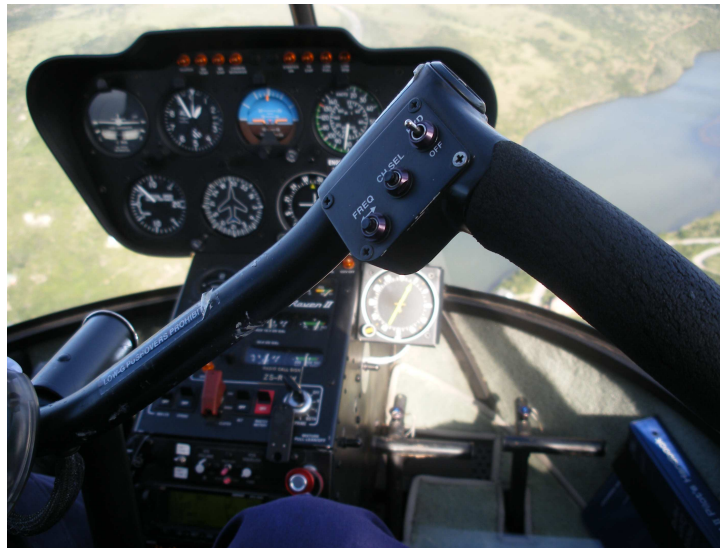
1.6.5 Instrument Panel ZS-RWW

Photo 4. An archive photo of the instrument panel of the accident helicopter ZS-RWW.

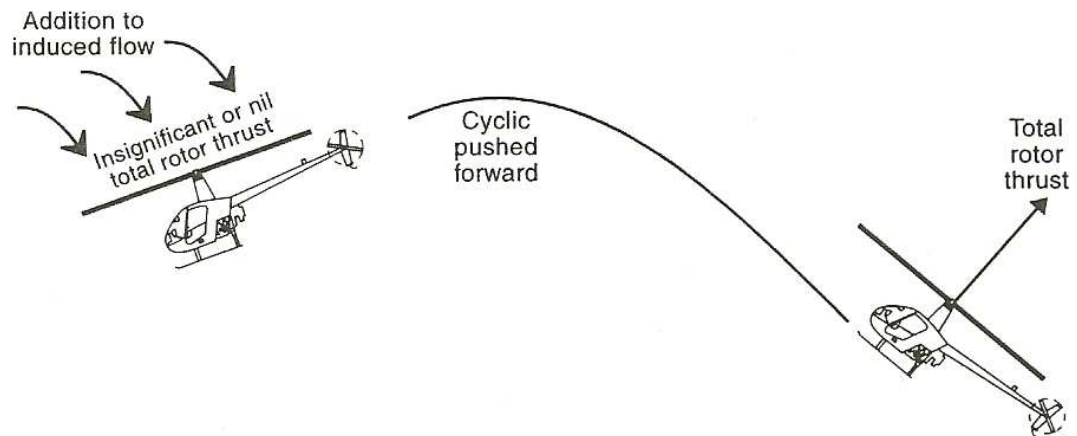
Low-*g* flight occurs when cyclic is moved forward rather firmly, such as during a pushover at the end of a zoom climb, especially if the pilot lowers collective at the same time. The effect of low, zero or negative-*g* on total main rotor thrust production (see Figure 2 below) is devastating.

Figure 1. Firm application of forward cyclic can cause low, zero or negative- g and a severe reduction in total rotor thrust.

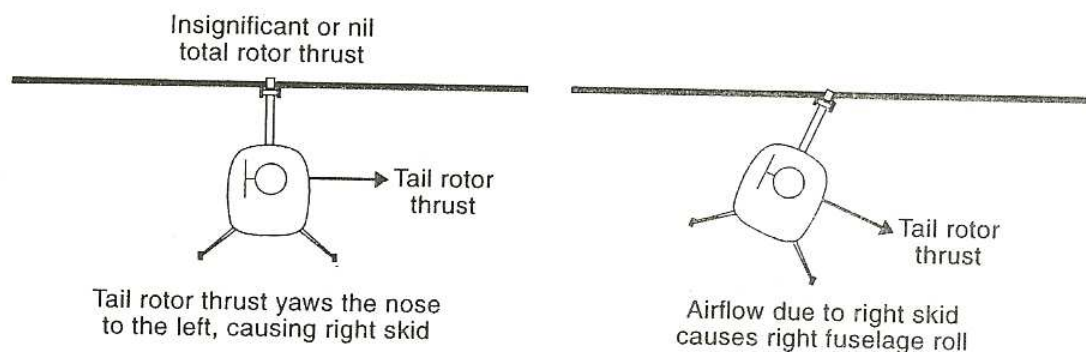
Tail rotor drift (translating tendency) is typically balanced by a slight tilt of the main rotor disc in a direction opposite tail rotor thrust. With a counter clockwise rotor, the disc is tilted slightly to the left, so the horizontal component of main rotor thrust opposes drift, and through that it opposes yaw. The amount of main rotor thrust is reduced or even eliminated by a combination of reduced collective and forward cyclic. Forward cyclic decreases blade angles of attack as the helicopter's up and forward momentum increases the induced flow. A greatly reduced or zero total rotor thrust allows the tail rotor thrust to yaw the aircraft's nose to the left. The resulting skid to the right causes the fuselage to lag so that a right roll results. The tail rotor thrust also forms a right-hand turning moment around the aircraft's centre of gravity, which is now much lower down than the tail rotor. As the aircraft continues to roll right (while cyclic is forward but not to the side) the clearance between the rotor head and the mast is reduced (see Figure 2 below). This condition is not in itself dangerous, but incorrect flying techniques can make it so.

Figure 2. Lateral cyclic neutral. Right fuselage roll reduces the clearance between the rotor head and shaft.

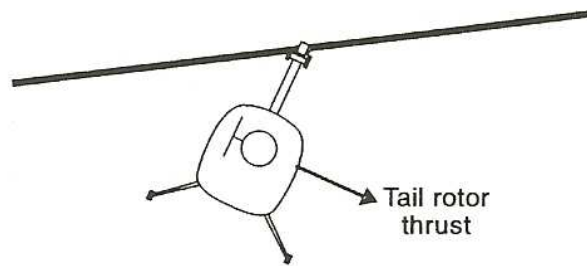
The unwary pilot may instinctively use left cyclic to oppose the increasing right roll. This left lateral cyclic action causes upward flapping on the right-hand side of the disc, so that the clearance between the rotor head and the mast on the left-hand side lessens even more. Under normal, positive- g conditions, this left cyclic input would have produced a horizontal component of total thrust to the left, creating a moment that would have brought the aircraft back to the required attitude.

Under zero or negative- g conditions, however, initial left cyclic fails to provide the restoring moment resulting from disc tilt and further left cyclic is similarly ineffective. The clearance between rotor head and mast becomes smaller still, and is not corrected, the two connect and the rotor may separate from the mast.

Figure 3. Left lateral cyclic application further reduces rotor head clearance. Mast contact may become inevitable.
