# AIRCRAFT ACCIDENT REPORT AND EXECUTIVE SUMMARY

Reference:	CA18/2/3/8416	
<b>Aircraft Registration</b>	ZS-ELT	<b>Date of Accident</b>	1 January 2008		<b>Time of Accident</b>	0940Z
<b>Type of Aircraft</b>	Piper PA28-180 Aeroplane		<b>Type of Operation</b>		Private	
<b>Pilot-in-command Licence Type</b>		Private Pilot	<b>Age</b>	51	<b>Licence Valid</b>	Yes
<b>Pilot-in-command Flying Experience</b>		Total Flying Hours as on 7 October 2006	268		Total Hours on Type as on 16 August 2005	40.1
<b>Last point of departure</b>		Mosselbay Aerodrome (FAMO)				
<b>Next point of intended landing</b>		Beaufort West Aerodrome (FABW)				
<b>Location of the accident site with reference to easily defined geographical points (GPS readings if possible)</b>						
On the Swartberg mountains next to the Swartberg pass at the geographical position determined as S 33° 21 31 E 022° 3 07.						
<b>Meteorological Information</b>		Wind: 100°TN at 10 Knots; Temperature: 18°C; Visibility: 50 metres or less in cloud.

**Name of Owner/Operator** : Medocar CC  
**Manufacturer** : Piper Aircraft Corporation  
**Model** : PA 28- 180  
**Nationality** : South African  
**Registration Marks** : ZS-ELT  
**Place** : Swar

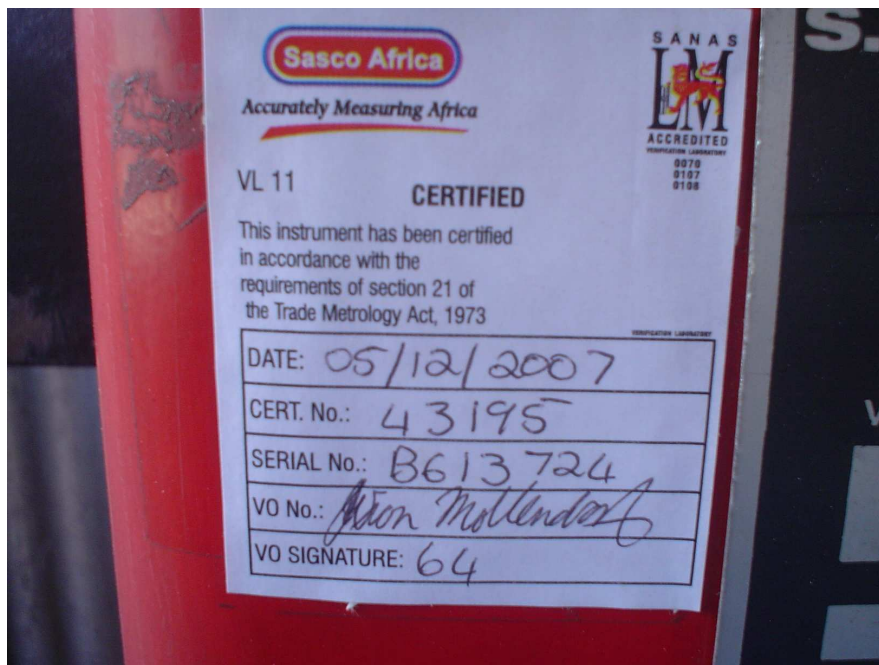
- 1.18.5 The baggage that was on board the aircraft was weighed on a calibrated scale. The baggage weighed was 47.5 kilograms.

**Image 8:** Indicated the certificate of the calibrated scale.
