## AIRCRAFT ACCIDENT REPORT AND EXECUTIVE SUMMARY

REVISED REPORT 5 October 2010

Reference	CA18/2/3/8613	
<b>Aircraft Registration</b>	ZS-BRU	<b>Date of Accident</b>	14 February 2009		<b>Time of accident</b>	0730Z
<b>Type of Aircraft</b>	Cessna 182P		<b>Type of Operation</b>	Skydiving		
<b>Pilot-in-command Licence Type</b>		Commercial	<b>Age</b>	33	<b>Licence Valid</b>	Yes
<b>Pilot-in-command Flying Experience</b>		Total Flying Hours	344.5		Hours on Type	30.5
<b>Last point of departure</b>		Cato Ridge Aerodrome, (KwaZulu-Natal province).				
<b>Next point of intended landing</b>		Cato Ridge Aerodrome, (KwaZulu-Natal province).				
<b>Location of the accident site with reference to easily defined geographical points (GPS readings if possible)</b>						
Cato Ridge at KwaXimba village, GPS co-ordinates: S 29°40.272' E 030°37.183' Elevation 1476 feet AMSL.						
<b>Meteorological Information</b>		Surface wind: 030° at 3 knots; Temperature: 27°C; Visibility: +10 km.				
<b>Number of people on board</b>	1 + 6	<b>No. of people injured</b>	5	<b>No. of people killed</b>	1

<b>Probable Cause</b>						
Unsuccessful forced landing, following an engine failure in-flight.						
<b>Contributory

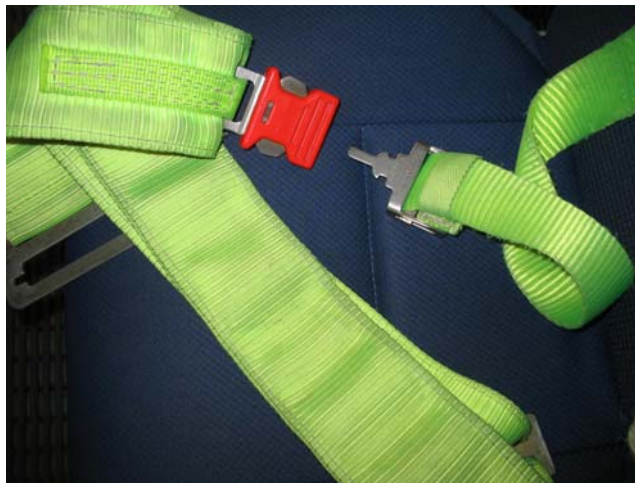
1.15.4 The passenger, a minor child who went along for the flight, was not properly restrained in the aircraft. During the investigation it was found that the child was “hooked up” and attached to a strong point in the aircraft with a monkey chain/belt. When the aircraft started experiencing problems, the child was released from the “hooked up” position and was sitting on the lap of the AFF student skydiver, whilst he was sitting on the floor of the aircraft with his back against the back of the pilot’s seat.

Figure 11: A view of a “monkey chain/belt” waste area, plus a safety latch with quick release mechanism.
