AIRCRAFT ACCIDENT REPORT AND EXECUTIVE SUMMARY

Reference:	CA18/2/3/8734	
Aircraft Registration	ZU-CWW	Date of Accident	09 January 2010		Time of Accident	1000Z
Type of Aircraft	Marabou Stork		Type of Operation		Private	
Pilot-in-command Licence Type		Private pilot	Age	53	Licence Valid	Yes
Pilot-in-command Flying Experience		Total Flying Hours	420.0		Hours on Type	350
Last point of departure		Rhino Park Aerodrome – Gauteng.				
Next point of intended landing		Rhino Park Aerodrome – Gauteng.				
Location of the accident site with reference to easily defined geographical points (GPS readings if possible)						
Rhino Park Aerodrome next to Runway 03.						
Meteorological Information		Wind direction: 30°/08 kts, Temperature: 21°C, Visibility: <10 km, Cloud base: SCT at 2500 ft, Cloud cover: SCT at 3500 ft.				
Number of people on board	1 + 1	No. of people injured	0	No. of people killed	0	
Synopsis						
<p>According to the pilot, he decided to fly from Rhino Park Aerodrome to Petit Aerodrome at 1000Z. The pilot noted that the surface wind was 030°/8 kts, directly down Runway 03. As the runway was muddy due to rain the previous day, he elected to take off from the grass surface to the le

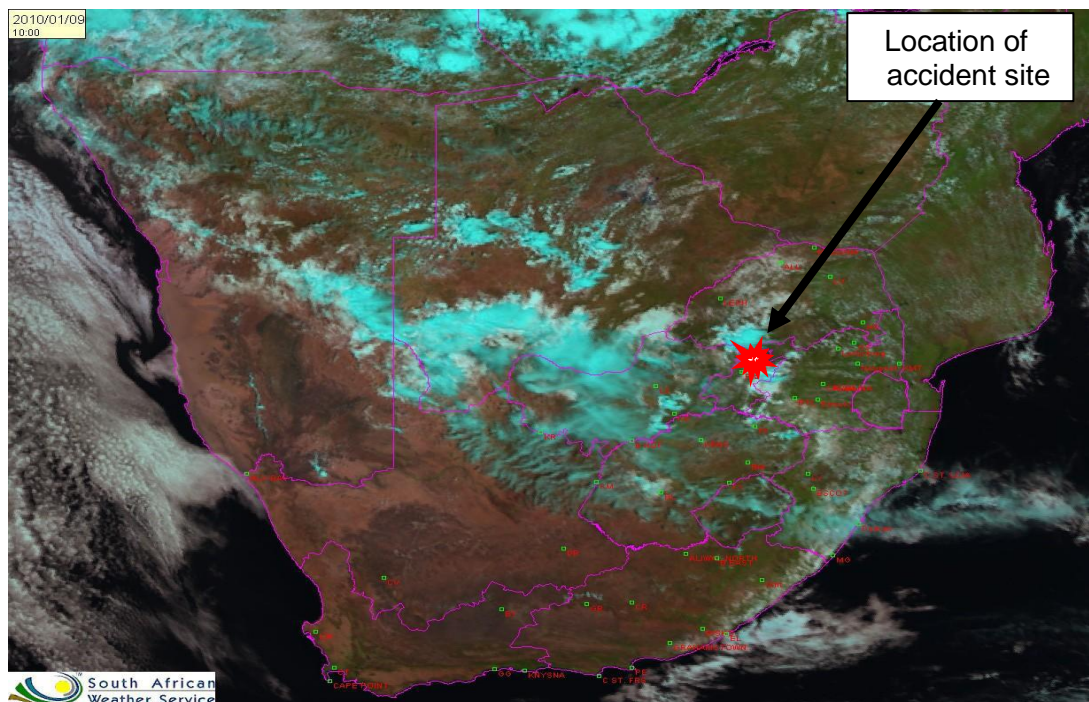
- 1.7.3 The weather information in the column above was obtained from the South African Weather Services. According to the weather report, a lot of moist air in circulation east of the trough caused cloudy rainy conditions over the central and eastern parts of the country.

Figure 3, Satellite image showing weather conditions in vicinity of the accident.
