AIRCRAFT ACCIDENT REPORT AND EXECUTIVE SUMMARY

Reference:	CA18/2/3/8840	
Aircraft Registration	ZU-BAS	Date of Accident	27 September 2010		Time of Accident	0700Z
Type of Aircraft	Aviatika 890U		Type of Operation	Private		
Pilot-in-command Licence Type	MPL(Microlight)	Age	47		Licence Valid	Yes
Pilot-in-command Flying Experience	Total Flying Hours	473,45			Hours on Type	473,45
Last point of departure	Roodekopjes Farm					
Next point of intended landing	Roodekopjes Farm					
Location of the accident site with reference to easily defined geographical points (GPS readings if possible)						
Private farm at Roodekopjes, 37 km from Brits. GPS coordinates:(S25°23,835 ' E027°36,231 ')						
Meteorological Information	Surface wind: 290°/ 5 kts; Temperature: 24°C; Visibility: Cavok					
Number of people on board	1+0	No. of people injured	0		No. of people killed	1
Synopsis	<p>The pilot-owner, sole occupant of the aircraft, took off from his private farm on a local private flight with the intention of returning to his farm after the flight. On the way back, while the pilot prepared for landing, the aircraft collided with electric power lines. The pilot lost control and hit the ground at high sp

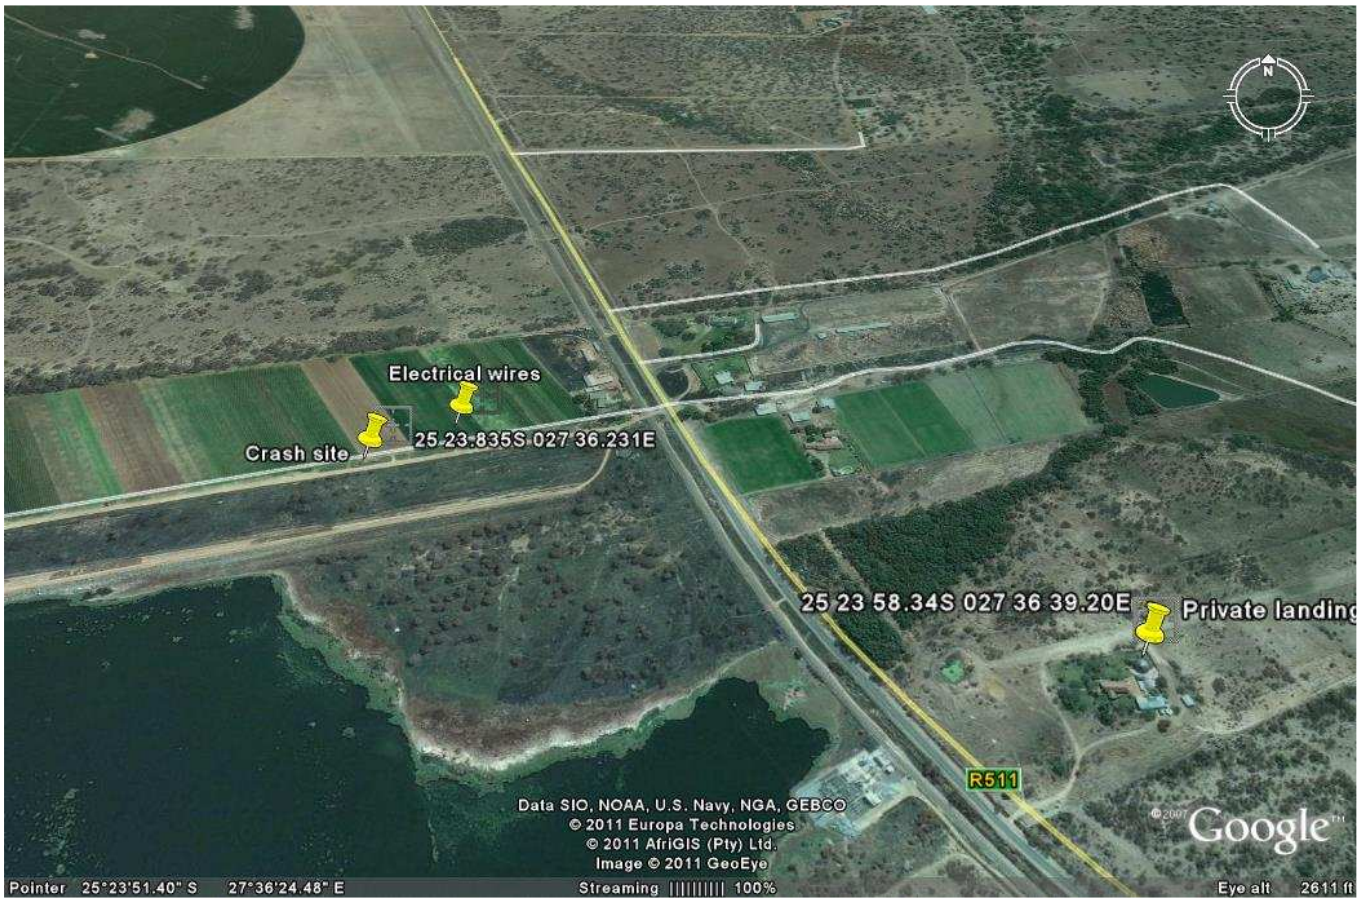
- 1.1.4 The accident happened in daylight, at approximately 0700Z, on a private farm in Roodekopjes 37 km outside Brits, at an elevation of 3 231 feet above mean sea level and GPS position S25°23,835' E27°36,231'.

FIGURE 1: Google picture showing the accident site
