AIRCRAFT ACCIDENT REPORT AND EXECUTIVE SUMMARY

Reference:	CA18/2/3/9011	
Aircraft Registration	ZS-NLR	Date of Accident	6 February 2012		Time of Accident	1605Z
Type of Aircraft	Dromader PZL-M18A		Type of Operation		Other Aerial Work	
Pilot-in-command Licence Type		Commercial Pilot	Age	68	Licence Valid	Yes
Pilot-in-command Flying Experience		Total Flying Hours	15 515,6		Hours on Type	1 800,0
Last point of departure		Pearly Beach aerodrome, (Western Cape province)				
Next point of intended landing		Andrew's aerodrome near Struisbaai, (Western Cape province)				
Location of the accident site with reference to easily defined geographical points (GPS readings if possible)						
Farm Duinefontein in the Overberg district (GPS position; South 34°37'24.7" East 019°28'14.1")						
Meteorological Information		Surface wind: 225°/ 3kt, Temperature: 28°C, Visibility: +10 km				
Number of people on board	1 + 0	No. of people injured	1	No. of people killed	0

AIRCRAFT ACCIDENT REPORT

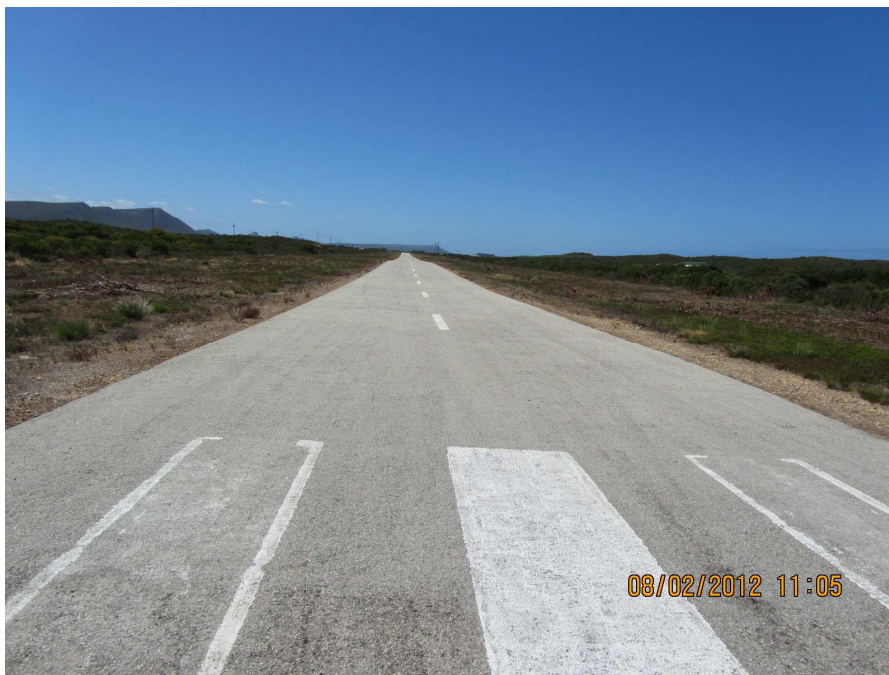
Figure 3. Photo was taken from the threshold of runway 30 in the direction of take-off.

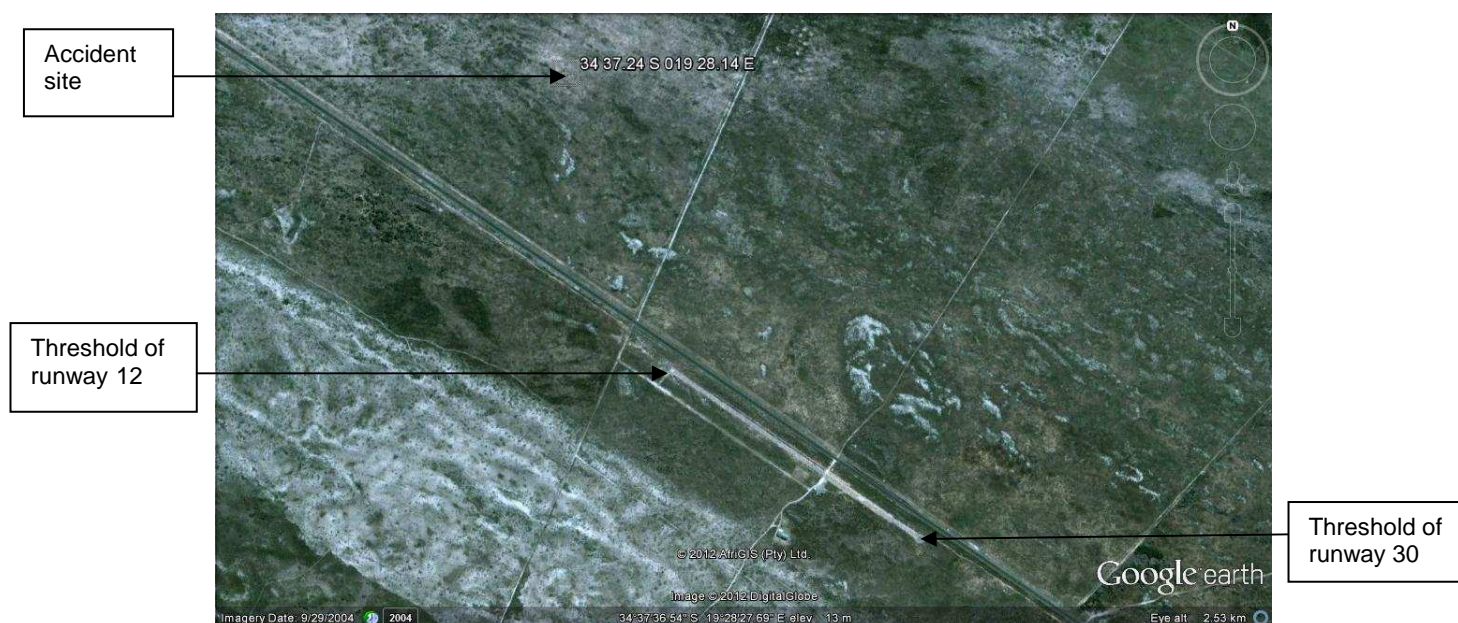
1.12.1 The aircraft took-off from runway 30 at Pearly Beach aerodrome. The aircraft first impacted with indigenous vegetation in a right wing low attitude approximately 805 m from the threshold of runway 12 in a northerly direction.

Figure 4. The Google Earth map indicates the accident site in relation to the runway (point of departure).
