AIRCRAFT ACCIDENT REPORT AND EXECUTIVE SUMMARY

Reference:	CA18/2/3/9061	
Aircraft Registration	ZS-HIG	Date of Accident	12 July 2012		Time of Accident	1320Z
Type of Aircraft	Robinson R44 Raven I		Type of Operation	Private flight		
Pilot-in-command Licence Type		Private Pilot	Age	53	Licence Valid	Yes
Pilot-in-command Flying Experience		Total Flying Hours	770.0		Hours on Type	114.0
Last point of departure		Farm Vucht, Lephalale district (Limpopo province)				
Next point of intended landing		Game farm Africa Sand Safaris, (Limpopo province)				
Location of the accident site with reference to easily defined geographical points (GPS readings if possible)						
Game farm Africa Sand Safaris (GPS position: South 23°25.465' East 027°35.079'); elevation 2 773 feet						
Meteorological Information		Surface wind: 225/20 knots, Temperature: 20°C, Visibility: > 10 km				
Number of people on board	1 + 1	No. of people injured	1 + 1	No. of people killed	0	
Synopsis

AIRCRAFT ACCIDENT REPORT

Name of Owner : Dr. D. Kriel
Name of Operator : Private flight
Manufacturer : Robinson Helicopter Company
Model : R44 Raven I
Nationality : South African
Registration Marks : ZS-HIG
Place : Africa Sand Safaris

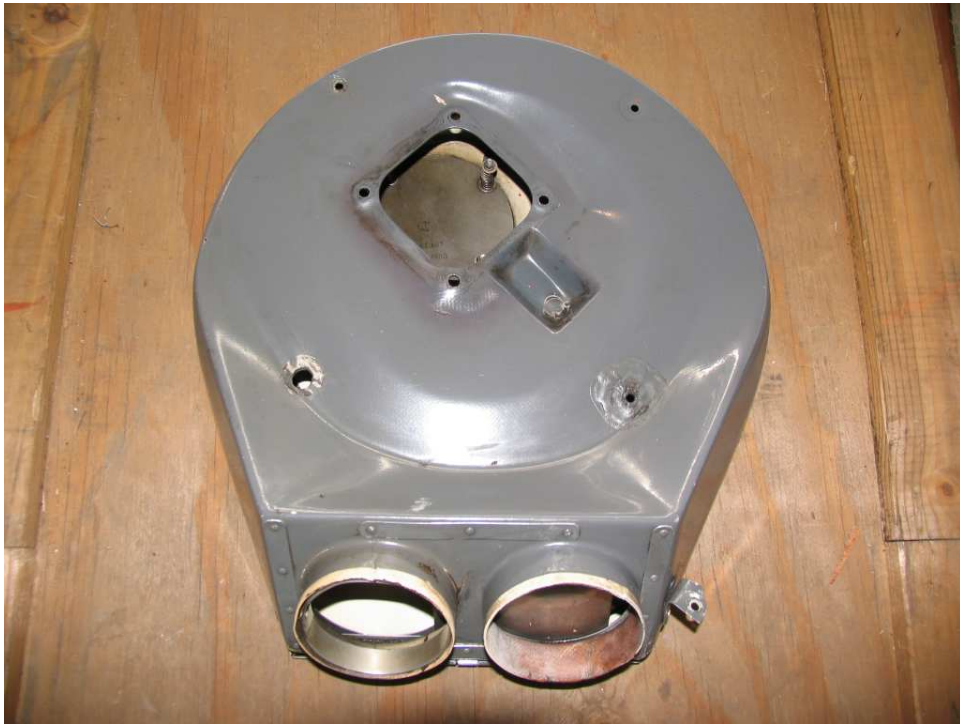
Figure 11. A view of the air box in the close position.

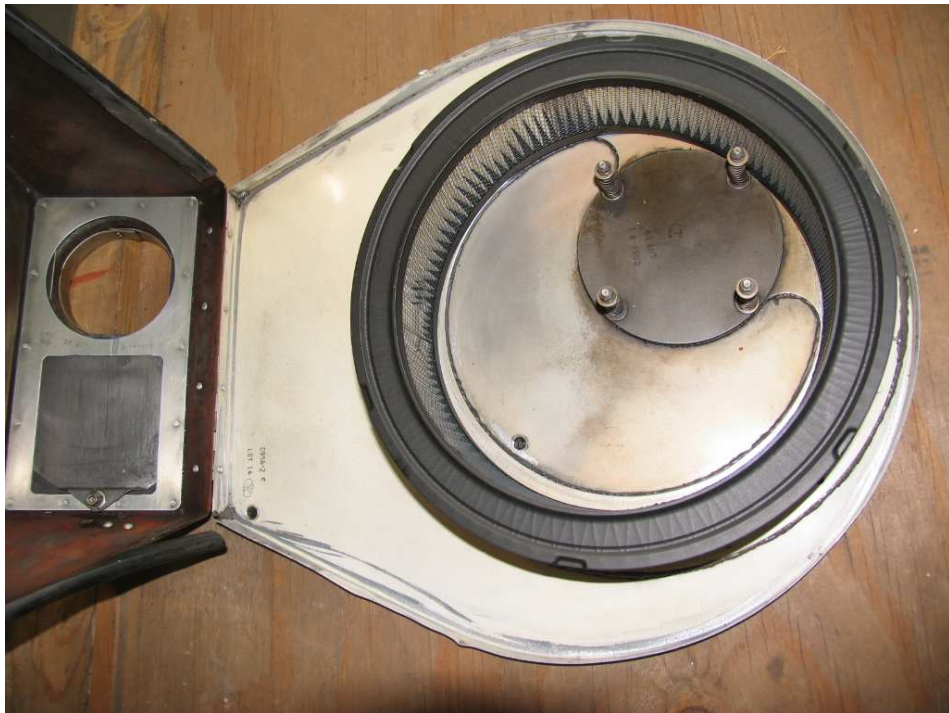
The photos in figure 11, 12 and 13 on the next two pages of the report serves as illustration to the reader what a serviceable air box looks like intact. In figure 12 the position of the alternate air door as well as the air filter is clearly visible. In figure 13 the air filter box is close with the air filter in position. With the air filter in position it does not allow any space that would or could allow an object like a moisture absorbent bag (26 x 12 cm) to get pass the air filter to the centre area of the box.

Figure 12. A view of the air filter box in the open position with the air filter and alternate air door visible.

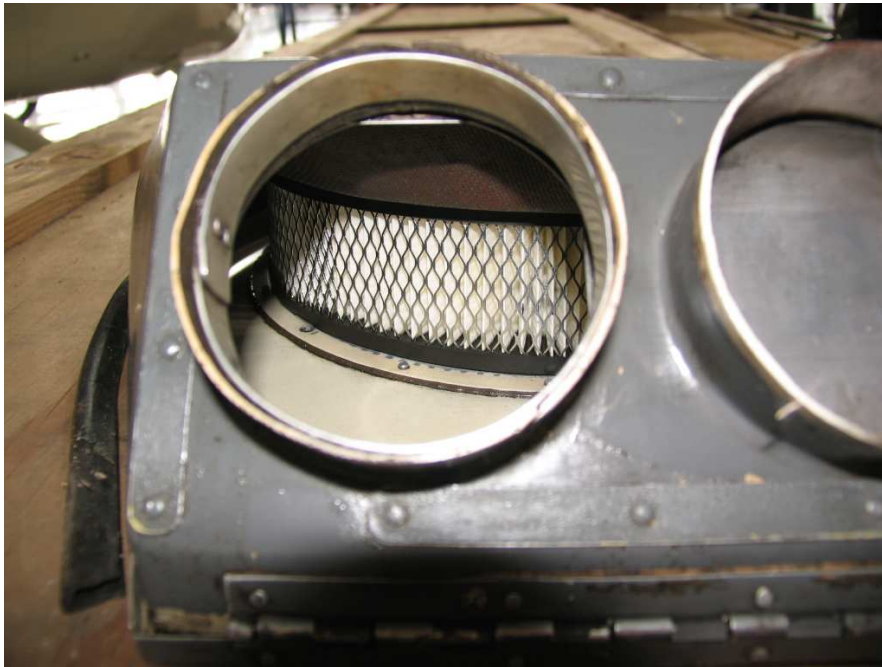
Figure 13. A view of the air box close with the air filter visible in position.

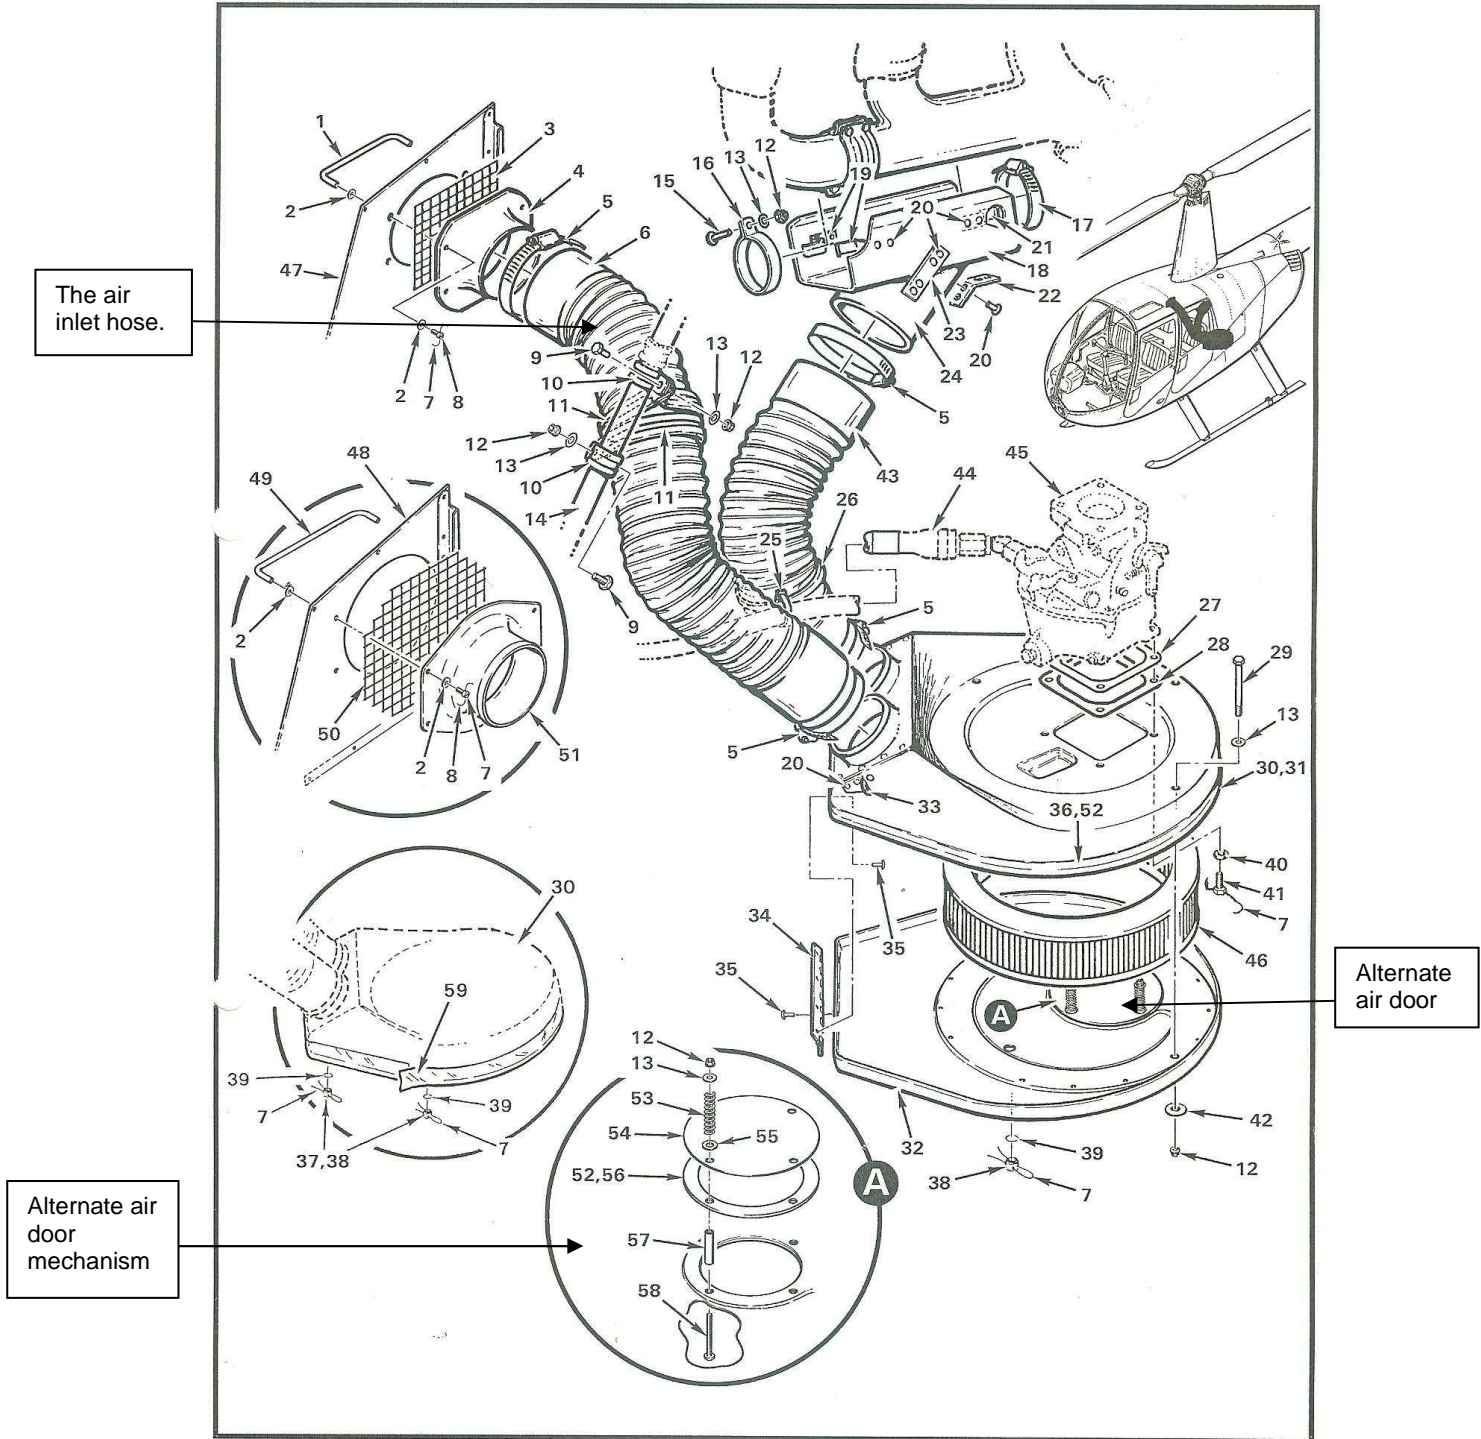
Figure 16. A diagram of the engine air induction system.

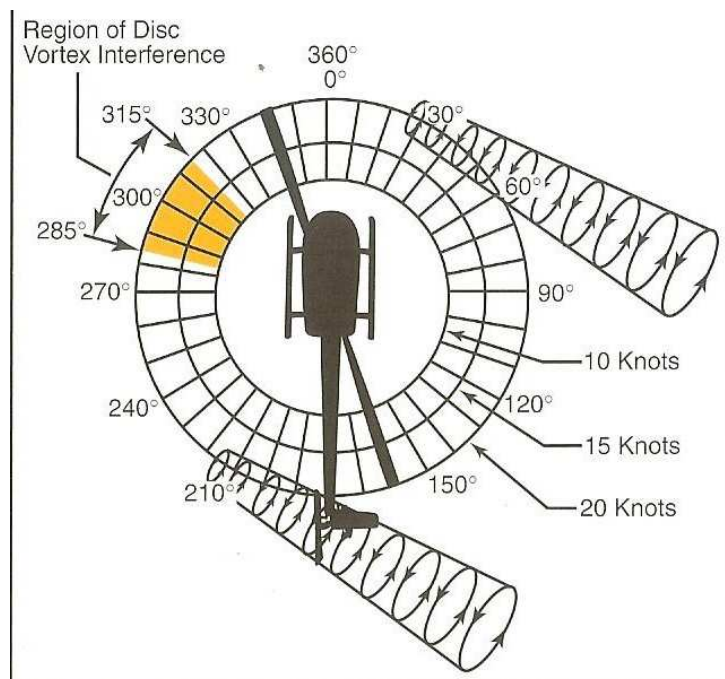
Figure 11-10. Main rotor disc vortex interference.

Refer to figure 11-10. Winds at velocities of 10 to 30 knots from the left front cause the main rotor vortex to be blown into the tail rotor by the relative wind. The effect of this main rotor disc vortex causes the tail rotor to operate in an extremely turbulent environment. During a right turn, the tail rotor experiences a reduction of thrust as it comes into the area of the main rotor disc vortex. The reduction in tail rotor thrust comes from the airflow changes experienced at the tail rotor as the main rotor disc vortex moves across the tail rotor disc. The effect of the main rotor disc vortex initially increases the angle of attack of the tail rotor blades, thus increasing tail rotor thrust. The increase in the angle of attack requires that right pedal pressure be added to reduce tail rotor thrust in order to maintain the same rate of turn. As the main rotor vortex passes the tail rotor, the tail rotor angle of attack is reduced. The reduction in the angle of attack causes a reduction in thrust and a right yaw acceleration begins. This acceleration can be surprising, since you were previously adding right pedal to maintain the right turn rate. This thrust reduction occurs suddenly, and if uncorrected, develops into an uncontrollable rapid rotation about the mast. When operating within this region, be aware that the reduction in tail rotor thrust can happen quite suddenly, and be prepared to react quickly to counter this reduction with additional left pedal input.

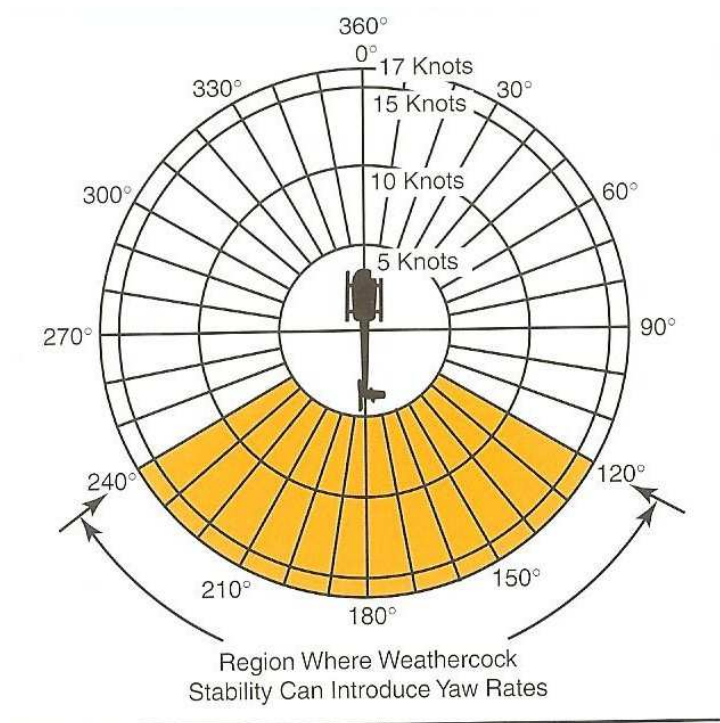
Figure 11-11. Weathercock stability.

When considering the wind assessment made by the farm manager it placed the helicopter tail rotor within the 120° to 240° wind azimuth range during approach for landing. With the tail rotor being in this critical wind azimuth range, the helicopter most probably started to weathervane, a condition where the nose of the helicopter wants to turn into the prevailing wind. During such a situation the pilot needed to be vigilant, and a positive tail rotor pedal input was required to counteract this tendency. However, the pilot did not correctly identify nor anticipate such a situation, and the helicopter was allowed to commence with an unanticipated yaw to the right.

In this region, the helicopter attempts to weathervane its nose into the relative wind. [Figure 11-11] Unless a resisting pedal input is made, the helicopter starts a slow, un-commanded turn either to the right or left depending upon the wind direction. If the pilot allows a right yaw rate to develop and the tail of the helicopter moves into this region, the yaw rate can accelerate rapidly. In order to avoid the onset of LTE in this downwind condition, it is imperative to maintain positive control of the yaw rate and devote full attention to flying the helicopter.

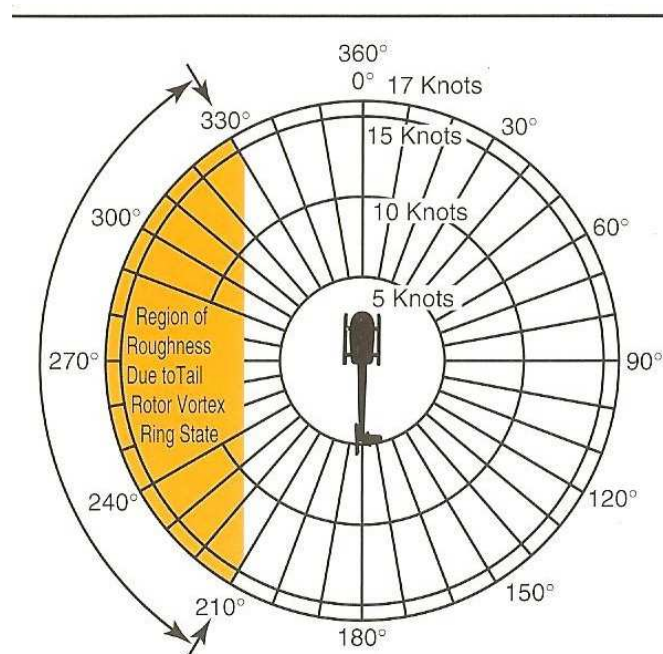
Figure 11-12. Tail rotor vortex ring state.

Winds within this region cause a tail rotor vortex ring state to develop. [Figure 11-12] The result is a non-uniform, unsteady flow into the tail rotor. The vortex ring state causes tail rotor thrust variations, which result in yaw deviations. The net effect of the unsteady flow is an oscillation of tail rotor thrust. Rapid and continuous pedal movements are necessary to compensate for the rapid changes in tail rotor thrust when hovering in a left crosswind. Maintaining a precise heading in this region is difficult, but this characteristic presents no significant problem unless corrective action is delayed. However, high pedal workload, lack of concentration and over controlling can all lead to LTE. When the tail rotor thrust being generated

is less than the thrust required, the helicopter yaws to the right. When hovering in left crosswinds, you must be concentrated on smooth pedal coordination and not allow an uncontrolled right yaw to develop. If a right yaw rate is allowed to build, the helicopter can rotate into the wind azimuth region where weathercock stability then accelerates the right turn rate. Pilot workload during a tail rotor vortex ring state is high. Do not allow a right yaw rate to increase.

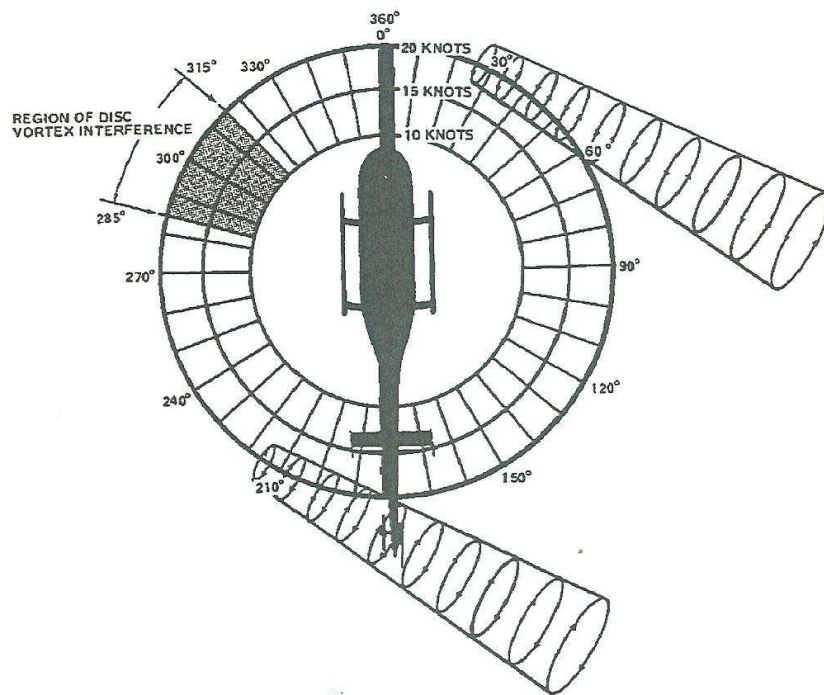
FIGURE 1. MAIN ROTOR DISC VORTEX INTERFERENCE

(1) Main rotor disc vortex interference (285° to 315°). (See figure 1.)

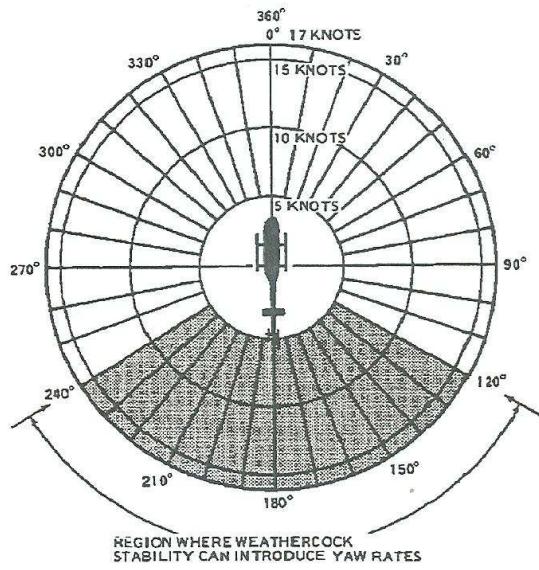
FIGURE 2. WEATHERCOCK STABILITY

(2) Weathercock stability (120° to 240°). (See figure 2.)

(c) If the pilot allows a right yaw rate to develop and the tail of the helicopter moves into this region, the yaw rate can accelerate rapidly. It is imperative that the pilot maintain positive control of the yaw rate and devote full attention to flying the aircraft when operating in a downwind condition.

(d) The helicopter can be operated safely in the above relative wind regions if proper attention is given to maintaining control. If the pilot is inattentive for some reason and a right yaw rate is initiated in one of the above relative wind regions, the yaw rate may increase.

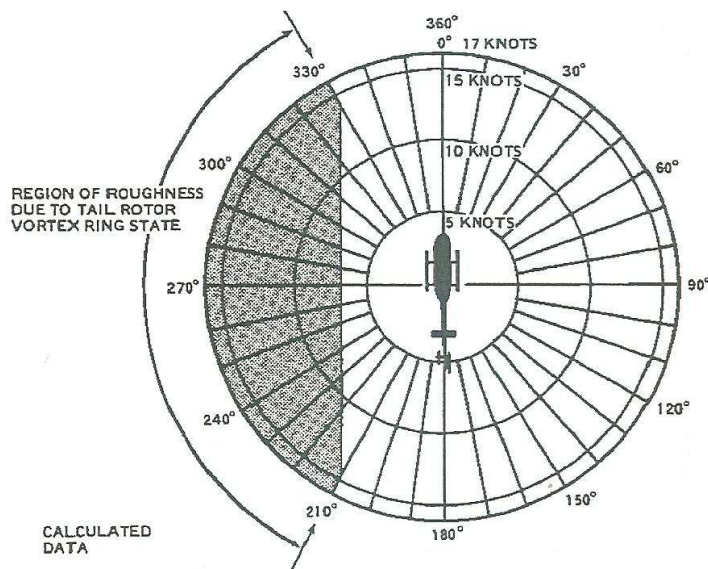
FIGURE 3. TAIL ROTOR VORTEX RING STATE

(3) Tail rotor vortex ring state (210° to 330°). (See figure 3.)
