AIRCRAFT ACCIDENT REPORT AND EXECUTIVE SUMMARY

Reference:	CA18/2/3/9104	
Aircraft Registration	ZS-SPI	Date of Accident	09 November 2012		Time of Accident	18:59Z
Type of Aircraft	Cessna172R		Type of Operation		Private	
Pilot-in-command Licence Type	Private		Age	24	Licence Valid	Yes
Pilot-in-command Flying Experience	Total Flying Hours		194		Hours on Type	158.3
Last point of departure		Wonderboom aerodrome (FAWB): Gauteng Province.				
Next point of intended landing		Wonderboom aerodrome (FAWB): Gauteng Province.				
Location of the accident site with reference to easily defined geographical points (GPS readings if possible)						
On the mountain at GPS coordinates determined to be (S 24° 07 6.76 E 029° 13 7 .58) at an elevation of approximately 5 940 feet above mean sea level (AMSL).						
Meteorological Information		Low clouds were observed in the vicinity of Polokwane area.				
Number of people on board	1 + 1	No. of people injured	0	No. of people killed	2

AIRCRAFT ACCIDENT REPORT

Name of Owner/Operator :Guzto Property Company
Manufacturer :Cessna Aircraft Company
Model :Cessna 172R
Nationality :South African
Registration Marks :ZS-SPI
Place :(S24°07 6.76 E 029°13 7 .58) en-rout

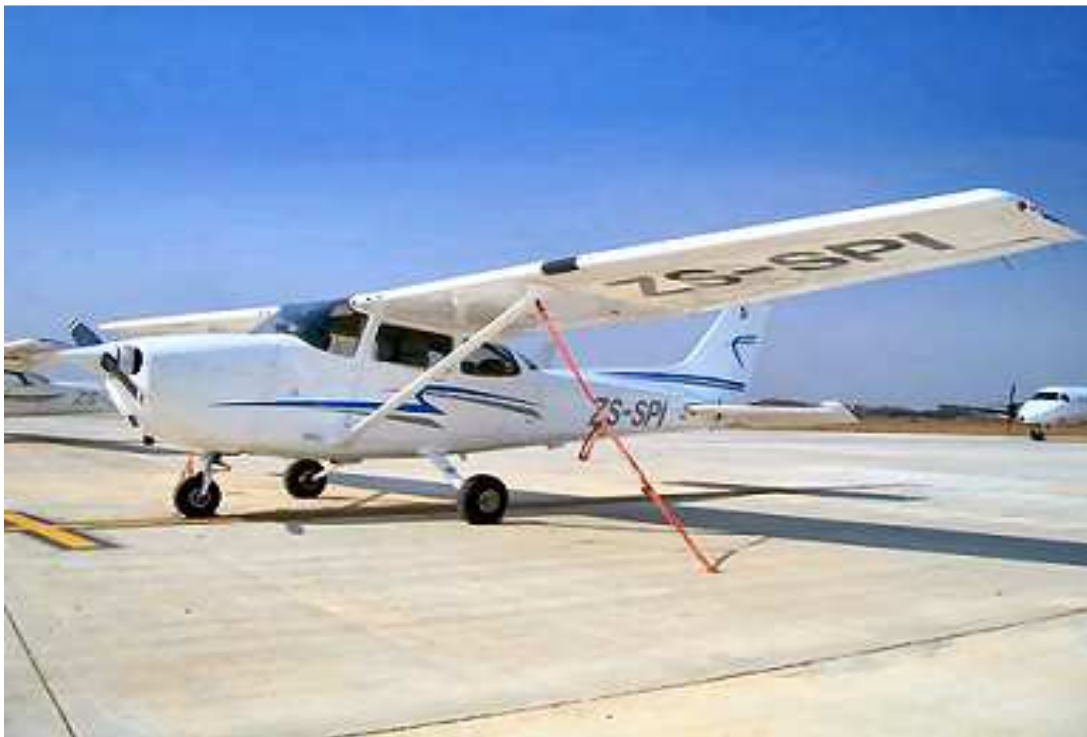
Figure 7: ZS-SPI aircraft parked on the apron (photo found on internet).

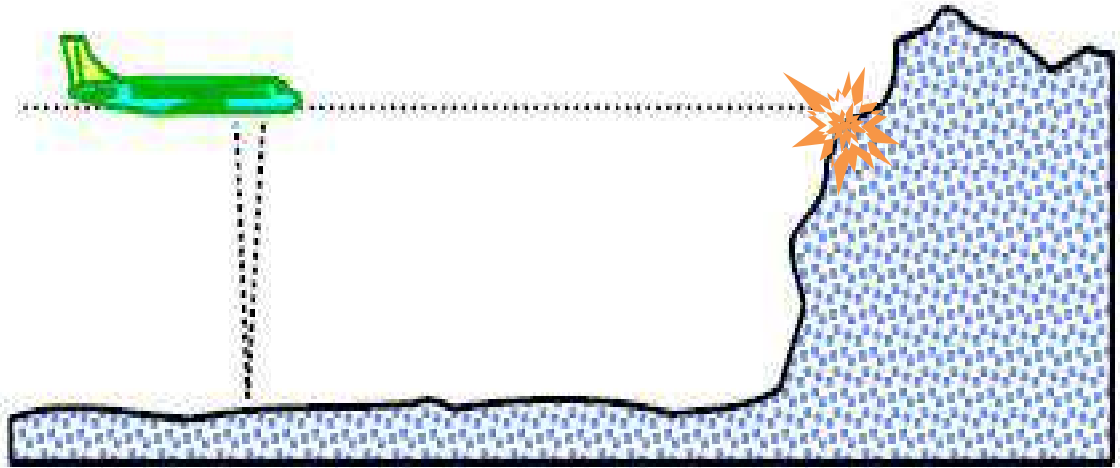
1.16.1 The aircraft was completely destroyed by impact and no fuel was available for analysis. The investigation revealed that the aircraft had enough fuel for the planned flight. According to available aircraft documentation no reported defects were recorded since the last maintenance inspection was certified. Investigation revealed that no communication to FAPP tower or distress call was made by the pilot prior to the accident. The on-site examination of the wreckage revealed that the aircraft had broken apart on impact. The diagram below illustrates a similar track flown by the accident aircraft into the mountain.

Figure 13: Illustration of CFIT.

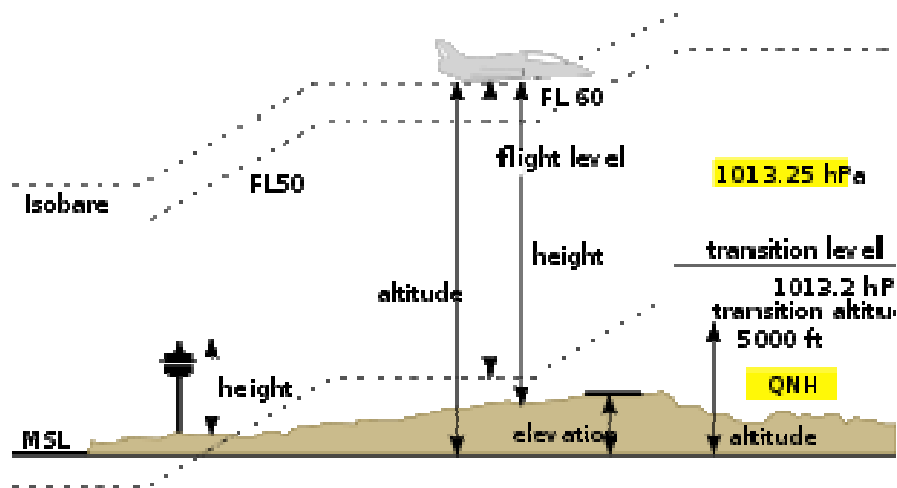
Figure 16: Transition from altitude to flight levels.

1.18.6 The altimeter recovered at the wreckage site indicated a subscale setting of 1013hpa.
