AIRCRAFT ACCIDENT REPORT AND EXECUTIVE SUMMARY

Reference:	CA18/2/3/9169	
Aircraft Registration	ZS-SAR	Date of Accident	27 April 2013		Time of Accident	±1440Z
Type of Aircraft	Cessna 152 (Aeroplane)		Type of Operation	Private Flight		
Pilot-in-command Licence Type		Private	Age	40	Licence Valid	Yes
Pilot-in-command Flying Experience		Total Flying Hours	173,0		Hours on Type	93,1
Last point of departure		Worcester aerodrome (FAWC), Western Cape province				
Next point of intended landing		Worcester aerodrome (FAWC), Western Cape province				
Location of the accident site with reference to easily defined geographical points (GPS readings if possible)						
Farm Wittekop in the Worcester district (GPS position; 33°42.507' South 019°35.794' East)						
Meteorological Information		Surface wind; 260°12kt gusting 23 kt, Temperature; 31°C, Visibility: + 10 km				
Number of people on board	1 + 0	No. of people injured	0	No. of people killed	1	
Synopsis

AIRCRAFT ACCIDENT REPORT

Name of Owner : Worcester Flying Club
Name of Operator : Worcester Flying Club
Manufacturer : Cessna Aircraft Company
Model : 152
Nationality : South African
Registration Marks : ZS-SAR
Place : Farm Wittekop, Worcester

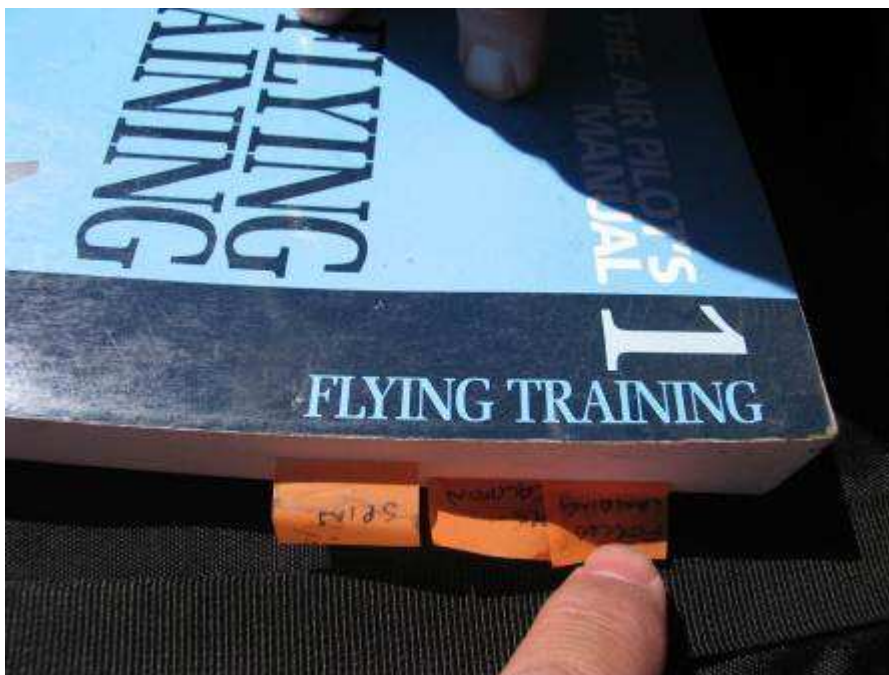
- 1.1.5 During the on-site investigation the team located the book *“The Air Pilot’s Manual, 1 Flying Training”*, by Trevor Thom, on the scene of the accident. The book had three subheadings highlighted by page markers, namely forced landings, precautionary landings and spins. The book was located on the right-hand side of the aircraft in close proximity to the right-hand door, which was found in the open position following ground impact.

Figure 2. The flying training handbook that was found on the accident site

The book *“The Air Pilot’s Manual - 1 Flying Training”* was located on the accident scene (see figure 2, page 4 of this report). The possibility cannot be excluded that the pilot intended to practise the three different flight manoeuvres highlighted by page markers in the book. From the accident scene it was evident that the book was not in his flying bag at the time, as the bag remained intact in the aft cabin area and all compartments were closed. The book was most probably lying next to the pilot on the right front seat during the flight. It should be noted that the accident occurred approximately 15 minutes after take-off (this information is based on the tachometer reading when compared with the last flight folio entry as found at the accident scene).

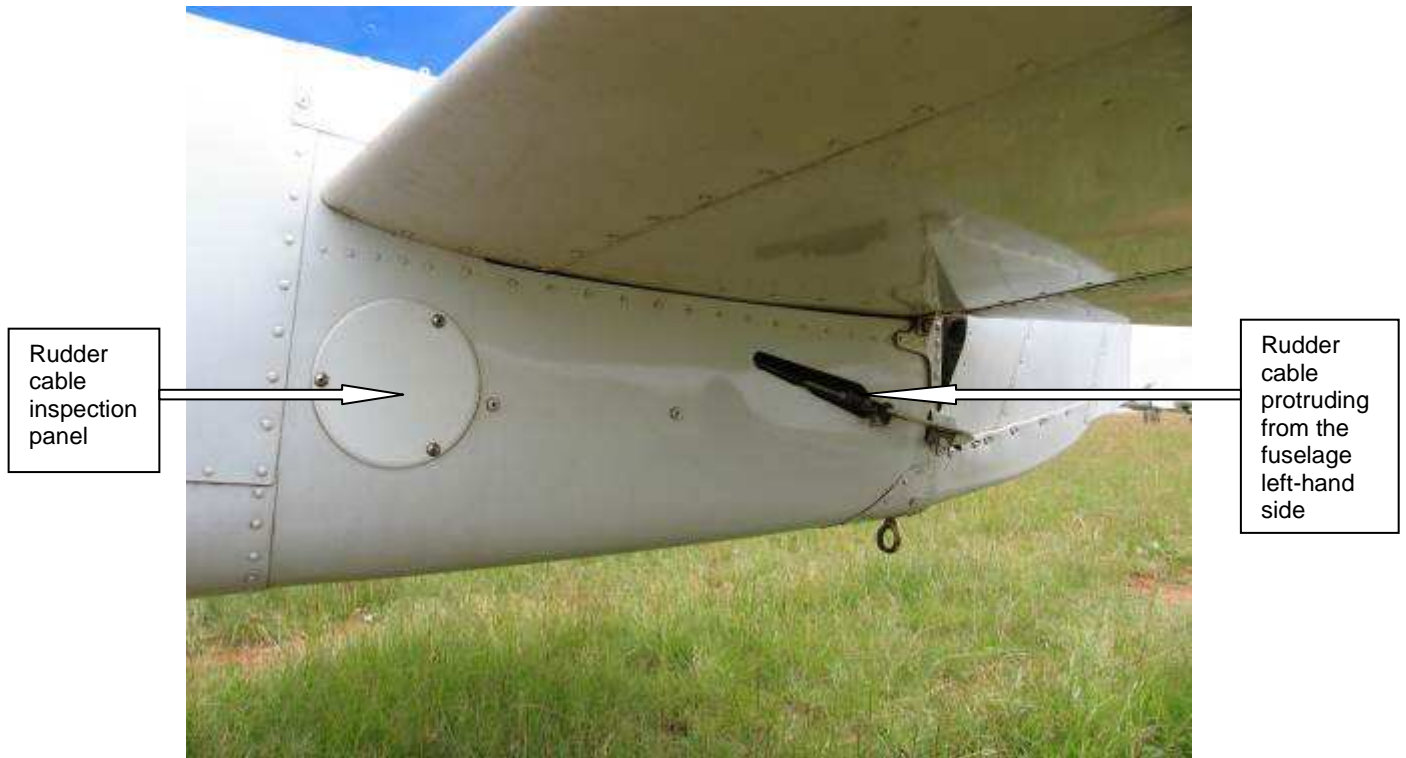
A very short section of the rudder cable and clevis can be visually inspected by the pilot during his/her pre-flight inspection; this is where the cable protrudes from the fuselage on the side and is attached to the rudder bell crank as can be seen in figure 6. These aircraft are fitted with two maintenance inspection panels, one on either side of the fuselage, also shown in figure 6; these panels are removed during maintenance inspections, as shown in figure 7. Once the panels have been

Figure 6. A view of the inspection panel as well as the rudder cable and attachment bracket

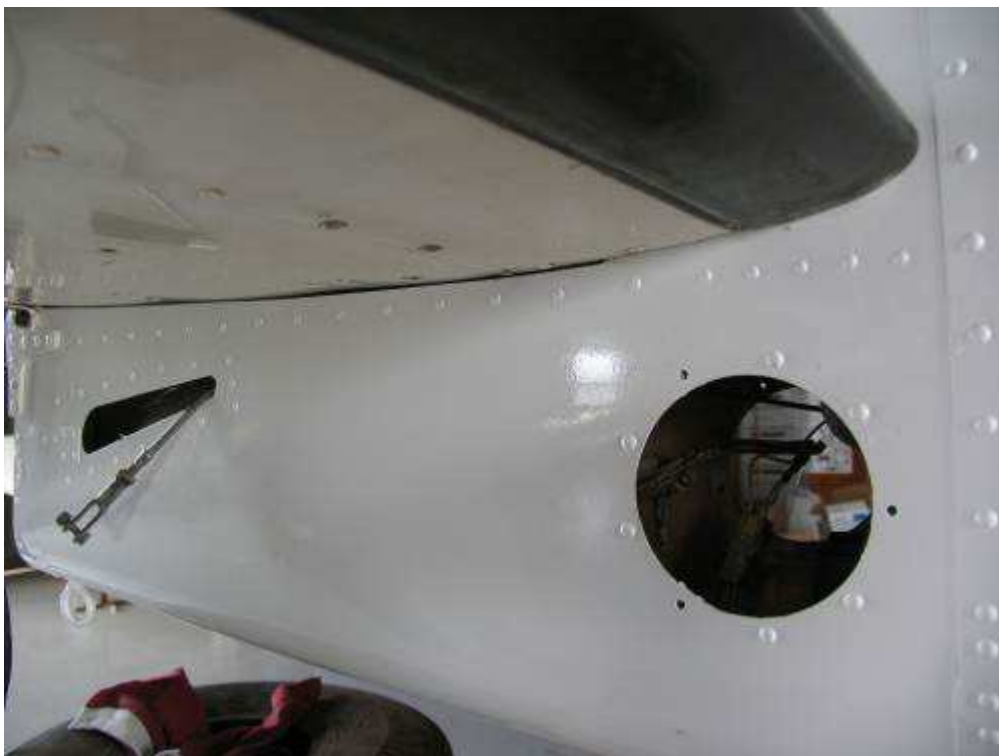
Figure 7. On the photo the inspection panel is removed and the rudder cable disconnected (maintenance)

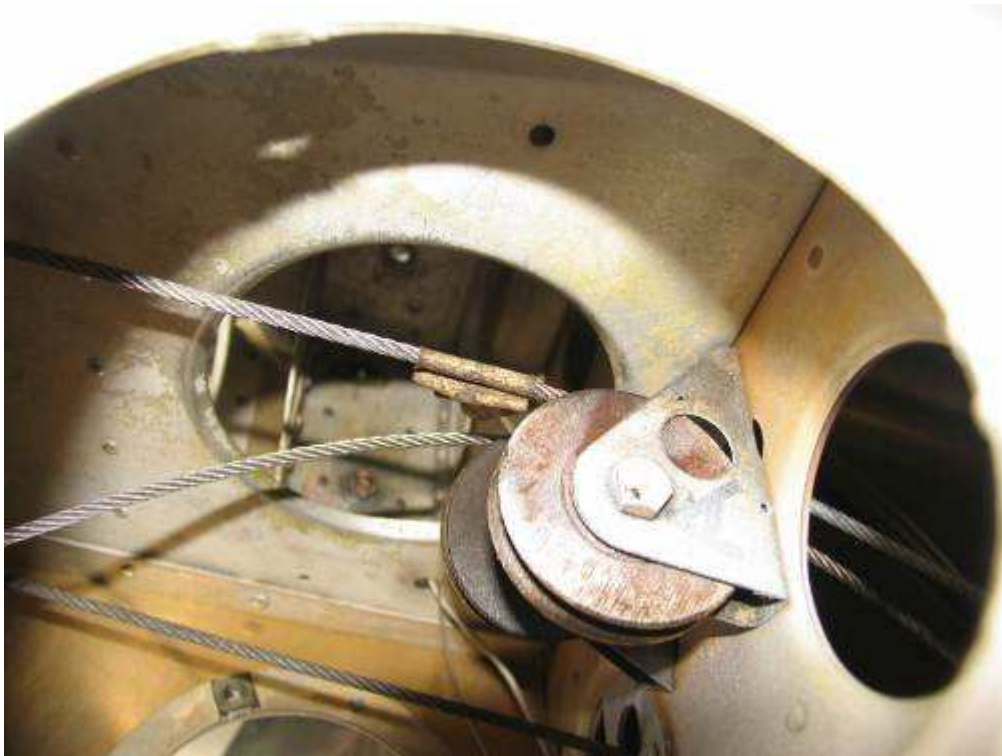
The photo in figure 8 was taken of the rudder cables and pulleys positioned inside the fuselage after the inspection panel as referred to in figure 6 was removed.

Figure 8. Photo of the rudder cables and pulleys taken through the inspection panel (maintenance in progress)

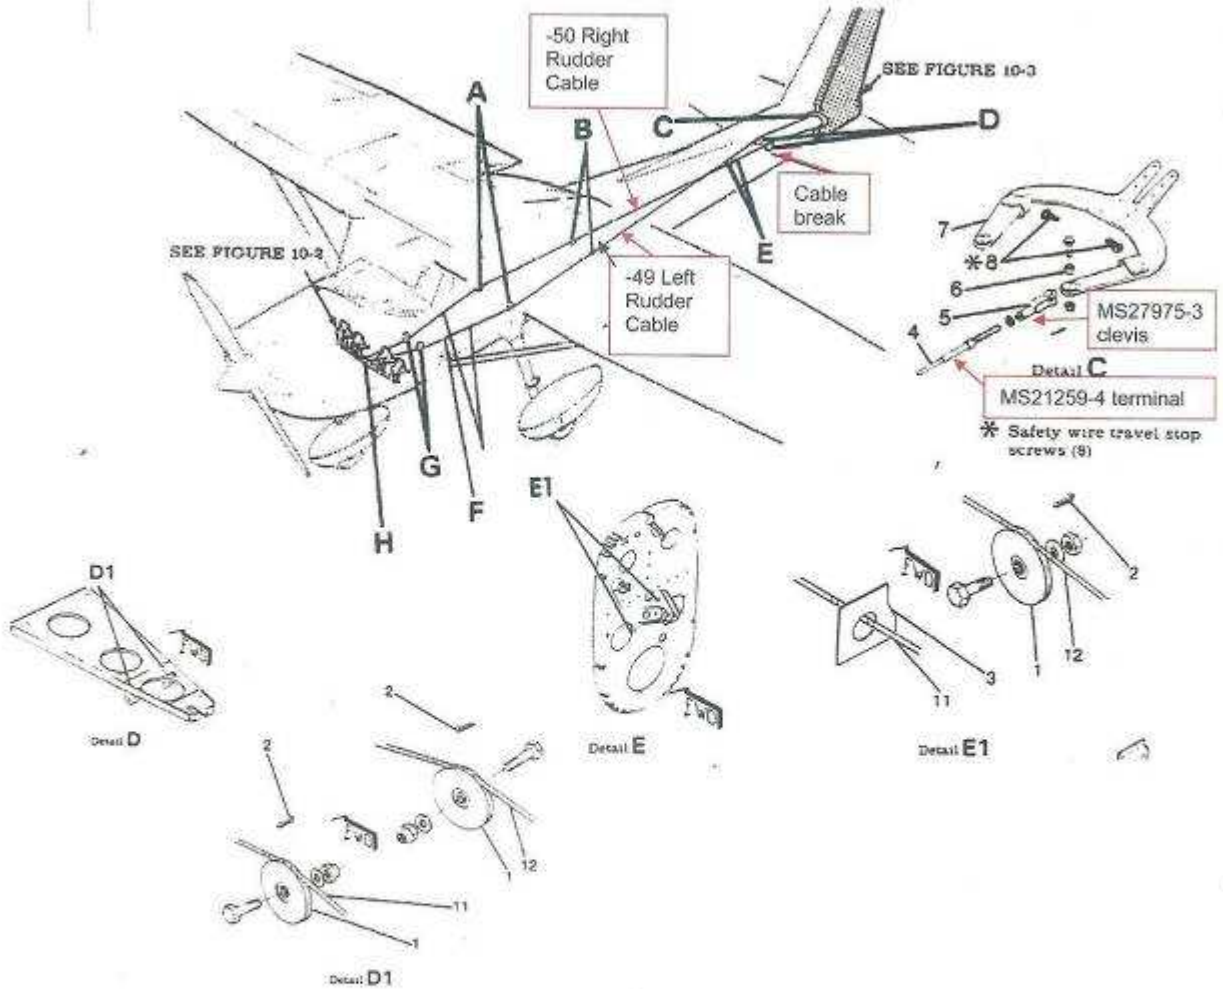
Cessna Air Safety Group and a FAA Representative brought portions of the right (R) and left (L) rudder control cable assemblies 0400107-49, and -50 from A/C 152-82591 to M&P for examination following an incident in South Africa. Figure 1 shows the rudder control system. The -50 (R) cable was separated into two pieces. The -49 (L) cable portion had been cut for removal from the system. See Figure 2. The engineering drawing required the cable assembly to be made from 1/8 inch diameter, 7x19 carbon steel cable per MIL-W-83420, with a MS20664C4 ball end and a MS21259-4RH terminal, and fabricated per CSAM026. M&P was requested to determine if the cable separated due to wear or fatigue, if the damaged areas contained aluminum or pulley material, and to determine the breaking strength of the cable of both undamaged and damaged cable.

Figure 1 - Figure showing an overview of the rudder control system from 152 Series Service Manual and figures showing details from the Illustrated Parts Catalog. The -49 and -50 cables are labeled, as well as the approximate location of the cable break.

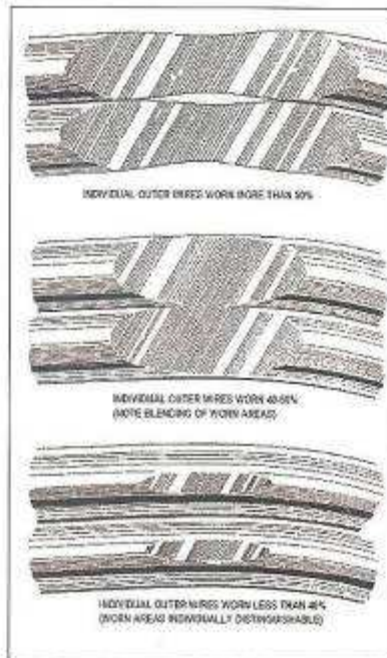
Figure 19 – Reference graphic excerpted from AC43.13-1B, Figure 7-17, which shows cable wear patterns.

FIGURE 7-17. Cable wear patterns.
