## AIRCRAFT ACCIDENT REPORT AND EXECUTIVE SUMMARY

Reference:	CA18/2/3/9360	
<b>Aircraft Registration</b>	ZS-TBW	<b>Date of Accident</b>	15 September 2014		<b>Time of Accident</b>	1309Z
<b>Type of Aircraft</b>	Air Tractor AT-802A		<b>Type of Operation</b>	Fire Fighting (Part 137 )		
<b>Pilot-in-command Licence Type</b>	Commercial Pilot		<b>Age</b>	65	<b>Licence Valid</b>	Yes
<b>Pilot-in-command Flying Experience</b>	Total Flying Hours		19796.1		Hours on Type	68
<b>Last point of departure</b>	Piet Retief Airfield (FAPF) -Mpumalanga Province					
<b>Next point of intended landing</b>	Piet Retief Airfield (FAPF)-Mpumalanga Province					
<b>Location of the accident site with reference to easily defined geographical points (GPS readings if possible)</b>						
Mondi Vrede Farm at GPS coordinates S 27°00'96.7" E 030°53'29.5 Elevation 4347feet AMSL in Mpumalanga Province						
<b>Meteorological Information</b>	Wind direction: 45°-54°; Wind speed: 8 knots; Temperature: 31.5°C; Dew Point: -0.9°C; Visibility: Fine. Cloud cover: CAVOK

**Name of Owner/Operator** : FFA Aviation (Pty) Ltd  
**Manufacturer** : Air Tractor Inc.  
**Model** : AT-802A  
**Nationality** : South African  
**Registrati

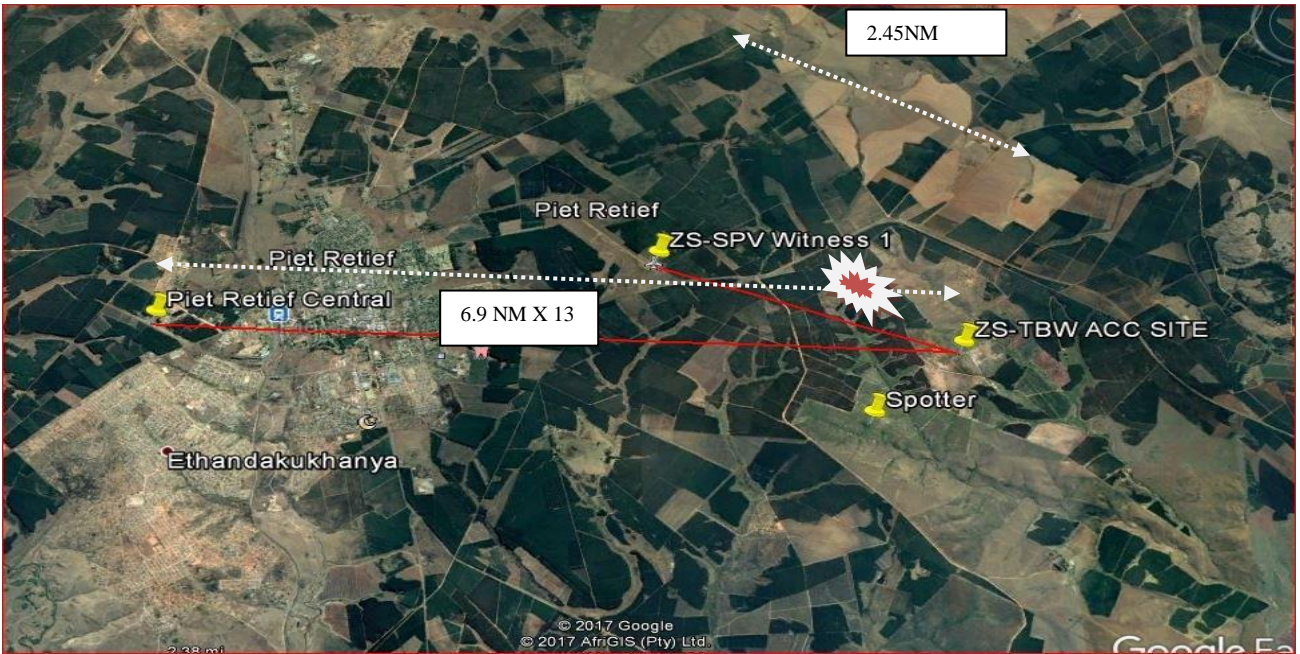
Figure 3: Fire-bombing operation to and from Mondri Vrede Farm

1.1.10 Bomber 9 couldn't drop the fire retardant load due to gate-doors not opening, the aircraft was observed descending to a height of approximately 50ft (15.2m) above ground level (AGL) in a nose up attitude before impacting with the pine trees ahead which severed the right-hand wing tip from the aircraft. The aircraft subsequently rolled over to the right hand side through 180<sup>o</sup> (inverted attitude) and impacted the ground in a nose-down attitude of approximately 70<sup>o</sup>.

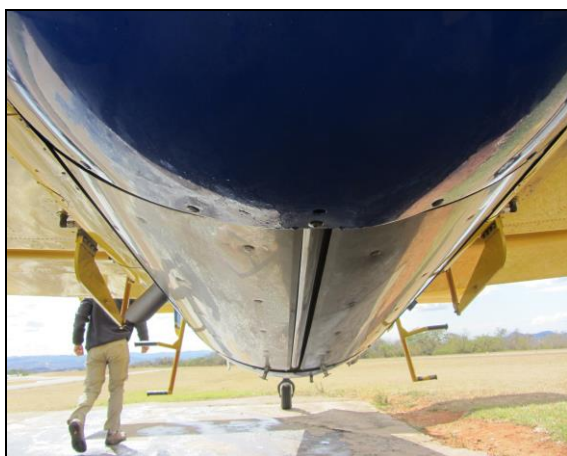
- 1.6.6 The pilot reported a defect/problem with the fire retardant load release system during the flight of the first operation before the accident occurred on the 15 September 2014 during the 2<sup>nd</sup> operation. In order to resolve the problem with the Gen I FRDS, he indicated that he was returning back to base where after a minute, he reported that the issue with the system was resolved.
- 1.6.7 According to available information, the Gen I FRDS operated without any incident for eight flights from the time that the pilot reported that the defect was resolved.
- 1.6.8 Below is the picture of the gatebox doors which are situated below the aircraft when in a closed position and opened position.

Figure 6: showing gatebox doors in a closed position

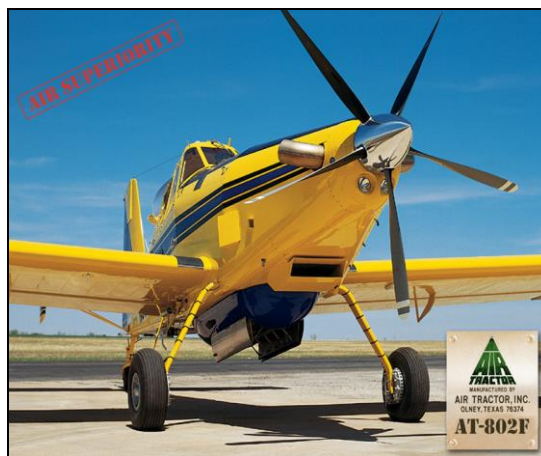
Figure 7: showing gatebox doors in an open position  
(Courtesy of Air Tractor website)
