AIRCRAFT ACCIDENT REPORT AND EXECUTIVE SUMMARY

Reference:	CA18/2/3/9361	
Aircraft Registration	ZS-IFK	Date of Accident	15 September 2014		Time of Accident	1808Z
Type of Aircraft	Cessna C172 (Aeroplane)		Type of Operation		Private	
Pilot-in-command Licence Type	Private pilot (PPL)		Age	24	Licence Valid	Yes
Pilot-in-command Flying Experience	Total Flying Hours	58		Hours on Type	Unknown	
Last point of departure		Newcastle Aerodrome (FANC): Kwa-Zulu Natal province.				
Next point of intended landing		Rand Aerodrome (FAGM): Gauteng province.				
Location of the accident site with reference to easily defined geographical points (GPS readings if possible)						
On a privately owned farm outside Newcastle at GPS co-ordinates determined to be South 27° 43.095 ' East 029° 49.777 ' at an elevation of approximately 4 445 feet above mean sea level (AMSL).						
Meteorological Information		Mid-level clouds were observed in the vicinity of the Newcastle area with surface data readings as follows: Temperature 32°C, Dew point temperature -3°C, Wind speed 07 knots.

AIRCRAFT ACCIDENT REPORT

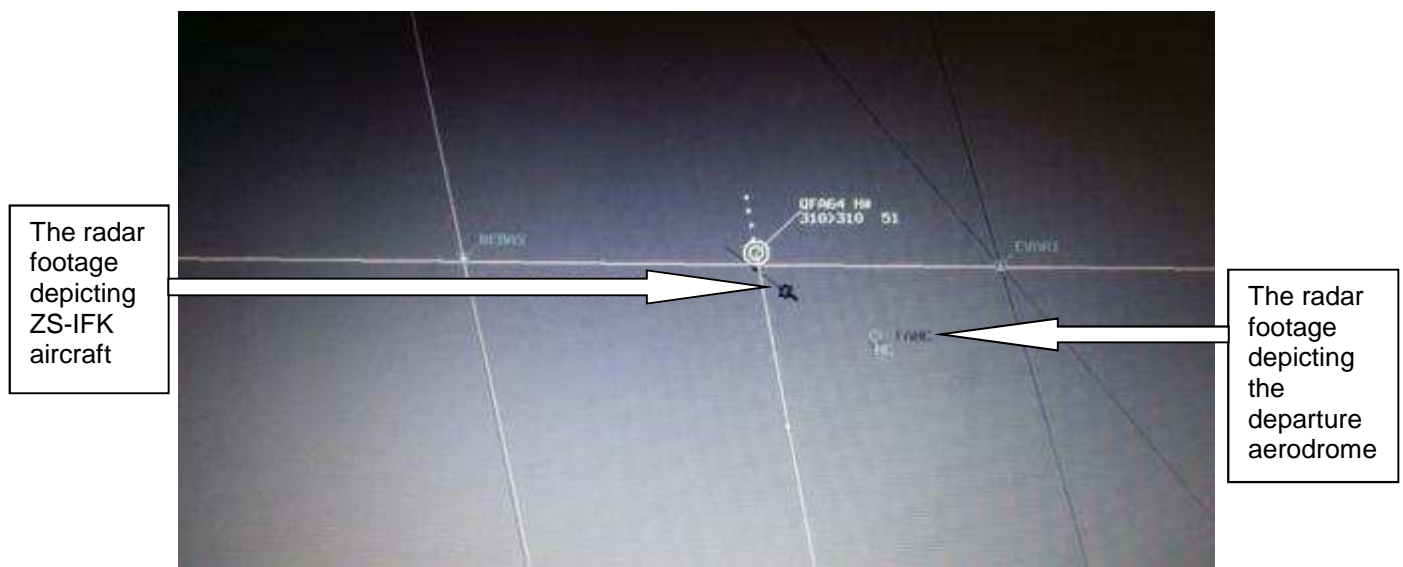
Figure 1: The radar footage depicting the ZS-IFK aircraft and FANC

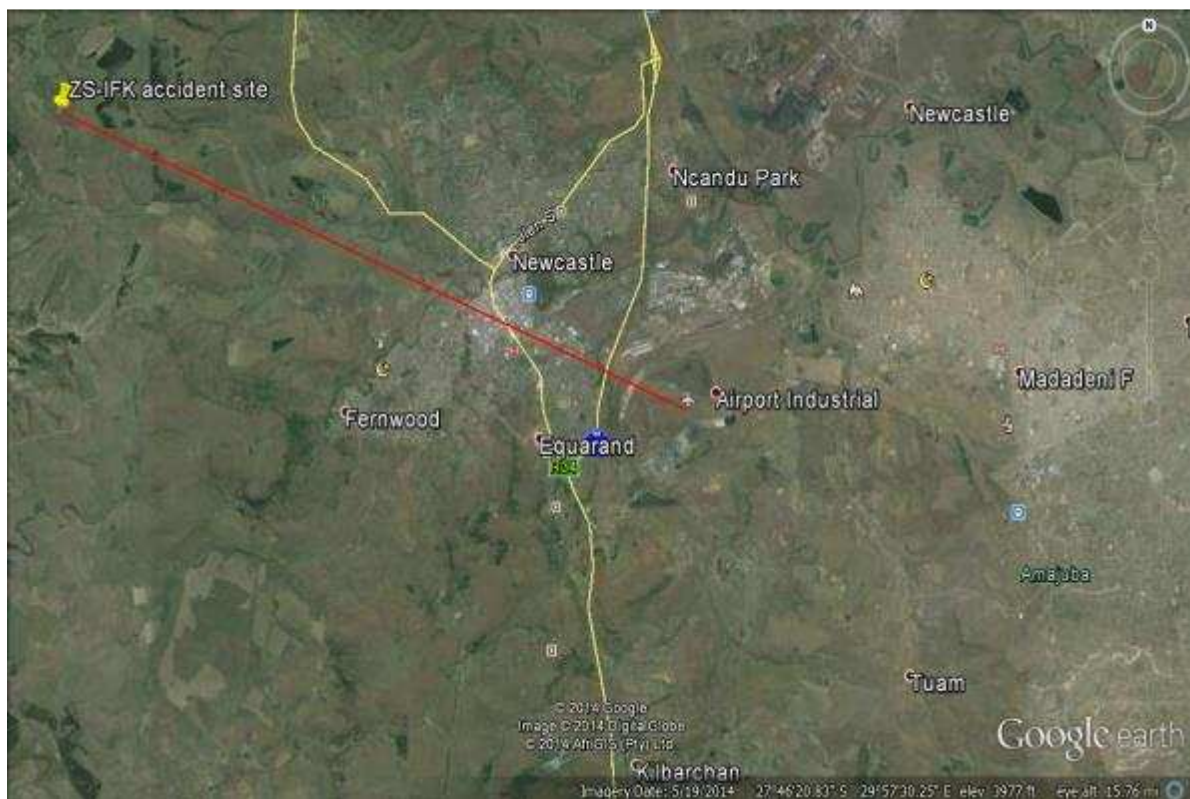
- 1.1.4 The accident happened at night time at GPS coordinates determined to be S27° 43' 095" E029° 49 ' 777" at an elevation of approximately 4 445 AMSL. The aircraft crashed approximately 8.3 NM north-west of FANC at 331°magnetic track.

Figure 3: A Google Earth map depicting the positions of FANC and the crash site

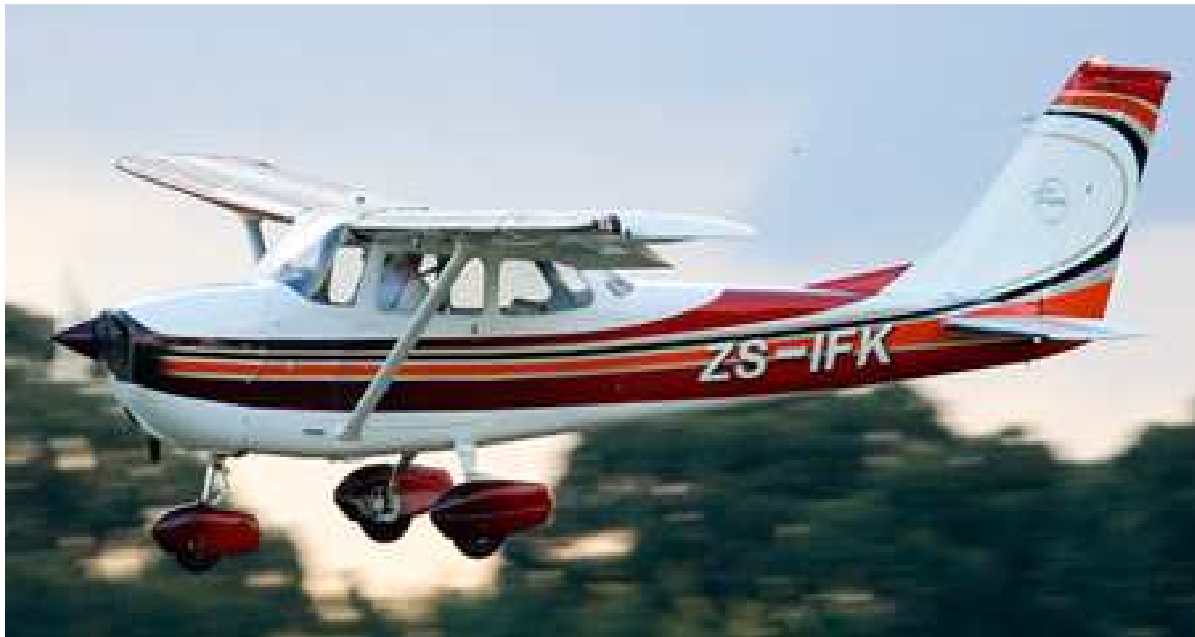
Figure 5: ZS-IFK aircraft photo

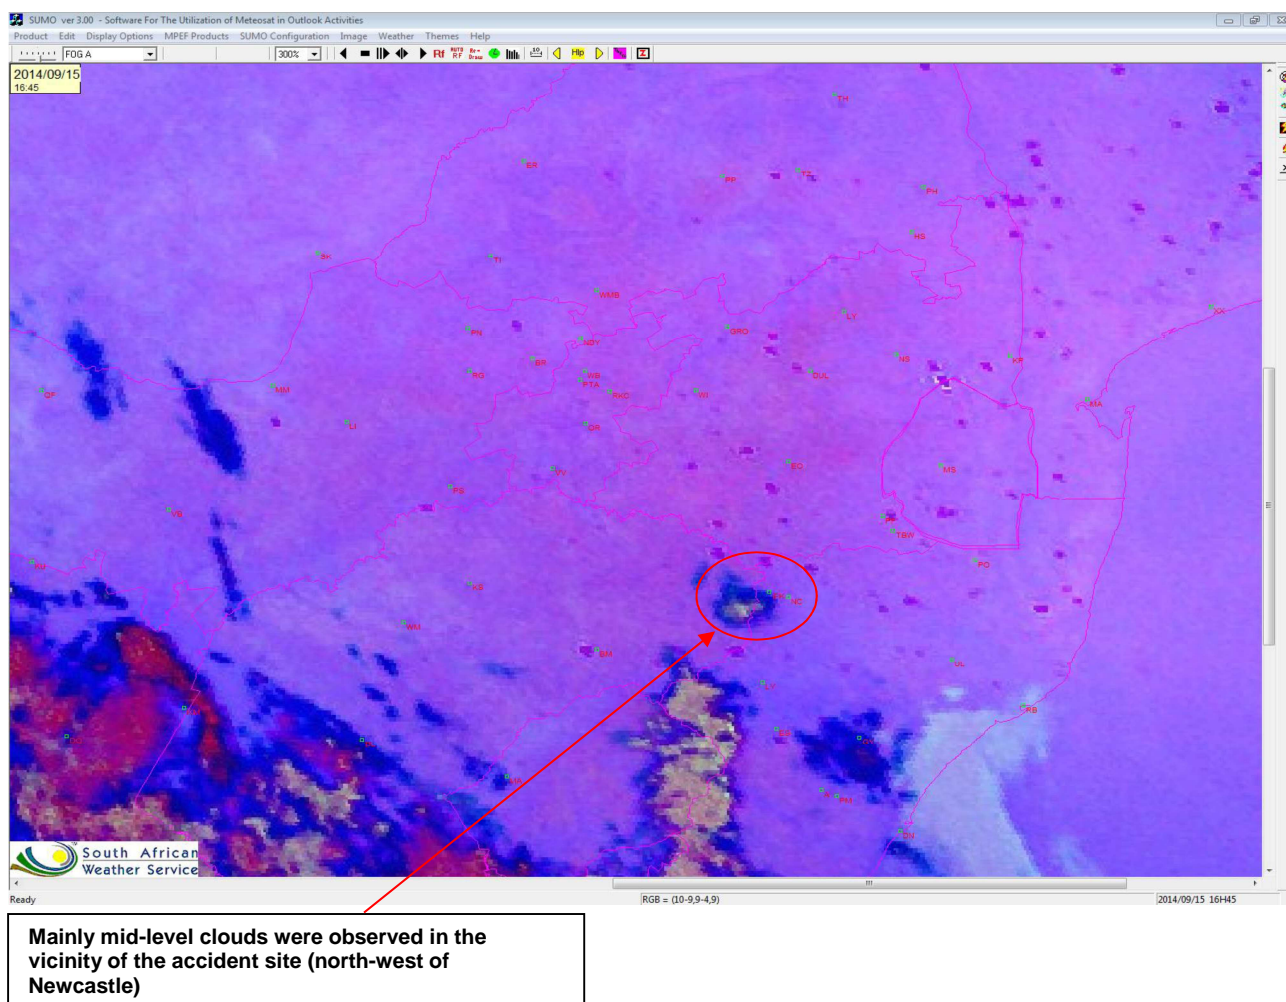
- 1.7.1 Weather information obtained from the SA Weather Services indicated mid-level clouds near the Newcastle area at the estimated time of the accident as shown by the satellite image in Figure 6.

Figure 6: Satellite image as on 15 September 2014

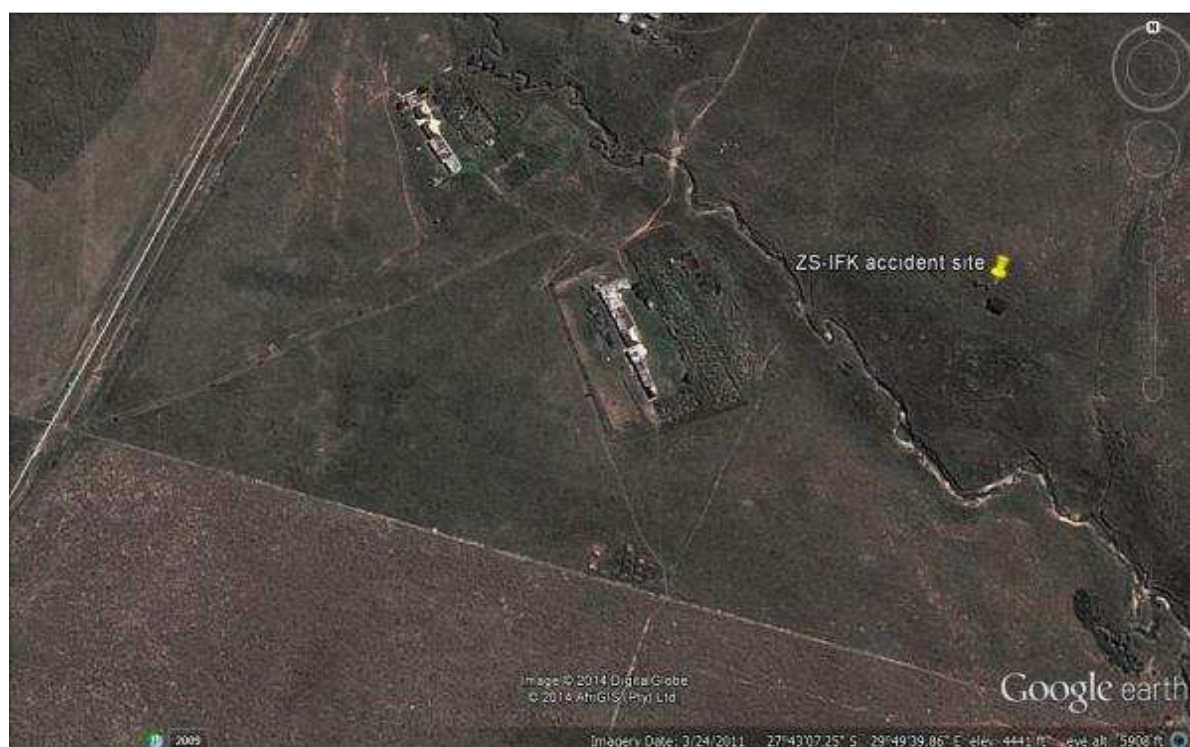
1.10.1 The accident happened at night on a privately owned farm outside Newcastle at GPS coordinates determined to be South 27° 43 ' 095" East 029° 49 ' 777" at an elevation of approximately 4 445 feet AMSL. Figure 7, below, shows the Google Earth map depicting the accident site.

Figure 7: Google Earth map depicting the accident site

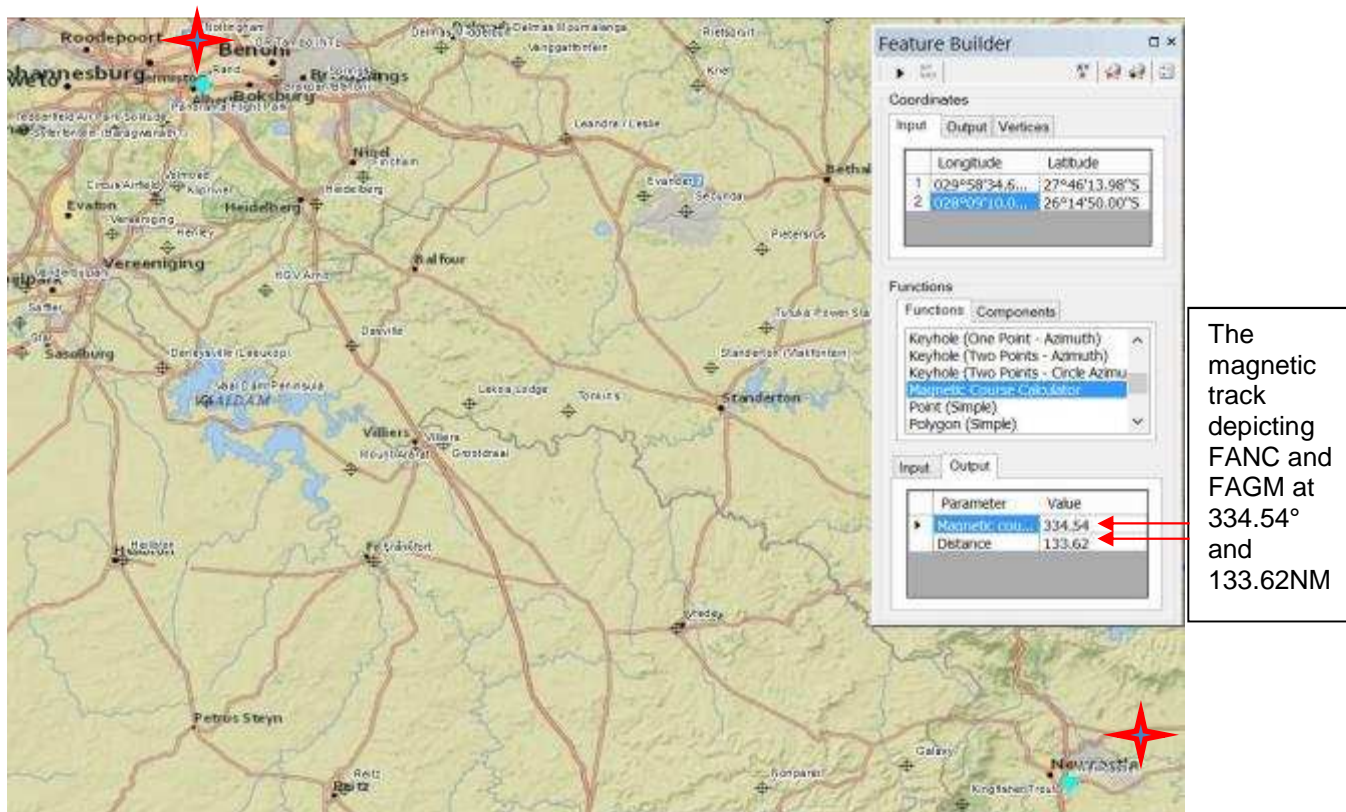
1.12.5 The aircraft crashed approximately 8.3 NM north-west of FANC at 331° magnetic track. The track between FANC and FAGM calculated as 334.54°M and the distance was 133.62 NM as shown in Figure 14. This does not take into account any wind or wind correction, and supports the suggestion that the aircraft could have been flown slightly off track. The correct procedure that the pilot should have followed was to circle the aircraft overhead FANC to the planned altitude and then set track/time before heading towards FAGM; this is standard procedure.

Figure 14: An area map depicting the distance between FANC and FAGM
