AIRCRAFT ACCIDENT REPORT AND EXECUTIVE SUMMARY

Reference:	CA18/2/3/9359	
Aircraft Registration	ZS-EJB	Date of Accident	15 September 2014		Time of Accident	1710Z
Type of Aircraft	Cessna 210 (Aeroplane)		Type of Operation		Commercial	
Pilot-in-command Licence Type		Commercial	Age	68	Licence Valid	Yes
Pilot-in-command Flying Experience		Total Flying Hours	1625		Hours on Type	180
Last point of departure		Nelspruit Aerodrome (FANS), Mpumalanga Province				
Next point of intended landing		Nelspruit Aerodrome (FANS), Mpumalanga Province				
Location of the accident site with reference to easily defined geographical points (GPS readings if possible)						
Approximately 20km North East of Nelspruit Aerodrome at the GPS: S25 17q56.8+E031 04q10.7+Elevation 870m.						
Meteorological Information		Surface wind North Easterly at 10knots. Visibility: Fair. Temperature: 30C.				
Number of people on board	1 + 0	No. of people injured	1	No. of people killed	0

Name of Owner : FFA Assets (PTY) LTD
Name of Operator : FFA Assets (PTY) LTD
Manufacturer : Cessna Aircraft Company
Model : T210F
Nationality : South African
Registration Marks : ZS-EJB
Place : 20km North East of Nelspruit Aerodrome
Date : 15

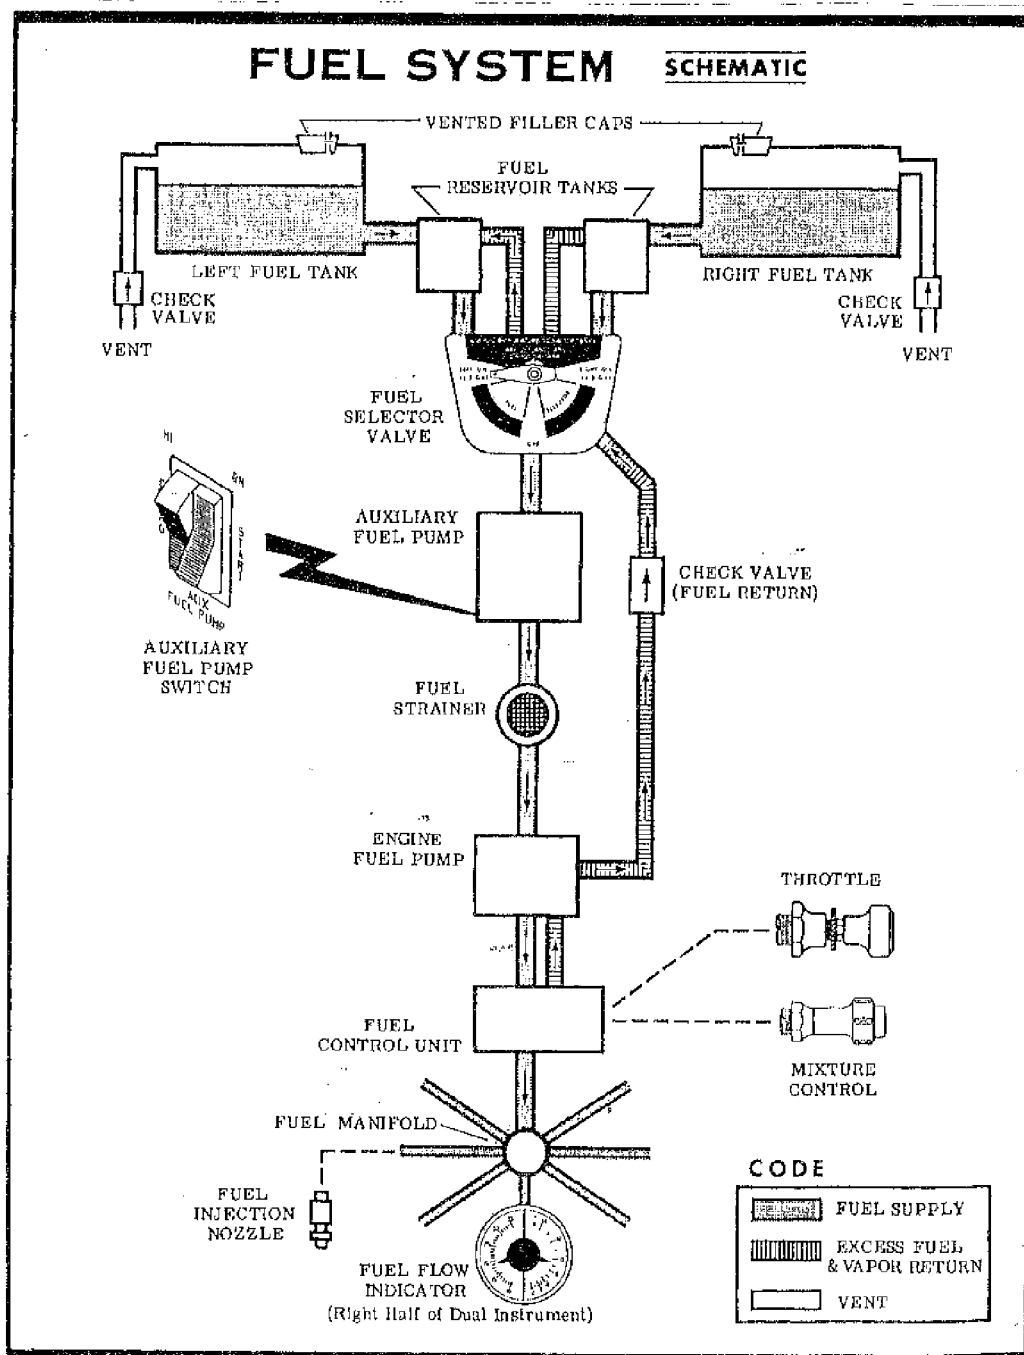
Figure 5: Schematic diagram of a fuel system

1.18.2 Fuel is supplied to the engine from two integral fuel tanks, one in each wing. Fuel from each tank flows through a reservoir tank to the fuel selector valve. Depending upon the setting of the selector valve, fuel from the left or right fuel tank and reservoir tank flows through a by-pass in the electric fuel pump (when it is not operating) and the fuel filter to the engine-driven fuel pump. From here fuel is distributed to the engine cylinders via a control unit and manifold. Fuel cannot be used from both fuel tanks simultaneously.
