Havarikommisjonen
Accident Investigation Board Denmark

FINAL REPORT

Serious incident

BOMBARDIER INC. DHC-8-202

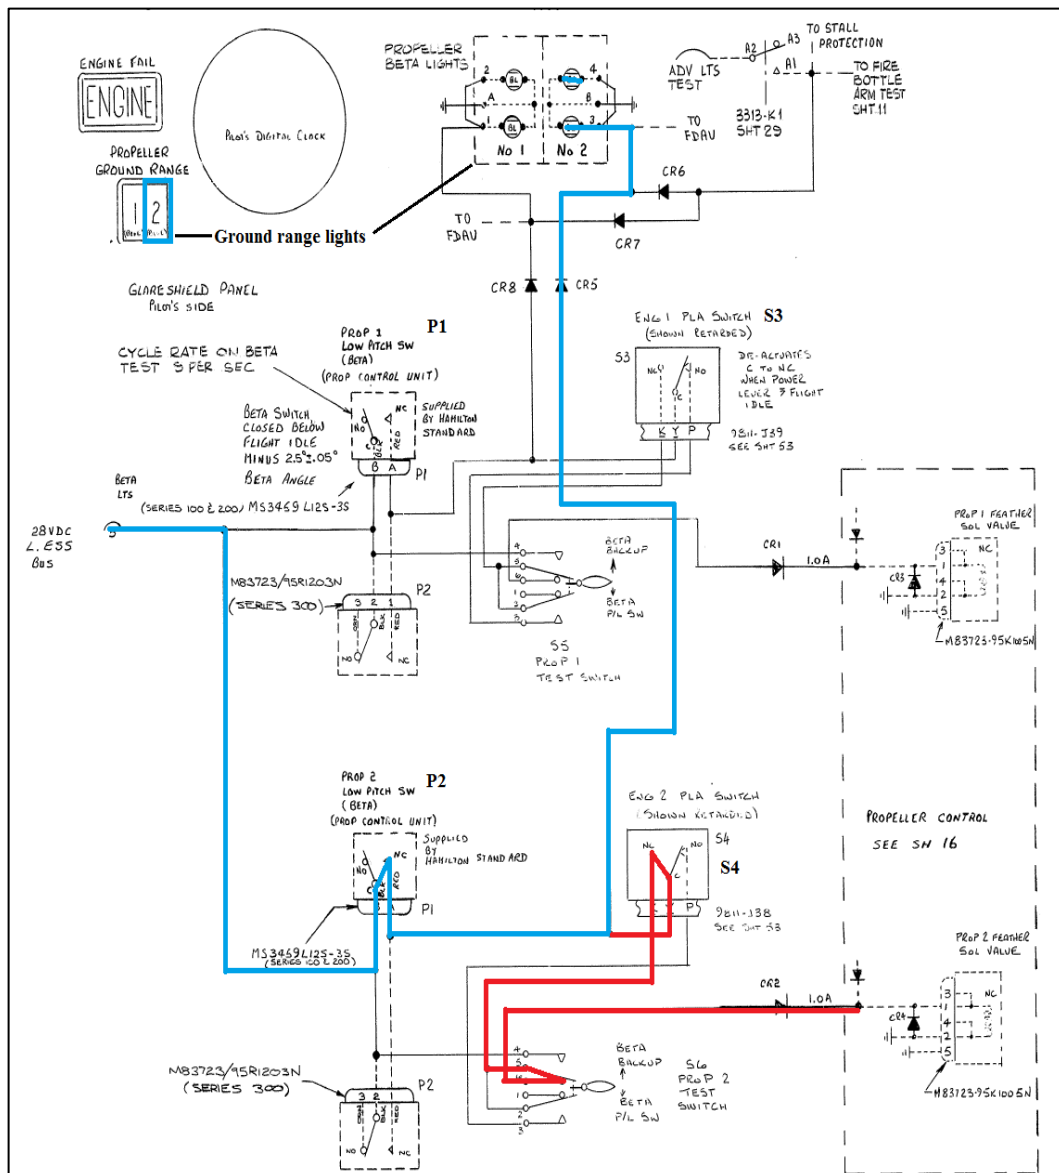
1.6.3.3.1 Beta backup protection - electrical wiring

The result is a continuous cycling in and out of propeller ground range, accompanied by an on/off flashing of the related PROPELLER GROUND RANGE indicator light. This occurs until the cause of the fault is rectified.

The scenario is illustrated in the electrical wire drawing as propeller low pitch signal 28V DC from P2 is relayed via S4 (red line shown in the electrical wire drawing) (power lever advanced above flight idle) to the PCU feather solenoid valve.

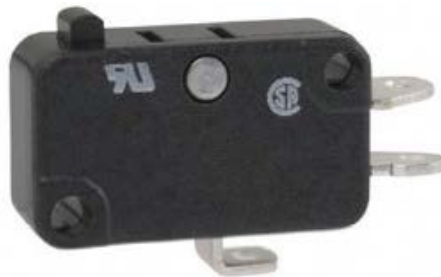
The V3-19 switch:

The power lever operated micro switch (S3 and S4 shown in the electrical wire drawings) - part number V3-19 - was installed in the power lever quadrant.

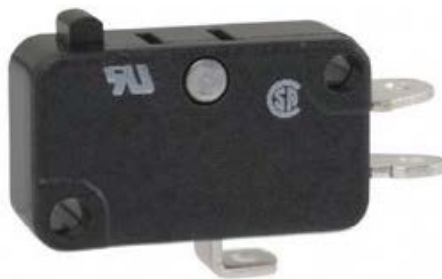
The photo below shows a factory new micro switch with the plunger correctly in place, ready for activation of the micro switch.

Activation of the micro switch is done when the plunger is moved towards the micro switch housing. The plunger is kept in this place by means of an internal spring inside the micro switch housing.

Upon landing on runway 23, the right hand power lever operated micro switch failed momentarily resulting in the propeller control system to momentarily react as the aircraft still was in flight and thereby causing the right hand propeller to begin momentarily feathering (beta backup protection).
