AIRCRAFT ACCIDENT REPORT AND EXECUTIVE SUMMARY

Reference:	CA18/2/3/9407	
Aircraft Registration	ZU-YUM	Date of Accident	14 February 2015		Time of Accident	1345Z
Type of Aircraft	Lancair 360		Type of Operation		Private(Part 91)	
Pilot-in-command Licence Type		Private Pilot	Age	38	Licence Valid	Yes
Pilot-in-command Flying Experience		Total Flying Hours	809.9		Hours on Type	366.8
Last point of departure		Parys Aerodrome (FAPY), Parys, Free State Province				
Next point of intended landing		Kitty Hawk Aerodrome (FAKT), Pretoria, Gauteng Province				
Location of the accident site with reference to easily defined geographical points (GPS readings if possible)						
On the farm Boomplaas next to Parys Aerodrome, Free State Province (GPS S26°52.820 E027°31.337 at 4728ft elevation)						
Meteorological Information		Temperature: 31 °C; Wind 270°/08 kt gusting 20-25 knots; Visibility: 10 000 m; Cloud Cover: None				
Number of people on board	1+1	No. of people injured	0	No. of people killed	2

AIRCRAFT ACCIDENT REPORT

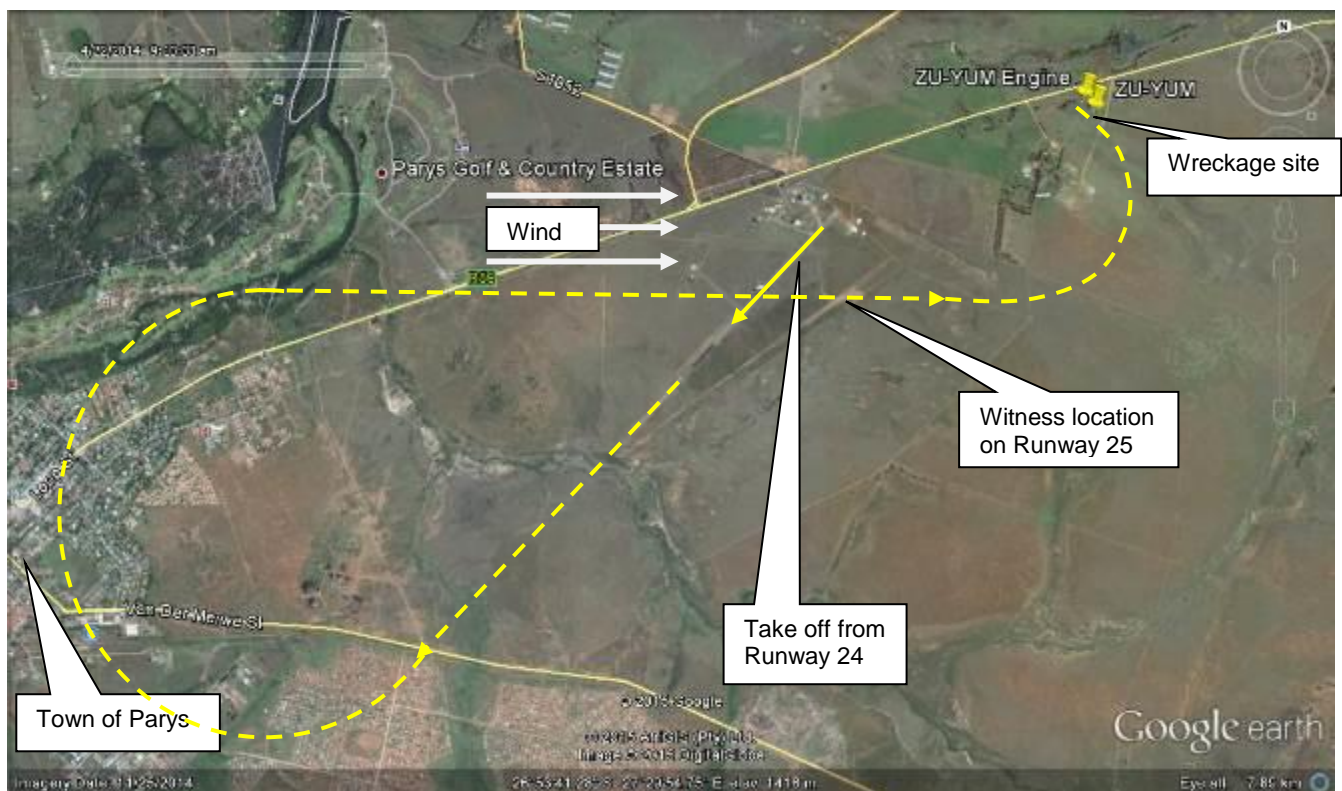
Figure 1: Google Earth view and flight path

witnesses at the airfield assumed to be about 170 knots. A witness described the weather at the time as “bad” and very turbulent with the aircraft flying with a tail wind component gusting between 20 to 25 knots. As the aircraft flew over the witness location, it was seen climbing. The intention of the pilot was then to perform a left turn, do a low level fly-past over Runway 24 and route back to Kitty Hawk Aerodrome. The aircraft was then seen by a witness in a steep left turn pitching up, where after it nosedived and impacted the ground.

- 1.1.4 Another witness, a driver of a motor vehicle travelling about 8 km outside the town of Parys along the R59 road towards Parys stated that his attention was drawn to the low flying aircraft and making what he described as a “back flip” at approximately 14 feet AGL with wings level and diving before it impacted the ground. The witness stopped his car at the side of the road and jumped over the farm fence to assist the occupants on board. He also alerted the emergency service who declared the occupants deceased at the scene of the accident. The accident occurred during daylight conditions at a GPS position S26°52.820 E027°31.337 at an elevation of 4728ft.

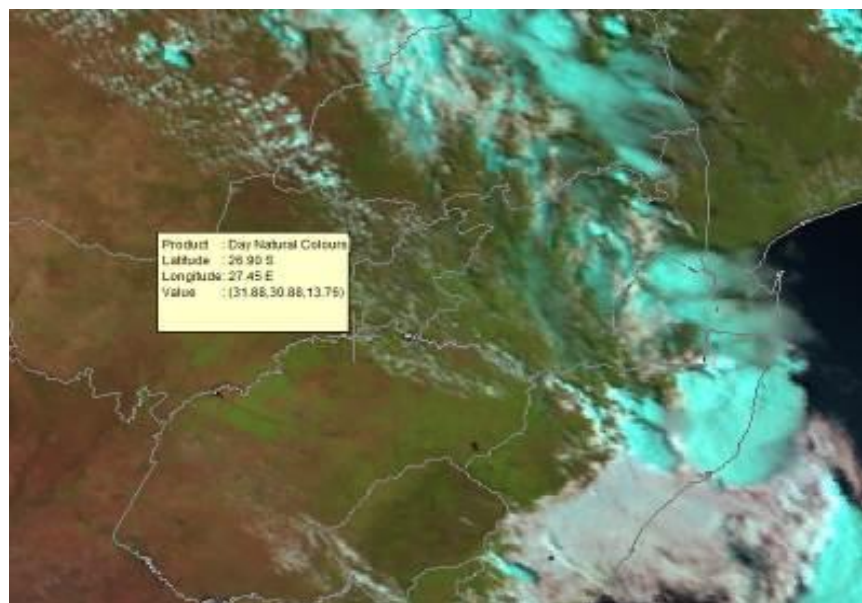
Figure 4: Satellite image of the weather in the area

In the above satellite image (EUMETSAT MSG), one can see that Parys is situated exactly on an air mass boundary. Cumulus and Towering Cumulus developed just east of Parys and this in itself can cause moderate to severe low level turbulence. No thunderstorms were in the vicinity of Parys during the accident (most of the development occurred well east of Parys). It's also evident from the observations that there wasn't a lot of moisture available in the low levels of the atmosphere around Parys.

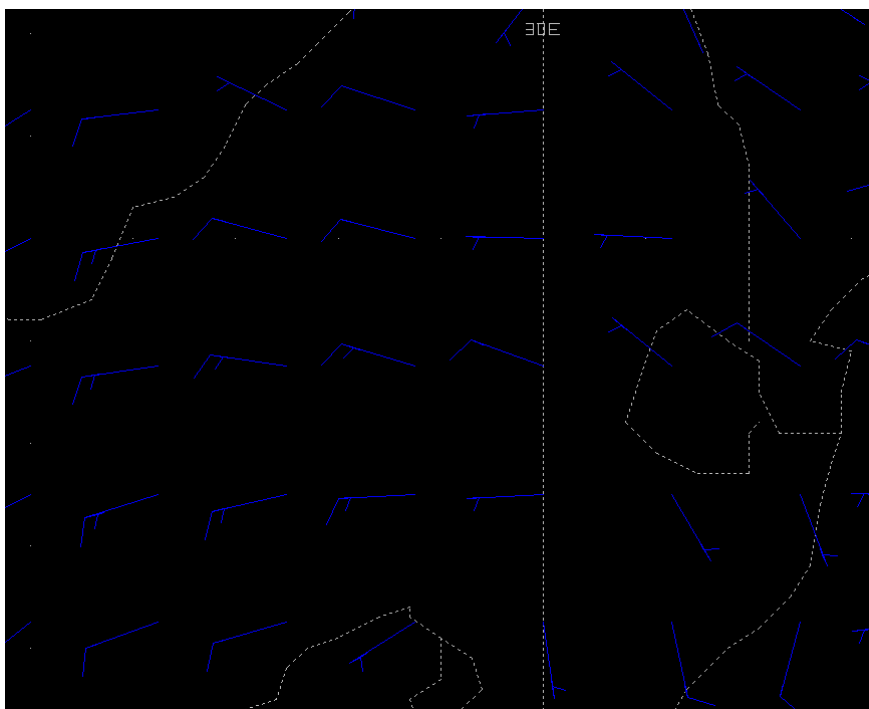
Figure 5: Numerical Model Prediction

Shown above is the wind for the 850hPa pressure level (~ 5000ft AMSL) for 1500 UTC on that day. Relatively strong winds were forecast by the models and this was confirmed when looking at the observations (some gusts were reported). This specific model run was suggesting a 15 knot average wind speed over the Parys area (gusts well over 15 knots would have been possible).

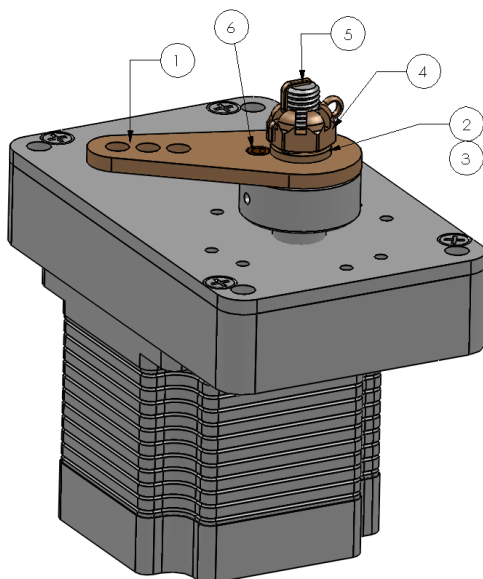
Figure 12: The elevator servo

The elevator servo was recovered with the brass shear screw still intact. The servo arm, which attaches via a push-pull rod to the elevator was, however, found bent caused by impact damage. The elevator servo was found jammed and when it was opened, it moved freely. The investigation determined that the elevator servo jammed due to impact damage during the accident sequence. The intact brass shear screw indicates that no manual override was necessary to disengage the elevator servo. The ZU-YUM accident occurred during the take-off/climb phase of flight and during this flight phase, the autopilot will also not be engaged.
