AIRCRAFT ACCIDENT REPORT AND EXECUTIVE SUMMARY

Reference:	CA18/2/3/9497	
Aircraft Registration	ZS-FHG	Date of Accident	07 November 2015		Time of Accident	1048Z
Type of Aircraft	Piper PA-28-180 (Aeroplane)		Type of Operation		Part 141	
Pilot-in-command Licence Type	Private pilot licence	Age	22	Licence Valid	Yes	
Pilot-in-command Flying Experience	Total Flying Hours	126.5		Hours on Type	102.7	
Last point of departure	Port Elizabeth international airport (FAPE): Eastern Cape province					
Next point of intended landing	George aerodrome (FAGG): Western Cape province					
Location of the accident site with reference to easily defined geographical points (GPS readings if possible)						
Westerly side of the airport on the perimeter fence at GPS co-ordinates, S33° 59' 28.64' E025° 36' 07.06'.						
Meteorological Information	Temperature: 22° C, Dew-point: 15°C, Wind speed: 14 knots, QNH 1013hPa					
Number of people on board	1 + 0	No. of people injured	0	No. of people killed	1

AIRCRAFT ACCIDENT REPORT

Name of Owner : 43 Air School
Operator : (AIFA) Avic international flight training academy
Manufacturer : Piper Aircraft Cooperation
Model : PA-28-180
Nationality : South African
Registra

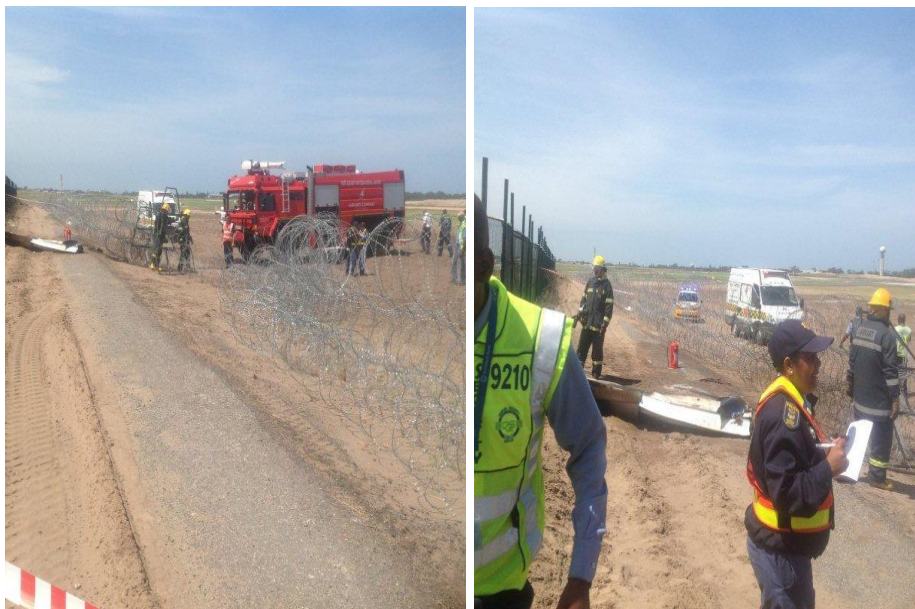
Figures 15: Emergency vehicles (fire truck and the ambulance) at accident site

1.15.1 The accident was considered non-survivable. The aircraft burst into flames after impact, suggesting that; though the pilot might still have been conscious after collision with the perimeter fence and the ground, he might have been incapable of vacating the burning wreckage. The emergency medical service was dispatched to the site of the accident, however the pilot was found to have succumbed to his injuries. The pilot's body was extracted from the wreckage and handed into the care of the Forensic Pathology services located at Port Elizabeth. Humewood police has opened an inquest investigation docket.

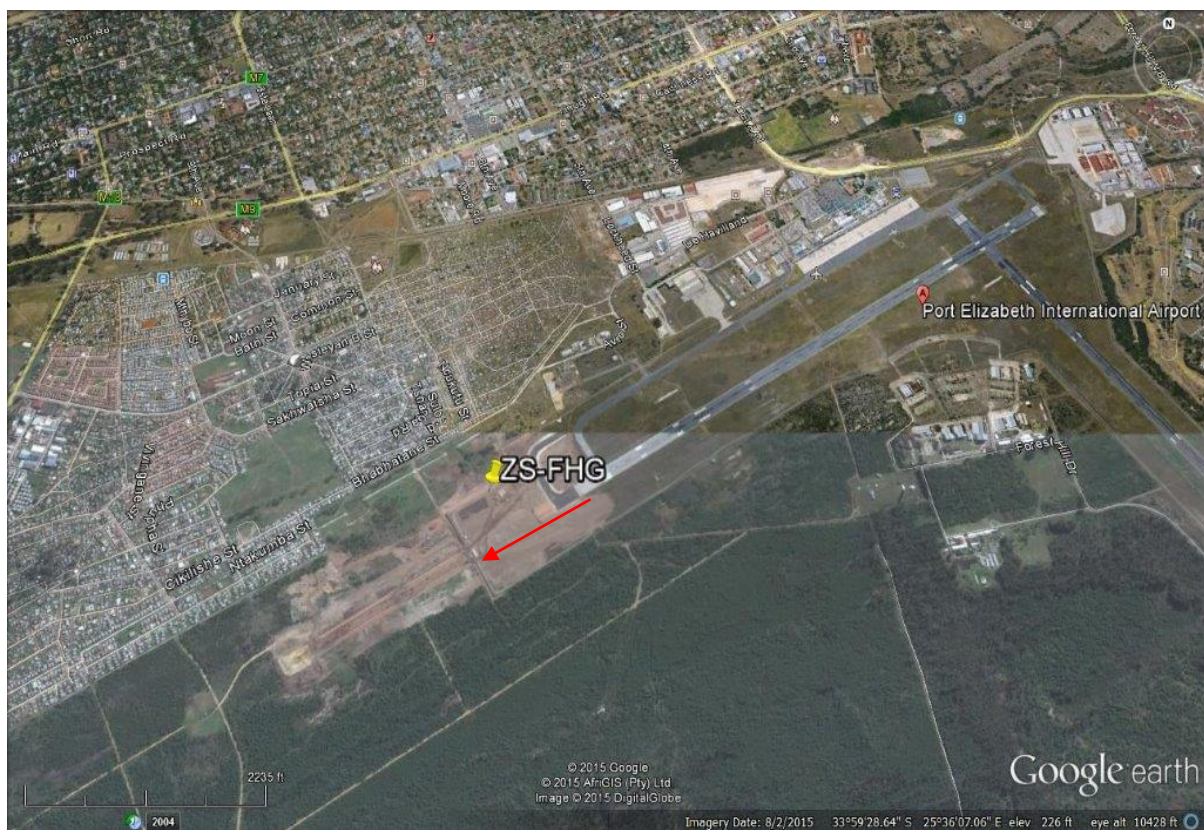
Figure 16: Google Earth map depicting the airport layout

FAPE ATC communication record was made available to the investigating team on a compact disc (CD) and examined later as part of the investigation. During the process it came to the attention of the investigators that the pilot broadcasted an emergency call (my engine is cutting off inside, requesting emergency landing on the runway) at 10:47:36, **600 feet AGL**.

The response from the control tower was made at 10:47:56 (AVQ327 you can land back on the runway), 20 seconds later. At this stage, the aircraft was on track still travelling at 85 miles per hour. The investigators with the aid of one of SACAA reputable flight schools flight instructors worked out the twenty seconds time lapse relative to the aircraft track leading up to the accident. The calculations were made considering the PA28-180 pilot operating handbook (POH) and the recent conditions for the day as per the official weather report. Temperature, 22°C: QNH, 1013 hectopascals (Hpa): Wind speed, 14 knots: Wind direction, 240 Density Altitude, zero (0) ft and the aircraft mass and balance which was within limits (standard aircraft weight with full tanks and 1 crew/pilot). From adding full power to rotate and to climb to 50 feet above the runway, 1 625 feet (495 meters) was used. Rate of climb for current conditions was 750 ft per minute. Vertical travel 350 ft @ 750 ft per minute {(0.46 minutes) (28 seconds)}. This was to climb from the end of the take-off distance at 50 ft above the runway to 400 ft above aerodrome level (ATC transcript indicated at 600 feet altitude, airfield elevation was 200 ft AMSL) best rate of climb (VY) 74 knots (recommended climb speed), headwind 14 knots. Therefore 60 knots ground speed = 6 080 feet per minute @ 28 seconds = 2 837 ft (864 meters). 864 meters travelled + take-off distance of 495 meters = 1 359 metres. Runway 26 length as publicised on the aeronautical information publication (AIP) was 1 980 metres - **1 359** metres = **620** metres short of the threshold. Therefore the investigation determined that the aircraft would have been 620 meters before the runway end when the aircraft report an engine failure at 600 ft altitude, assuming reported conditions were correct and flying accuracy was maintained. According to FAPE apron manager, the clear way/grass area available from the threshold to the airport perimeter fence was **340.4** metres. The 620 meters short of runway end + 340.4 clear way/grass area = 960.4 meters. The aircraft travelled additional **514** meters before a call “you can land back on the runway” (10:47:56) was made. Meaning that the aircraft was right at the runway end when a call was made heading towards the airport perimeter fence before commencing a 180° turn to the right. Nine seconds later (illustrated on figure 2) the aircraft lost height and dropped to 400 feet AGL. Seconds later, the aircraft disappeared from the radar, suggesting that during the series of turns, it entered into a stall condition, from which it impacted the airport perimeter fence before bursting into flames. The accident scene also revealed that the aircraft did not have forward speed at the time of the accident. Below is the Google earth map depicting FAPE aerodrome layout and the calculated aircraft performance/travel.
