AIRCRAFT ACCIDENT REPORT AND EXECUTIVE SUMMARY

Reference:	CA18/2/3/9503	
Aircraft registration	ZS-SDJ	Date of accident	2 December 2015		Time of accident	0329Z
Type of aircraft	Robinson R44 Raven II		Type of operation		Private (Part 91)	
Pilot-in-command licence type		Commercial	Age	30	Licence valid	Yes
Pilot-in-command flying experience		Total flying hours	1 058,7		Hours on type	1 024,5
Last point of departure		Farm Uitenpas near the town of Musina, Limpopo province				
Next point of intended landing		Farm Ehrenbreitstein, Limpopo province				
Location of the accident site with reference to easily defined geographical points (GPS readings if possible)						
Portion 66 of the farm Musina (GPS position; 22°20.242' South 030°02.891' East), elevation 1780 ft AMSL						
Meteorological information		Surface wind: Light and variable; Temperature: 22°C; CAVOK				
Number of people on board	1 + 1	No. of people injured	0	No. of people killed	2	
Synopsis

AIRCRAFT ACCIDENT REPORT

Name of Owner : Central Africa Transport (Pty) Ltd
Name of Operator : Private (Part 91)
Manufacturer : Robinson Helicopter Company
Model : R44 Raven II
Nationality : South African
Registration : ZS-SDJ
Place : Musina

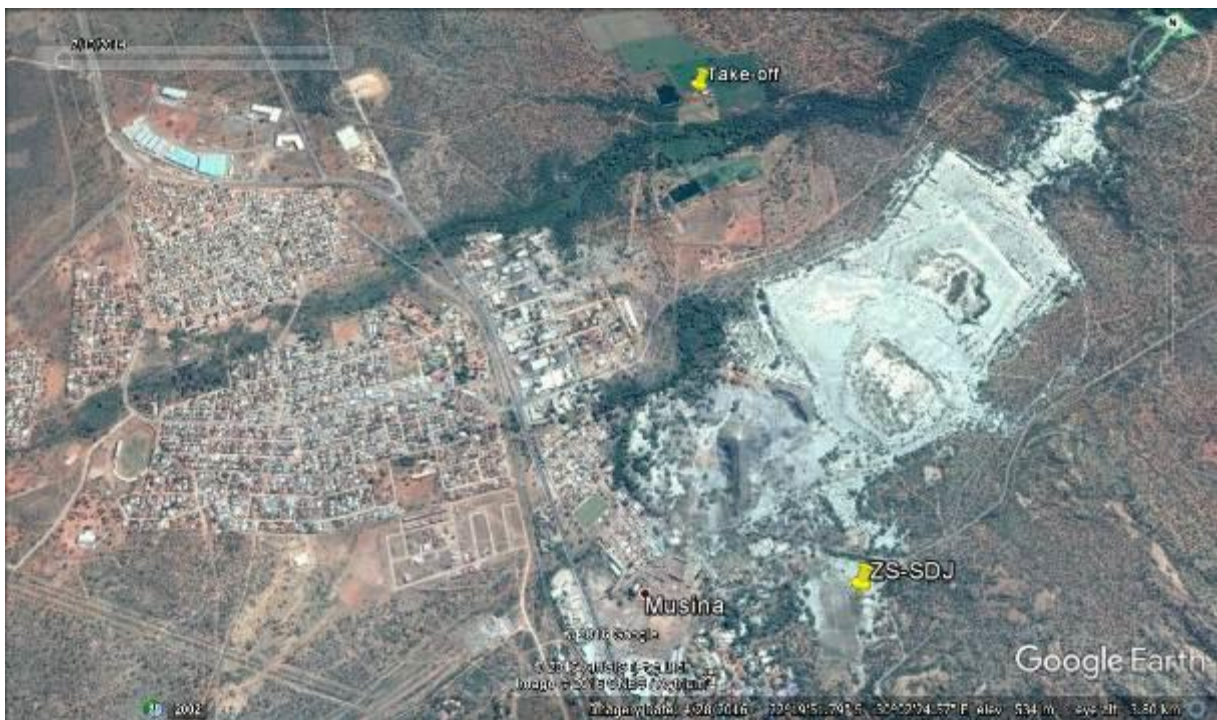
1.12.1 The accident site was 1 nm south of the helipad on the farm Uitenpas, from where they took off, from as can be seen on the Google Earth overlay in Figure 3.

Figure 3. Google Earth overlay indicating take-off location and accident site (ZS-SDJ)
