## AIRCRAFT ACCIDENT REPORT AND EXECUTIVE SUMMARY

CA18/2/3/9520

<b>Aircraft Registration</b>	ZS-PME	<b>Date of Accident</b>	3 February 2016		<b>Time of Accident</b>	0945Z
<b>Type of Aircraft</b>	Piper PA-32-300			<b>Type of Operation</b>	Private (Part 91)	
<b>Pilot-in-command Licence Type</b>	Private Pilot Licence	<b>Age</b>	63	<b>Licence Valid</b>	Yes	
<b>Pilot-in-command Flying Experience</b>	<b>Total Flying Hours</b>	4130.90		<b>Hours on Type</b>	388.6	
<b>Last Point of Departure</b>	Brakpan Aerodrome (FABB), Gauteng Province					
<b>Next Point of Intended Landing</b>	Entabeni Lodge, Limpopo Province					
<b>Location of the accident site with reference to easily defined geographical points (GPS readings if possible)</b>						
500m past the end of Runway 36 at FABB (GPS position 26° 13, 35.54"S 028° 17' 54.06"E) Elevation 5300ft AMSL						
<b>Meteorological Information</b>	Wind: 300°/10°kt; Temperature: 27°C; Dew point: 10°C; Visibility: CAVOK; Clouds: Few

**AIRCRAFT ACCIDENT REPORT**

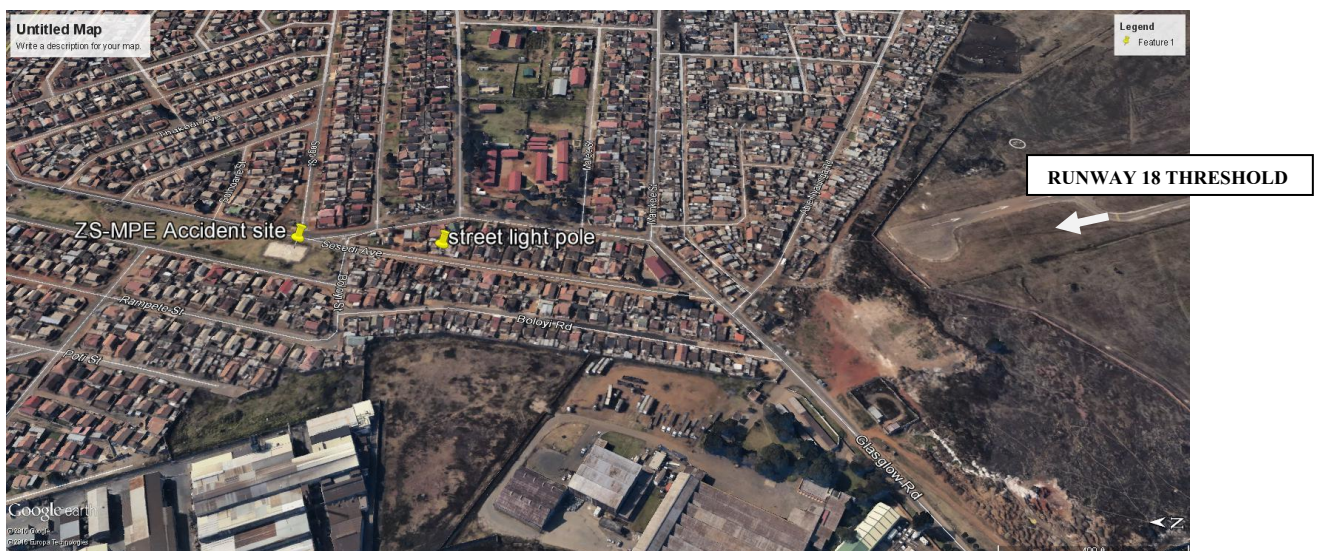
- 1.1.5 The aircraft was destroyed during the impact sequence, as well as by the post-impact fire that erupted.
- 1.1.6 The Emergency Services arrived at the accident site but found that the occupants had already succumbed to their injuries. The accident occurred 500m past the end of Runway 36 at FABB (GPS position 26° 13, 35.54" S 028° 17' 54.06" E) at an elevation of 5300 feet (ft) above mean sea level (AMSL).

**Figure 1:** The accident site in relation to Brakpan Aerodrome.

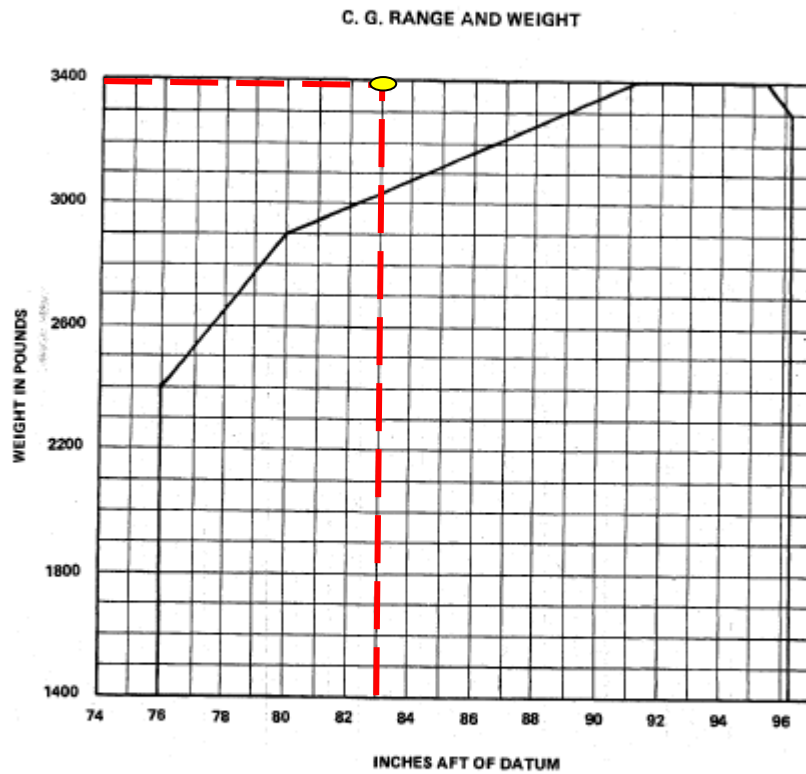
# Graph 1: Indicates the forward CG position scenario

It is the opinion of the investigators that the correct pre-flight planning had not been carried out. The aircraft balance (CG) was outside the manufacturer's envelope. The current weather conditions were not viable for a departure as the density altitude had increased to the above the limits set out by the performance charts provided by the manufacturer.

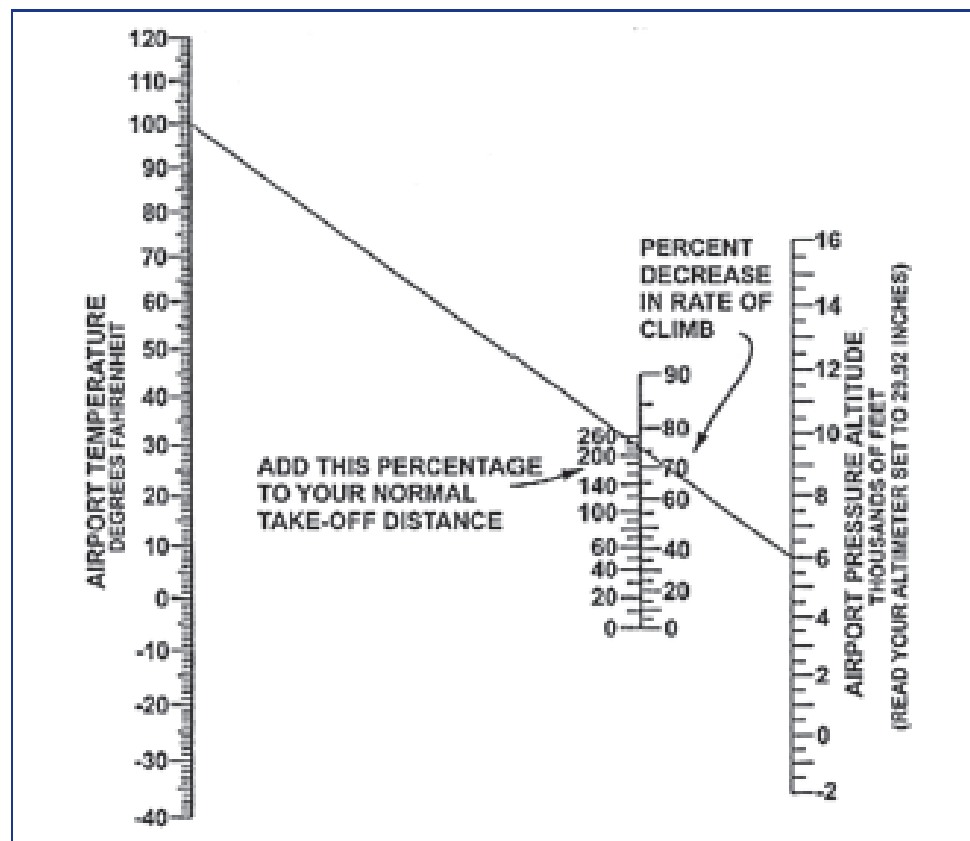
### Koch Chart

1.18.5 The Red diagonal line shows that 140% must be added for a temperature of 27°C (80.6°F) and a pressure altitude of 5300ft (1615.4m). Therefore, with the standard temperature for the sea level take-off distance requiring 1500 feet of runway to climb to 50 feet, it would become 3600 feet under the conditions shown in the chart. In addition, the rate of climb would be decreased by 65 percent. Which means this aircraft normal sea level rate of climb is 1050 feet per minute, it would become 368 feet per minute.

For example, the diagonal line shows that 230 percent must be added for a temperature of 100 °F and a pressure altitude of 6,000 feet. Therefore, if your standard temperature sea level takeoff distance normally requires 1,000 feet of runway to climb to 50 feet, it would become 3,300 feet under the conditions shown in the chart. In addition, the rate of climb would be decreased by 76 percent. Also, if your normal sea level rate of climb is 500 feet per minute, it would become 120 feet per minute.
