**FINAL REPORT ON SERIOUS INCIDENT INVOLVING
M/S INDIGO AIRCRAFT VT-IFP (A320)
AND
M/S KUWAIT AIRWAYS AIRCRAFT 9K-APA (A330-200)
AT
MUMBAI
ON
30.11.2016**

**FINAL REPORT ON SERIOUS INCIDENT INVOLVING M/S INDIGO
AIRCRAFT VT – IFP (A320) AND KUWAIT AIRWAYS AIRCRAFT
9K-APA (A330-200) AT MUMBAI ON 30.11.2016**

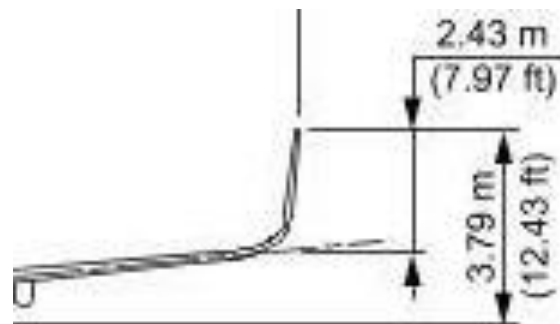
Front View of sharklet

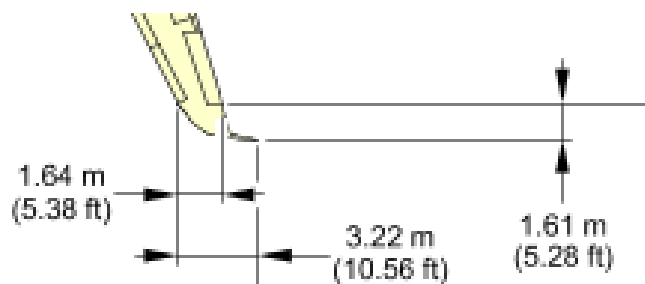
Top View of sharklet

So, for aircraft such as the aircraft 1, the addition of sharklet / winglets does increase the wing dimensions of the aircraft. However, they do not extend upwards perpendicular to the horizontal plane, but rather extend upwards, backwards and outwards from the wing itself. Specific to the aircraft 1, the winglet extends the wing by 1.61 m from the wing joint and rises to a height of 2.43m above the wing.

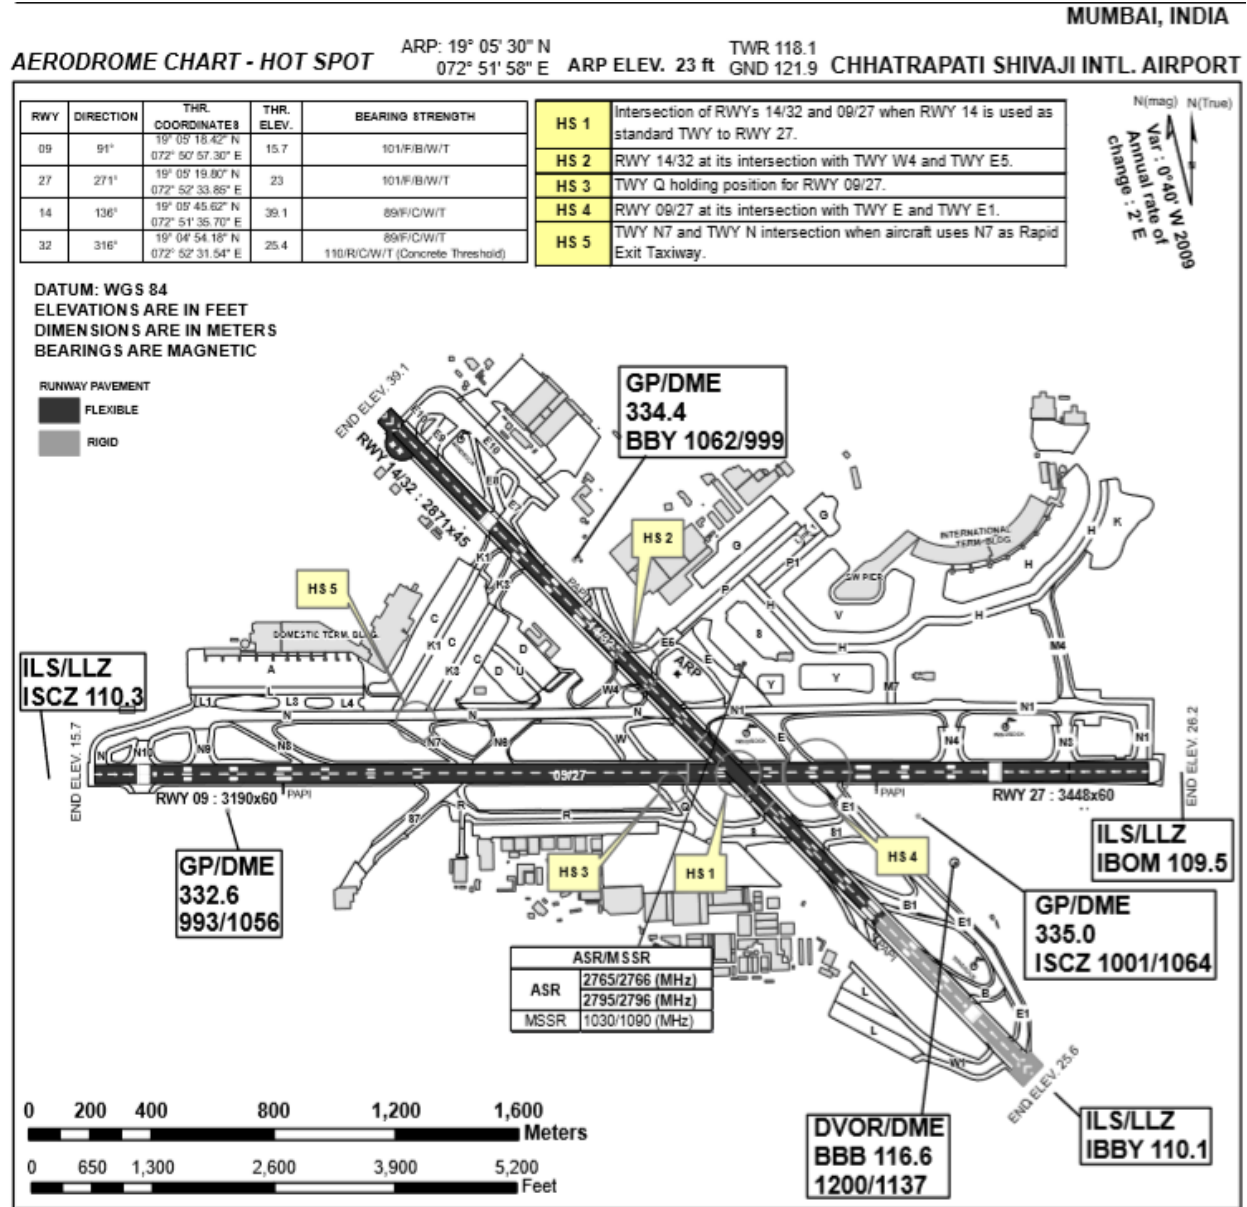
Hot Spots

The following figure shows the “hot spots” at the C.S.I.A which do not include the location where the wings of the two aircraft had hit each other.
