AIRCRAFT ACCIDENT REPORT AND EXECUTIVE SUMMARY

Reference:	CA18/2/3/9587	
Aircraft Registration	ZS-OWB	Date of Accident	10 December 2016		Time of Accident	1118Z
Type of Aircraft	Piper PA-28-181		Type of Operation	Private (Part 91)		
Pilot-in-command Licence Type	Private Pilot Licence		Age	20	Licence Valid	Yes
Pilot-in-command Flying Experience	Total Flying Hours		100.7		Hours on Type	100.7
Last point of departure	Kruger International Airport (FAKN), Mpumalanga Province.					
Next point of intended landing	Rand Airport (FAGM), Gauteng Province.					
Location of the accident site with reference to easily defined geographical points (GPS readings if possible)						
At Ngodwana, Mpumalanga in a mountainous area about 30NM west of Kruger International Airport (FAKN) at position GPS 25°30'55.3"S 30°31'30.7"E, elevation 4724 ft AMSL.						
Meteorological Information	Wind direction: 040°, Wind speed: 02 knots, Temperature: 24°C, Dew point: 15°C, Cloud: BKN 025 and Visibility: Good.

Probable Cause						
The aircraft collided with terrain in cloudy and overcast weather conditions. Controlled flight into terrain (CFIT) due to adverse weather.						
SRP Date	10 October 2017		Release Date	05 A

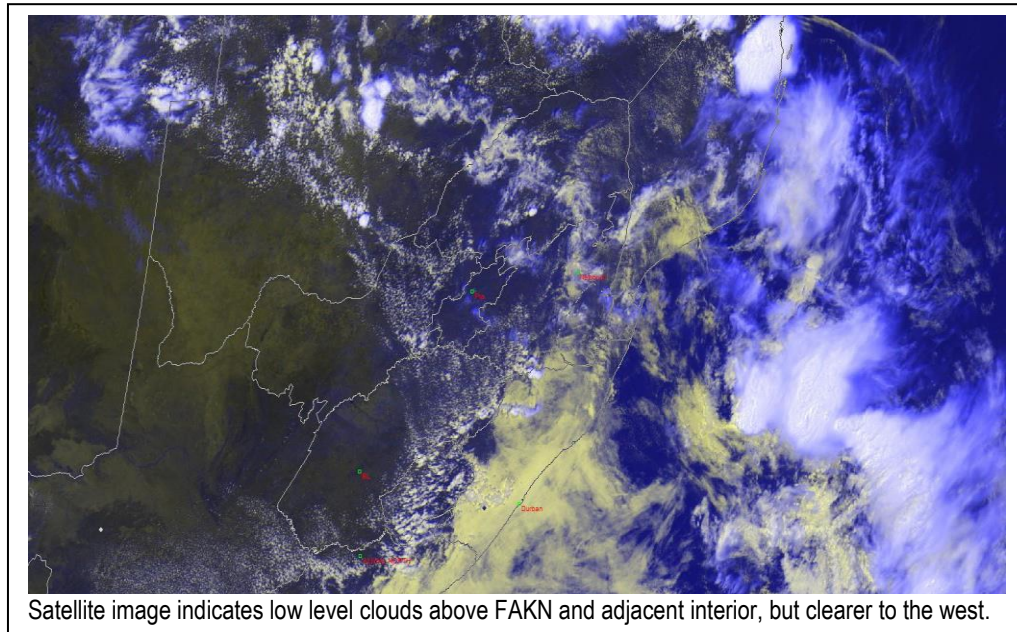
Figure 2 indicating the satellite image of the area of FAKN

1.7.1.2 The SAWS Report concluded that *“The surface wind was light easterly, with cloudy to overcast conditions reported between 2000 – 3000 feet above ground level. The data also agrees with the satellite data in terms of presence of cloud”*.

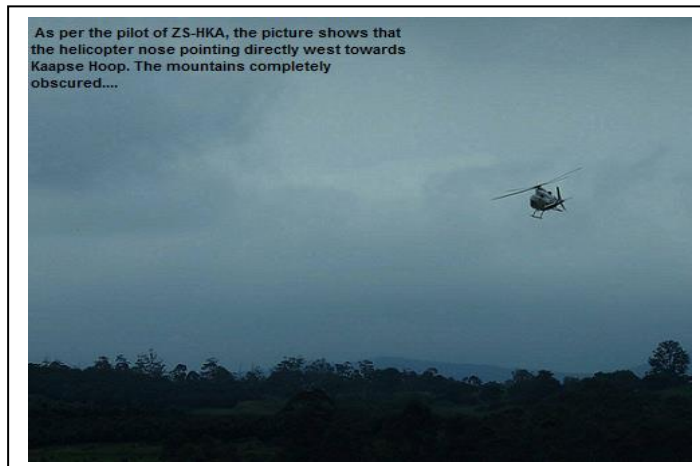
Figure 4 showing the clouds obscuring the mountains

The pilot stated that at the time when he was passing Belfast to the south a lot of cloud was observed on the high ground stretching to the horizon in the north. He managed to follow his planned route to the south and could remain VFR under low overcast conditions. At approximately 0818Z he landed on the farm of his friend under solid overcast with the mountains to the west obscured in cloud.

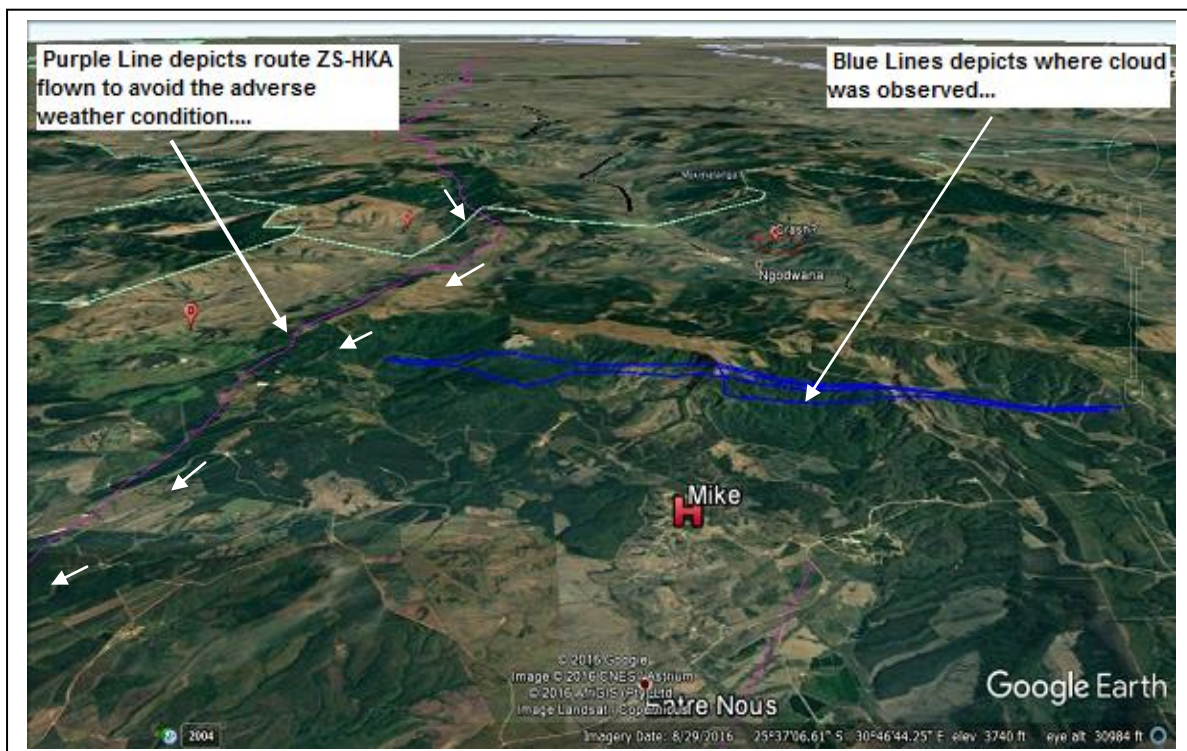
Figure 5 indicating the route taken by ZS-HKA and the area which was covered by clouds.

After about 1007Z (± 3 hours 9 min time) on the ground visiting his friend, he took off for FAKN to the north. His observation was that the ridge line between the Barberton Valley and Nelspruit was open under overcast and broken cloud. The mountain tops towards Ngodwana/Kaapse Hoop were still obscured at this time. He flew to FAKN without incident and landed there at about 1021Z. Whilst waiting to be refuelled, he observed a light aircraft (possibly ZS-OWB) taking off. It should be noted that due to deteriorating weather condition Wx on route he decided to do a night stop at FAKN”.

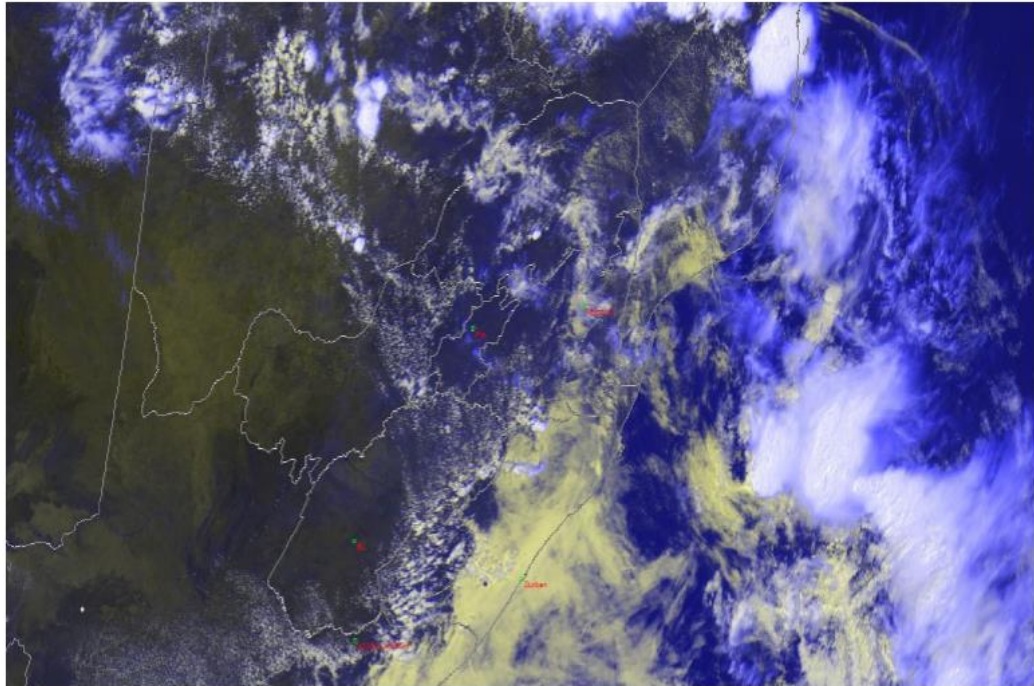
(ii) Satellite image

The satellite image in Attachment A indicates low level clouds above FAKN and adjacent interior, but clearer to the west.

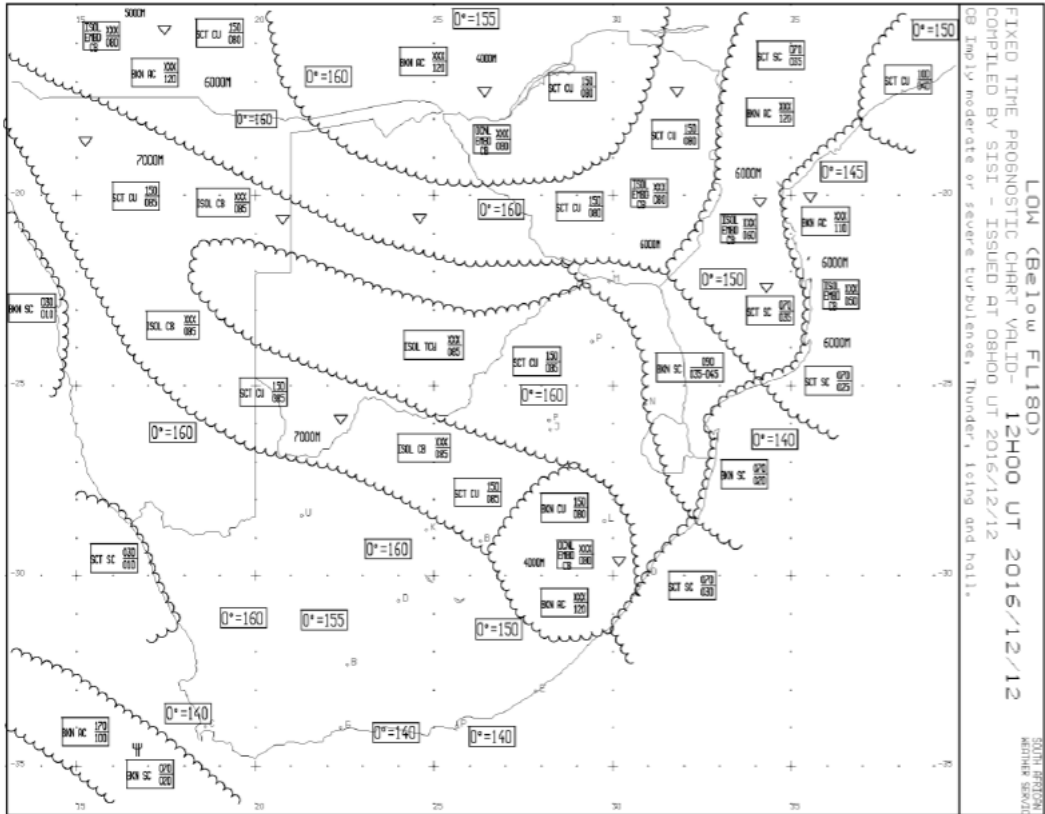
ATTACHMENT C: 12Z Significant Weather Chart

The forecast valid at 1200Z: Broken low cloud (Stratocumulus) was forecast with bases at 3500-4500 feet above MSL with tops at 9000 feet, but clearing westwards to Scattered Cumulus with bases at 8500 feet and tops at 16000 feet
