AIRCRAFT ACCIDENT REPORT AND EXECUTIVE SUMMARY

Reference:	CA18/2/3/9606	
Aircraft Registration	ZS-JTC	Date of Accident	18 March 2017		Time of Accident	1245Z
Type of Aircraft	Cessna 172N (Aeroplane)		Type of Operation		Part 141	
Pilot-in-command Licence Type	Student Pilot	Age	20	Licence Valid	Yes	
Pilot-in-command Flying Experience	Total Flying Hours	49.4		Hours on Type	26.4	
Last point of departure	Vereeniging aerodrome (FAVV): Gauteng province					
Next point of intended landing	Potchefstroom aerodrome (FAPS): North West province					
Location of the accident site with reference to easily defined geographical points (GPS readings if possible)						
177m right of runway 21 threshold at GPS co-ordinates determined to be S26° 40. 14.8" E27° 04. 29.4" at an elevation of approximately 4 520 ft AMSL.						
Meteorological Information	Temperature, 27°C: Dew point, 7°C: Wind speed, 12 knots: Wind direction, 200° magnetic: Visibility, 10 km: CAVOK.

AIRCRAFT ACCIDENT REPORT

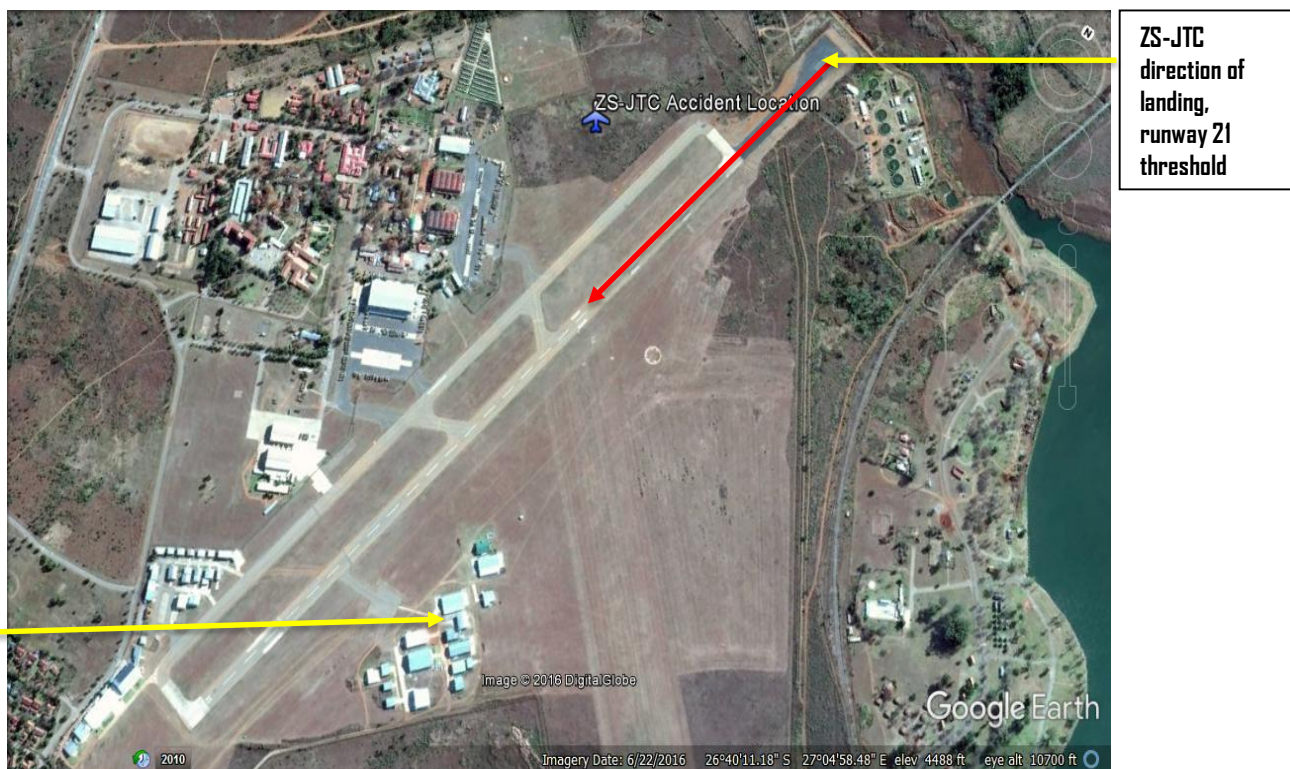
Figure 4: FAPS Google Earth map showing the accident side, about 177 metres parallel to runway 21

1.12.1 The wreckage was located on the eastern side of the runway boundary fence of FAPS aerodrome, approximately 177 meters parallel to the threshold of runway 21. During the impact sequence, the aircraft structure and airframe received progressively more damage as it impacted the ground surface. However, the aircraft structure remained intact except for the failed nose gear strut. The nose wheel was properly secured into the wheel axle/fork with the tyre properly inflated with nitrogen dry air as recommended by the manufacturer. The aircraft spring loaded main gear was examined and found to be intact, with both main wheel tires properly inflated with nitrogen dry air following the manufacture's specifications. The aircraft structure was thoroughly examined and nothing was missing. Visual inspection showed no evidence of a possible engine oil leak on the aircraft structure and the underbelly. All antennas and the navigation lights were accounted for and were properly secured to their respective mounting areas.

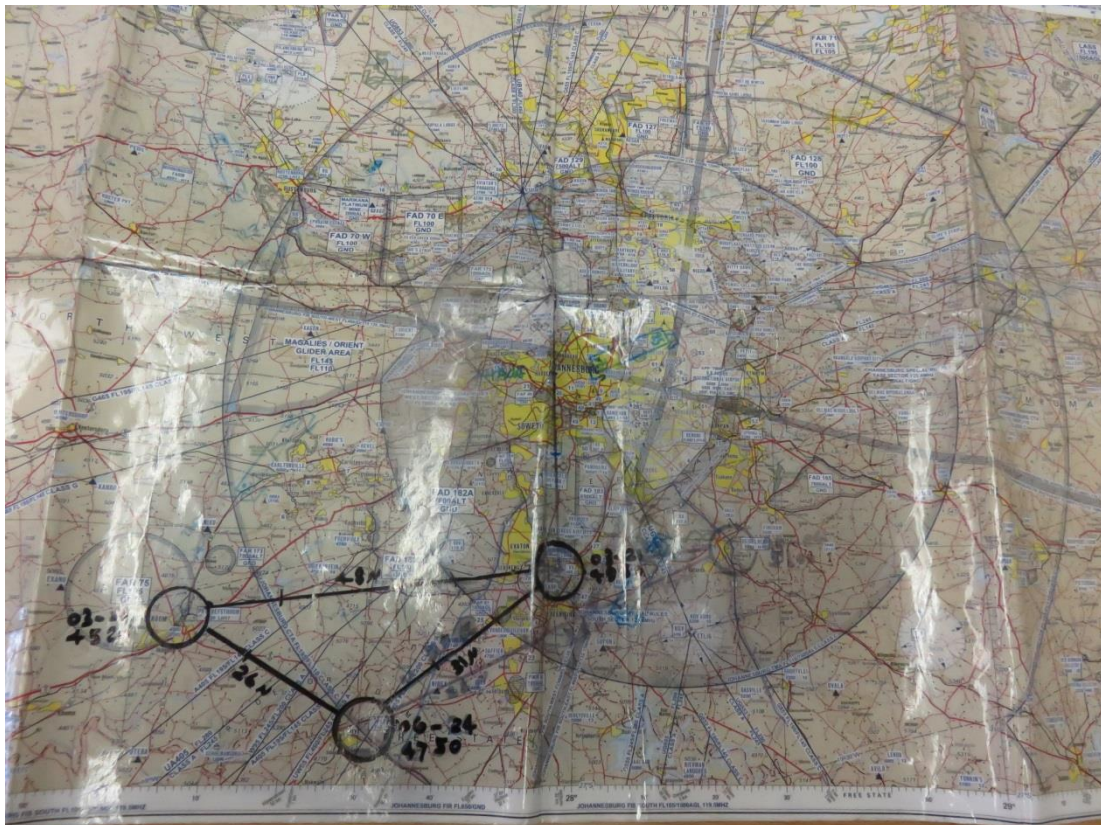
5.2 Aeronautical map found in the aircraft.

1.8.1 The aircraft was equipped with standard navigational equipment that meets the requirements of the regulator. According to the available information, the student pilot had an iPad on-board the aircraft. The iPad was found on the student's feet inside the aircraft. A white universal serial bus (USB) charger cable was also found lying near the rudder pedals. The device was removed from the aircraft and handed over to one of his associates after he was rushed to hospital for medical care. Efforts were made to find the iPad, but without success. According to the flight school, students are not allowed to use iPads during any portion of their initial training. However what they do outside of flying was entirely up to them. The school had recommended that students should learn to fly using steam gauge type instruments. After they have qualified they can do what they feel works for them. In addition a 1:50 000 000 aeronautical map (attached on appendices) was found with en-route checkpoints marked.
